Application Notes

Diagnosis of Vibration Problems in Holland

Case Studies from the Groenpol Vibration Consultancy

Matt o'Sullivan
Mechanical Engineer
Brüel and Kjær, Denmark

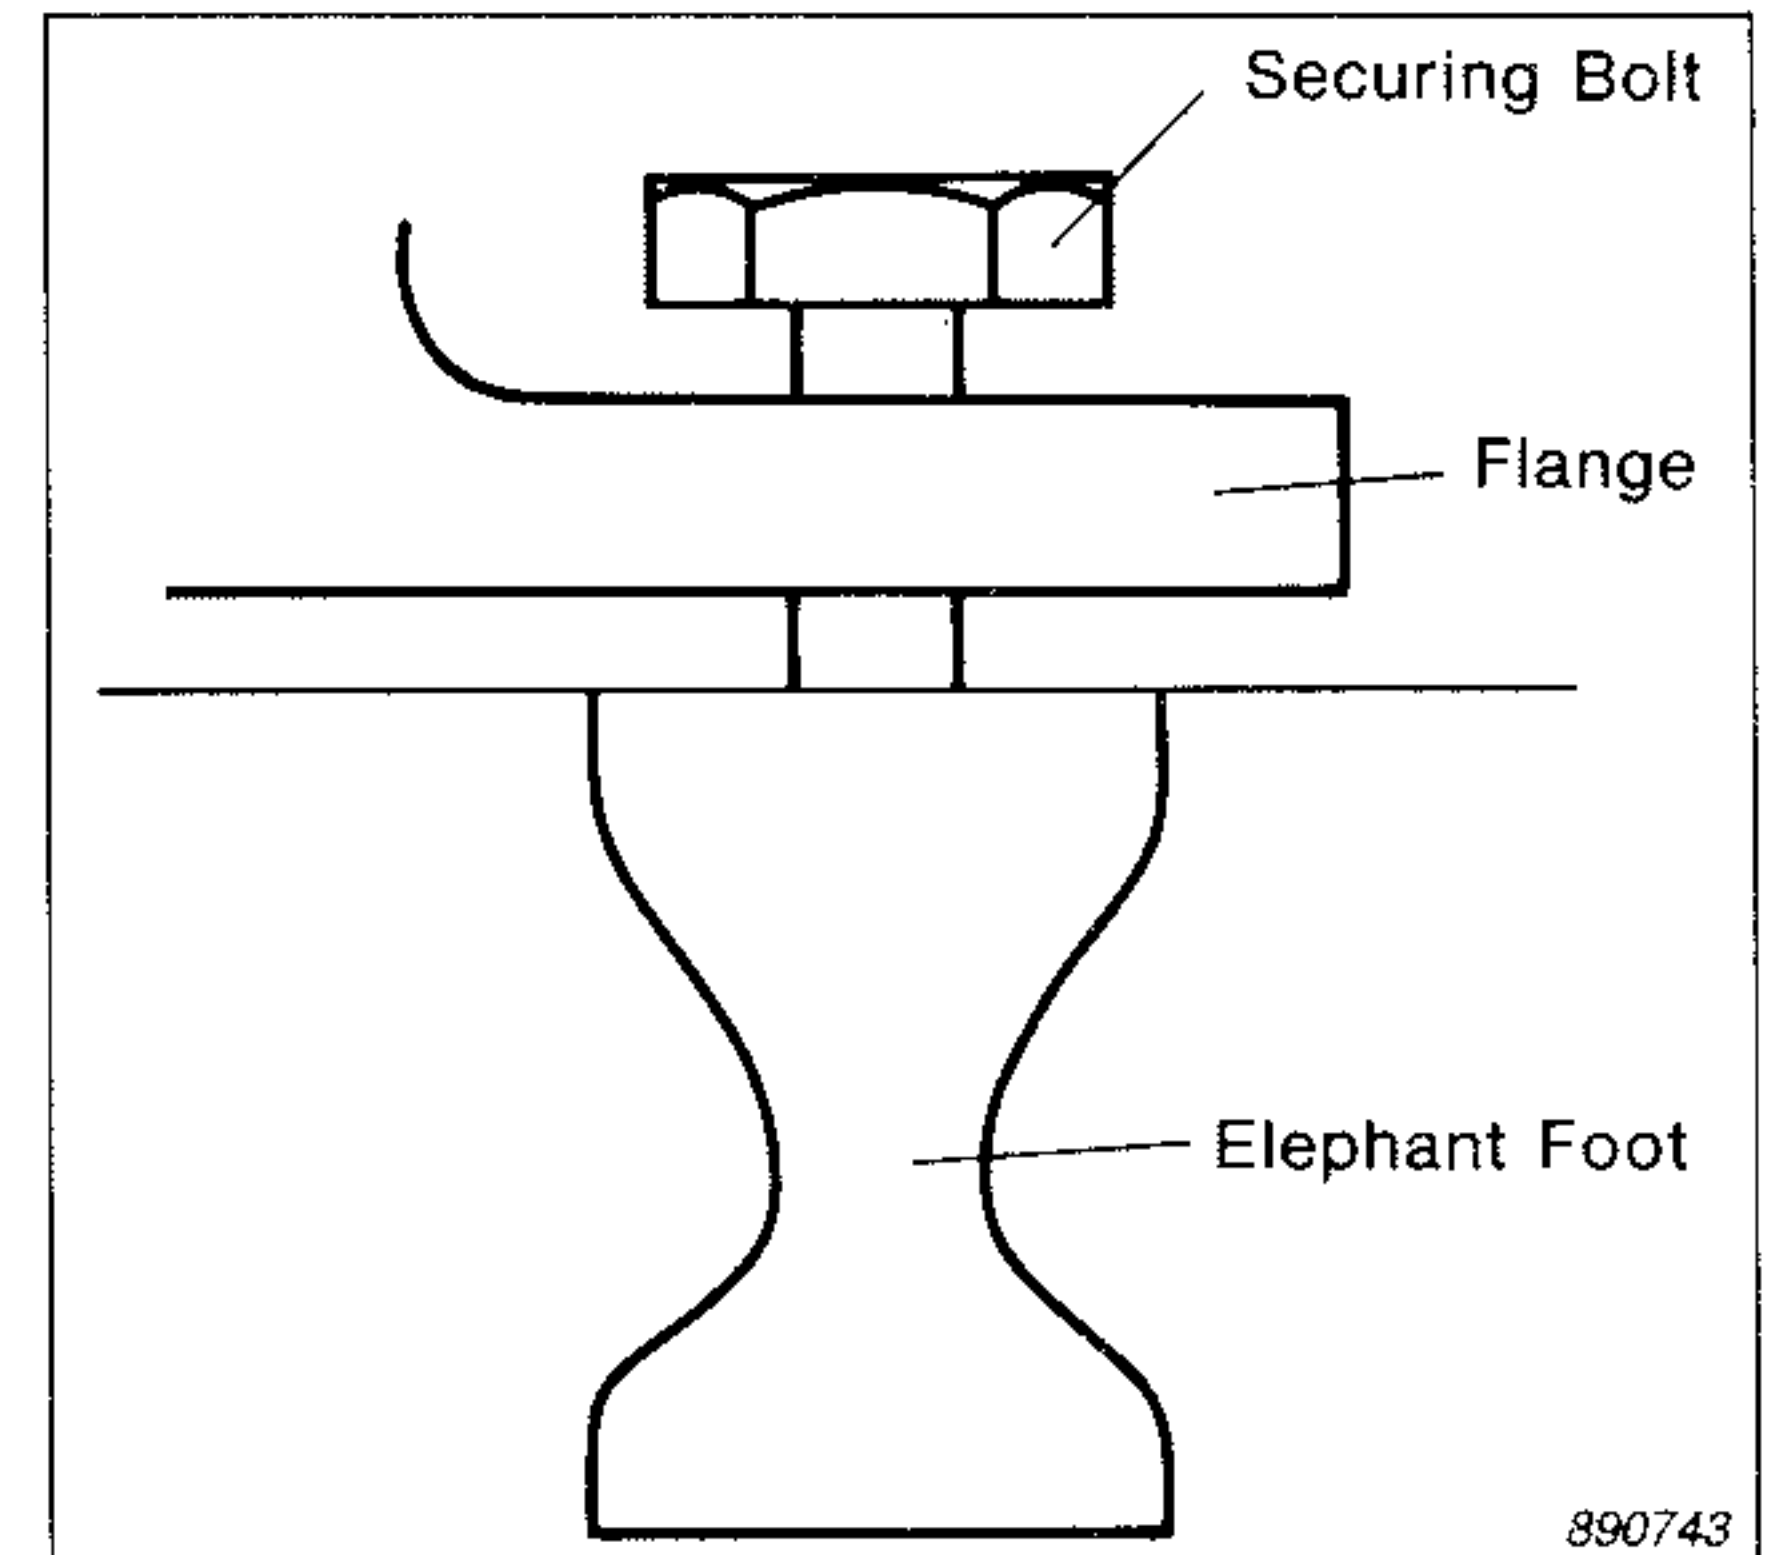
Fig. 2. A loose bolt, in its elephant foot, at the base of the non-driven end of the compressor. The casing is excited at the shaft rotation speed, causing a harmonic family of the shaft speed in the spectrum

They found two loose, worn bolts on the elephant feet at the non-driven end of the compressor, see Fig. 2. The company decided to wait until the next scheduled stop before replacing the bolts. After that, the machines would be ready for systematic monitoring.

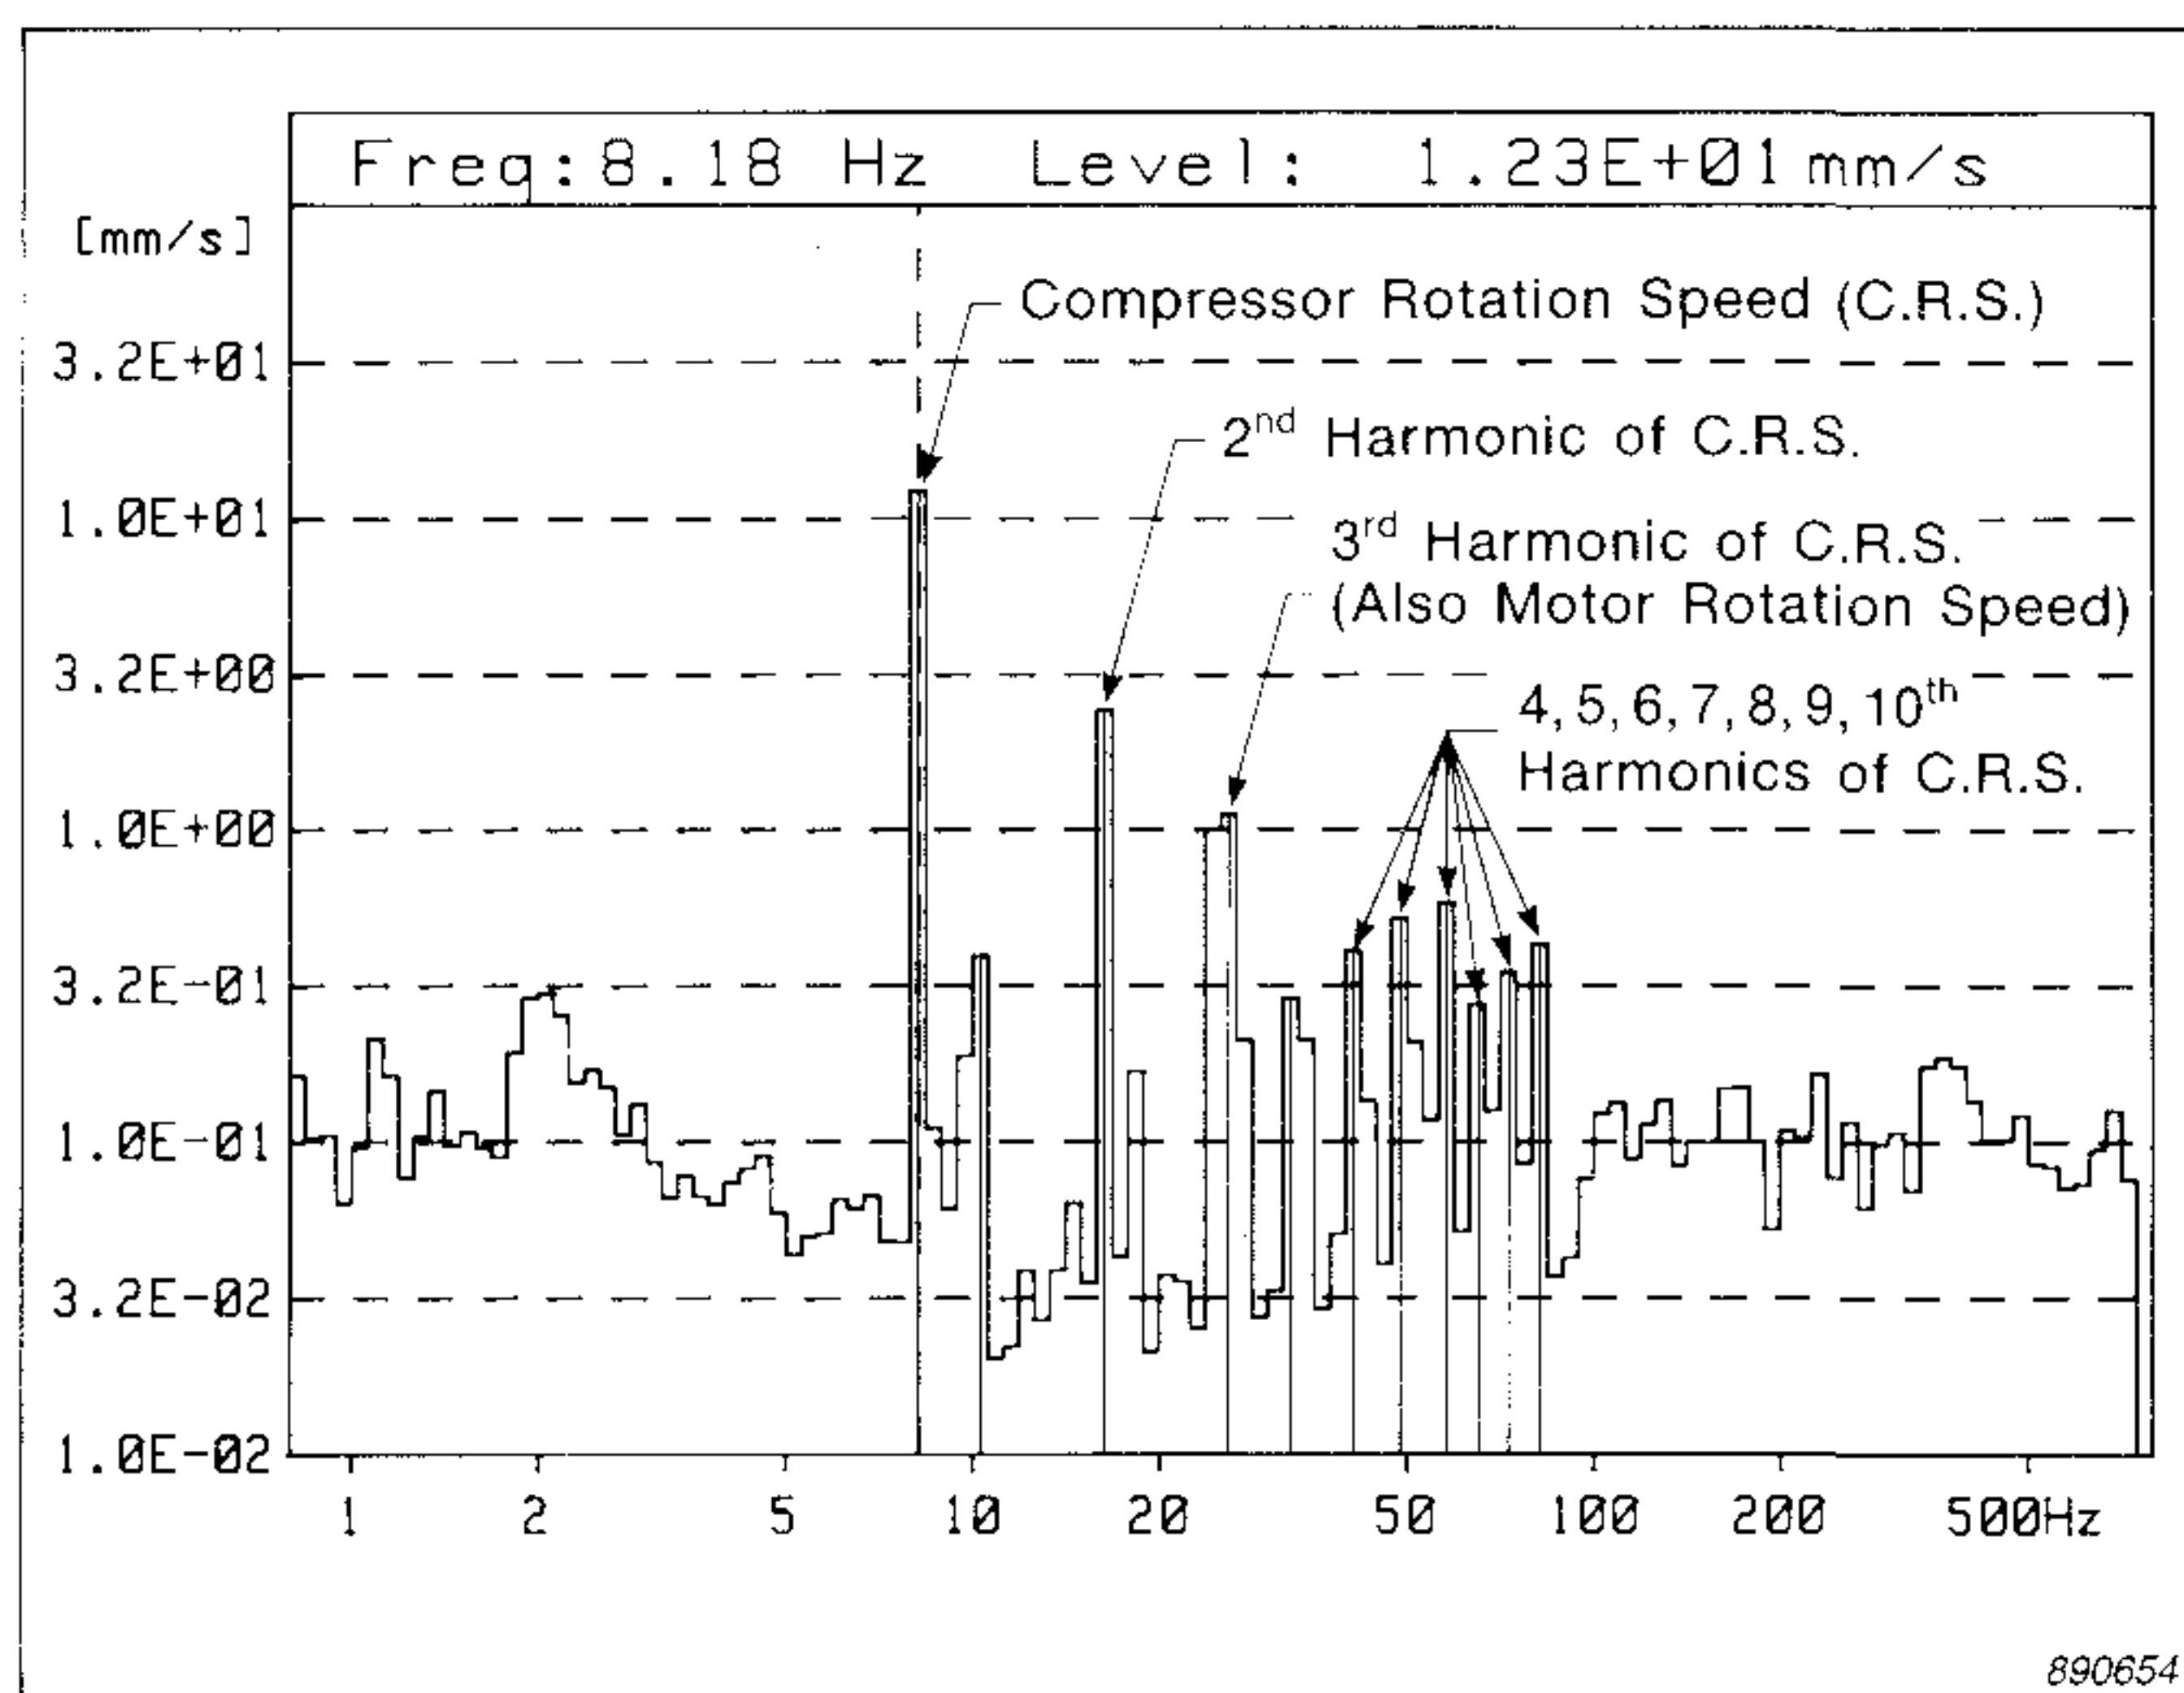
Fig. 3. A vertical measurement (500 Hz, CPB spectrum) from the compressor casing. The prominent harmonic family of the compressor rotation speed indicates looseness

The spectrum from the vertical measurement point is shown in Fig. 3. It contains a harmonic family of the rotation speed. They compared the vertical and horizontal spectra as shown in Fig. 4. The harmonic family in the vertical spectrum exceeds that in the horizontal spectrum, a result which indicates that the excessive vertical vibration is caused by mechanical looseness. Groenpol decided to check the bolts securing the compressor to its foundation.

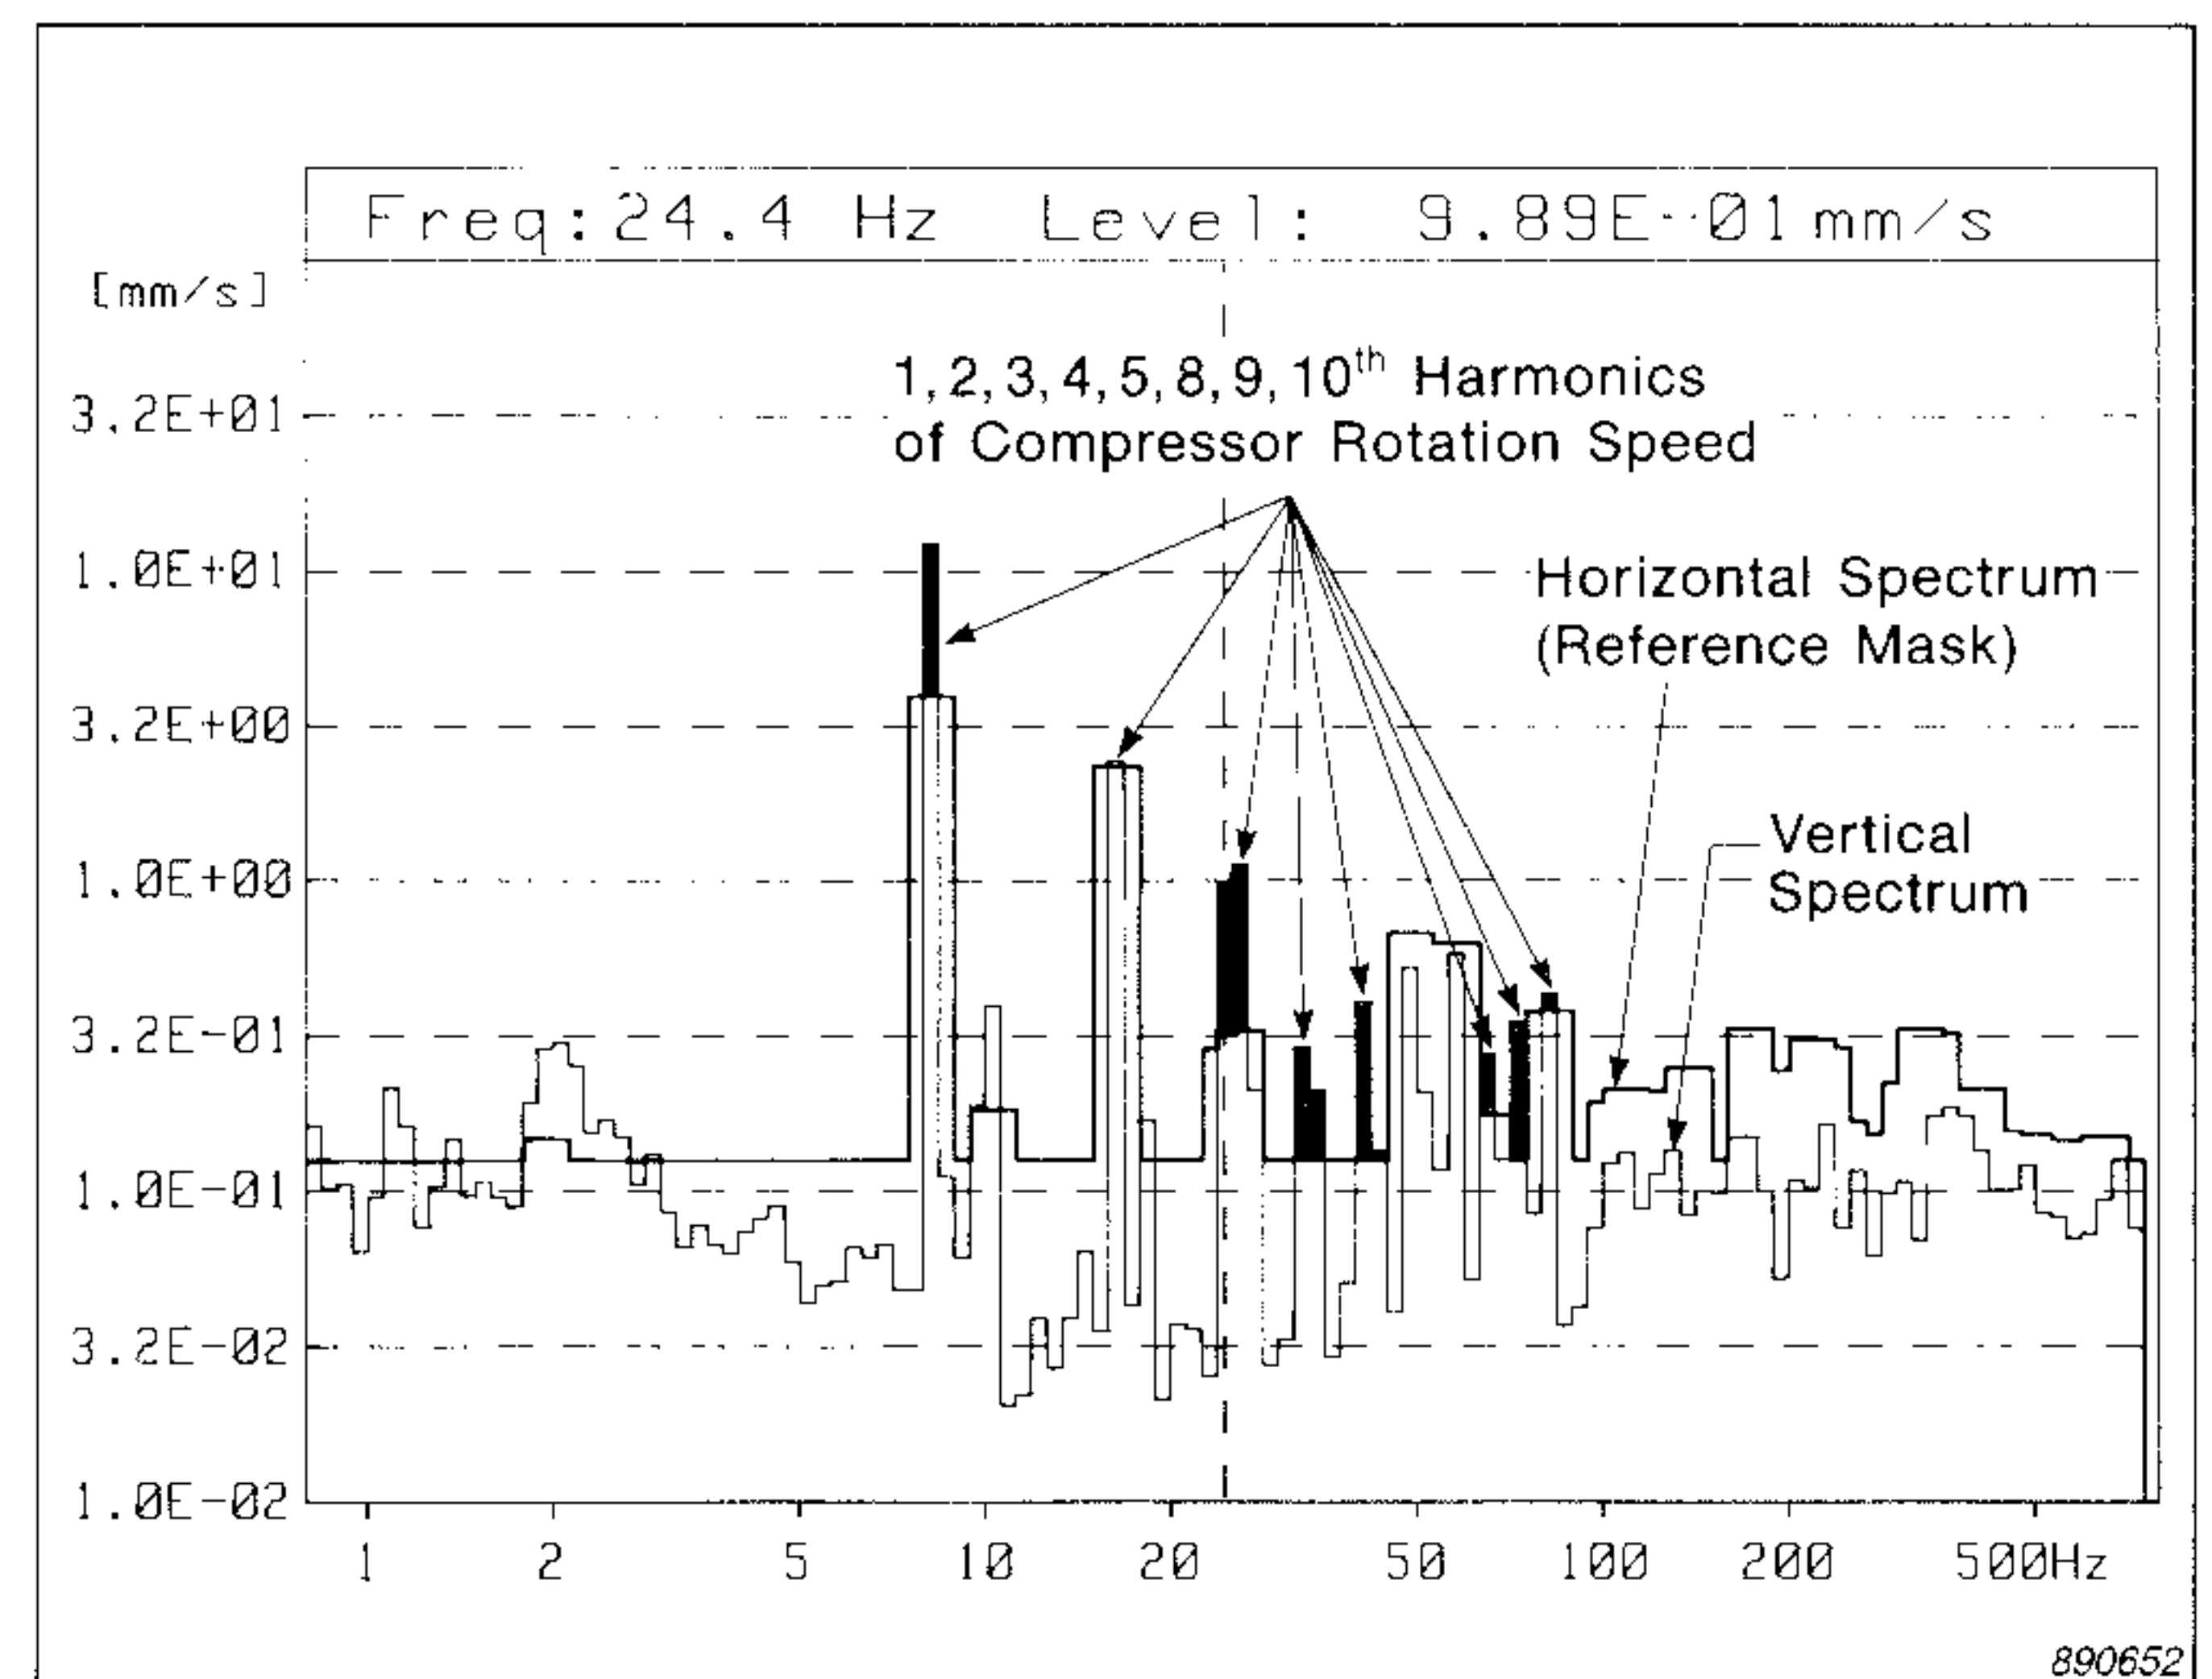
Fig. 4. A comparison of vertical and horizontal measurements (500 Hz, CPB spectra) from the compressor casing. The horizontal measurement is the reference. Note that the vertical exceeds the horizontal at harmonics of the compressor rotation speed

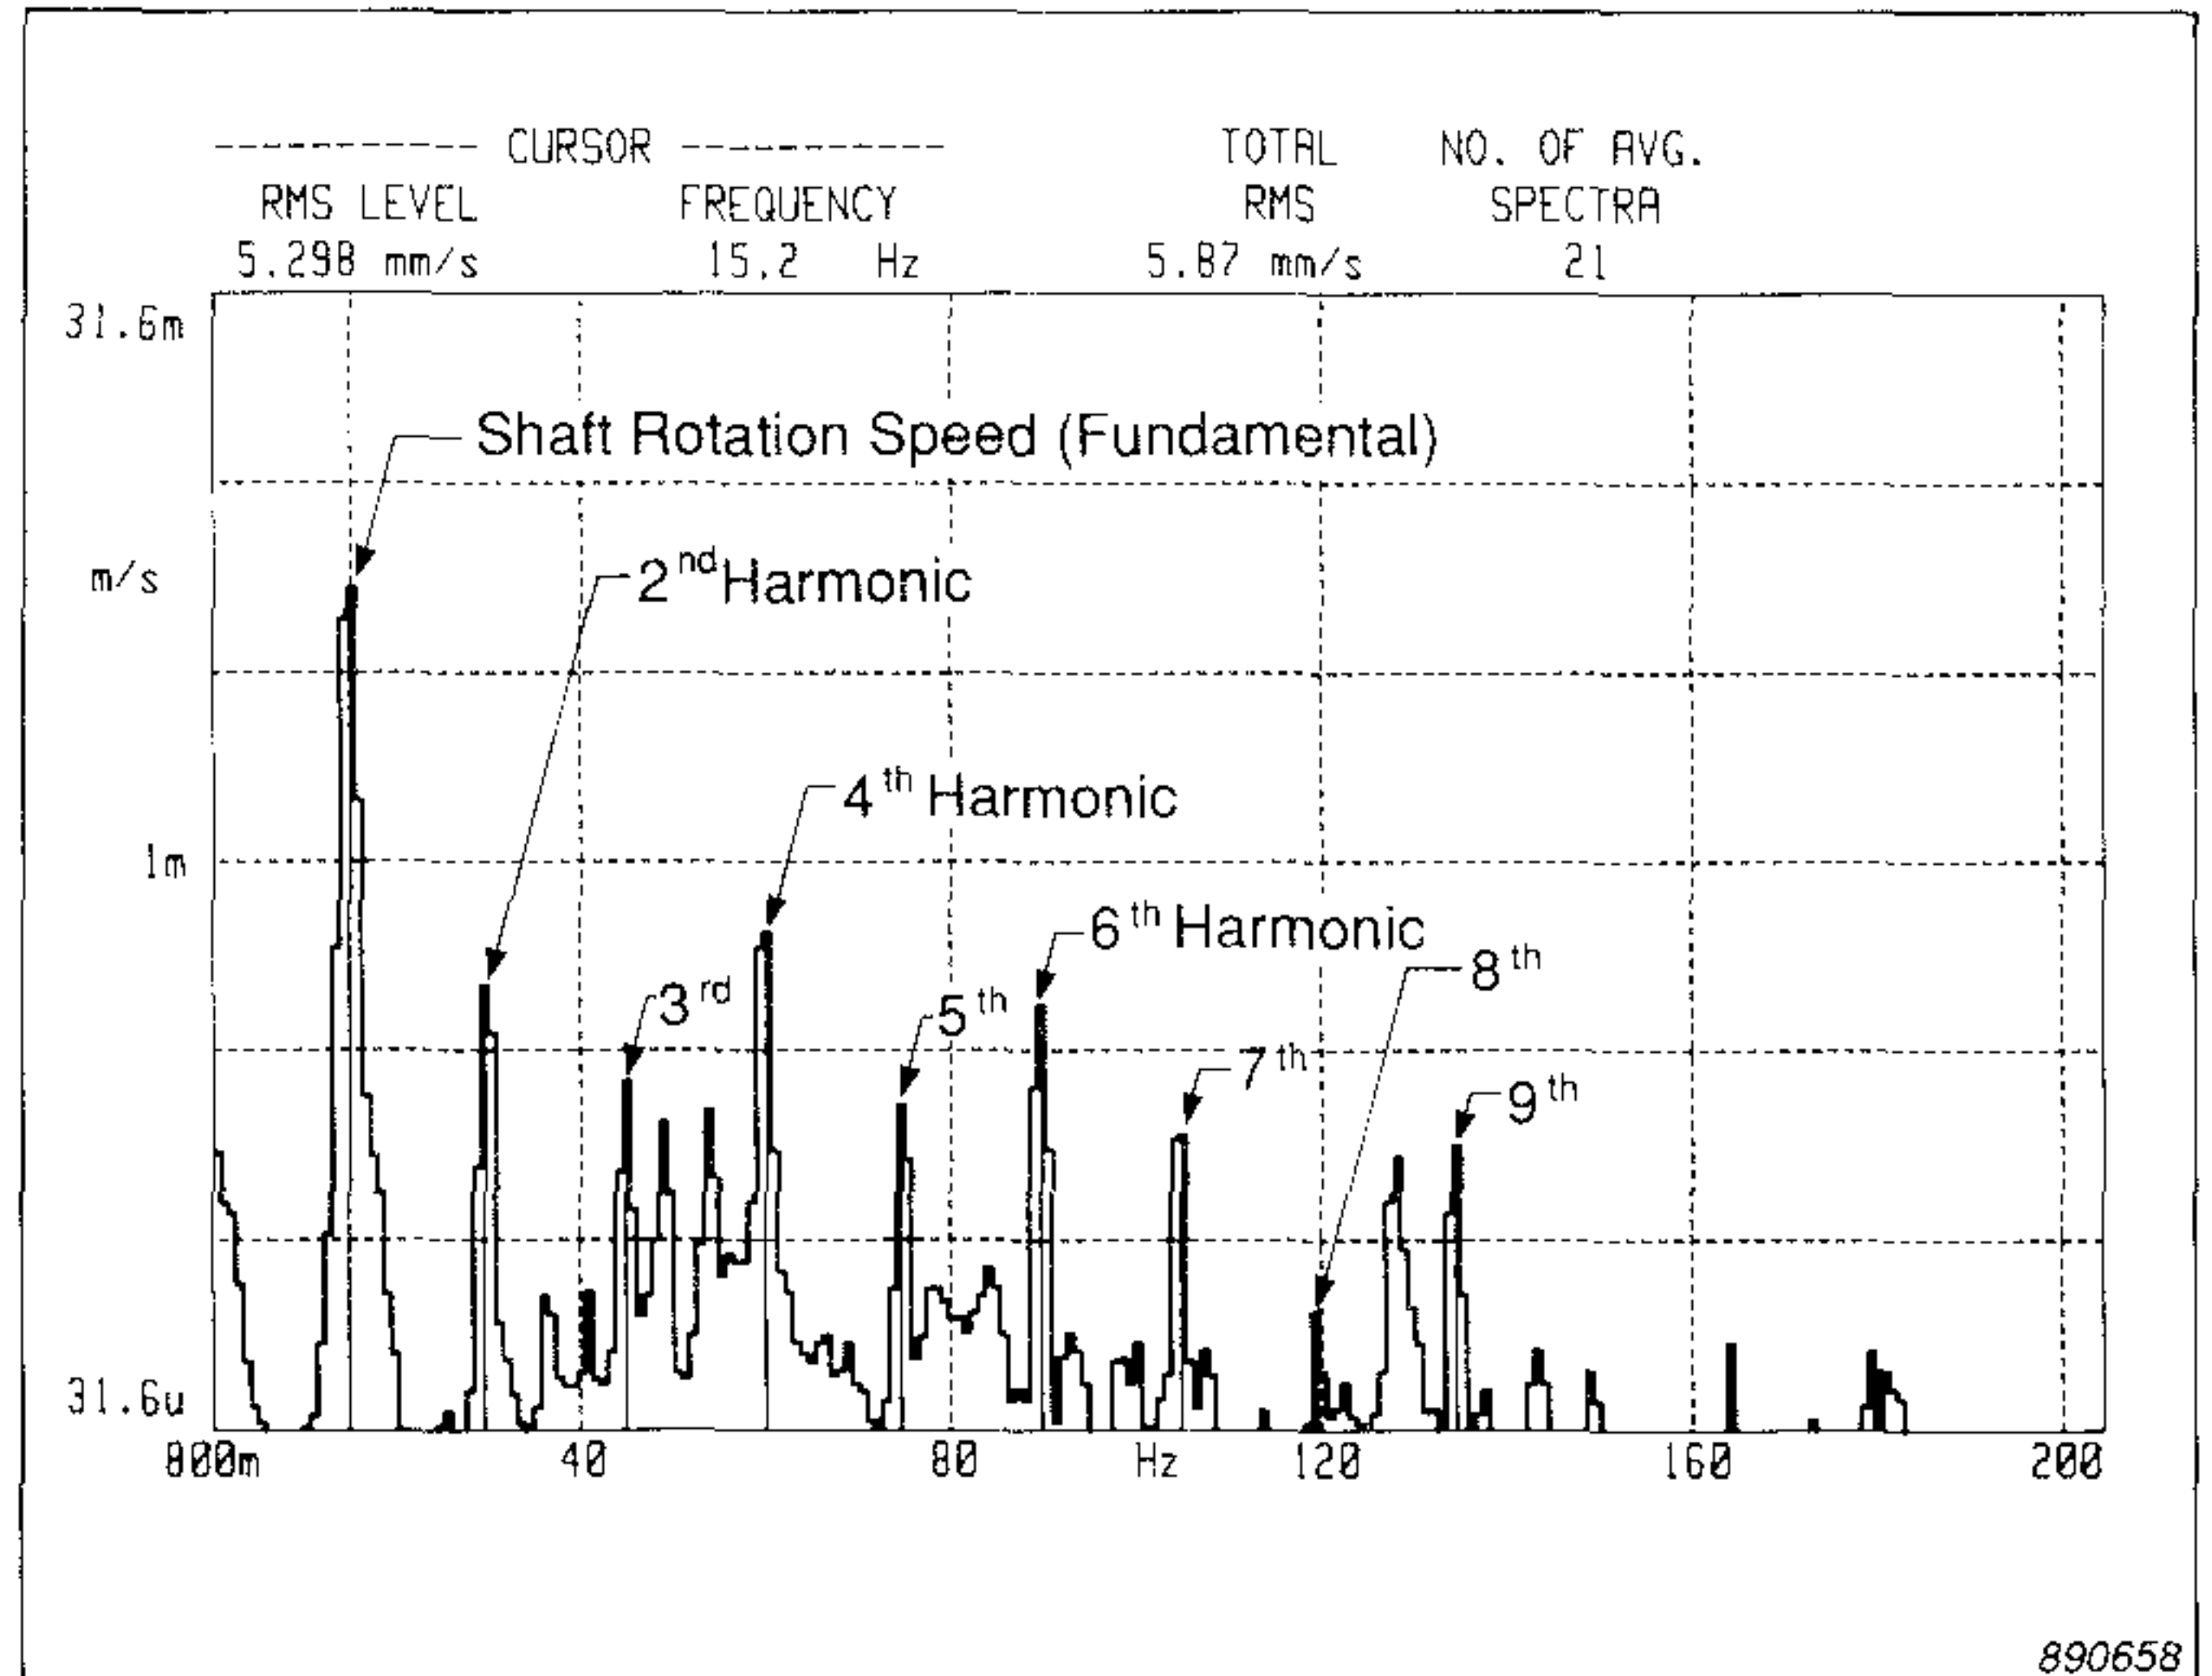
bration level at the motor rotation speed. The spectrum from measurement point 2 is shown in Fig.8. It shows that most of the vibration occurs at the rotation speed; from this Groenpol concluded that the main problem was unbalance.

The 2nd, 4th and 6th harmonics of rotation speed are prominent but their level is much lower; from this Groenpol suspected a misalignment problem at the coupling near measurement point 2.

Fig. 8. A horizontal, linear-baseband spectrum from measurement point 2. The high level at the motor speed indicates that the main problem is unbalance. The prominent $2 \times$ rotation speed harmonic family suggests a misalignment or coupling problem

Groenpol balanced the two pulleys in-situ. Next they uncoupled the pulleys from the motor and balanced the mo-

tor in-situ. Finally they examined the coupling and they found it was stiff and worn due to lack of grease. After it was cleaned and greased, and the shafts re-coupled, the machine operated normally. An overall RMS measurement confirmed that the vibration level was now acceptable.

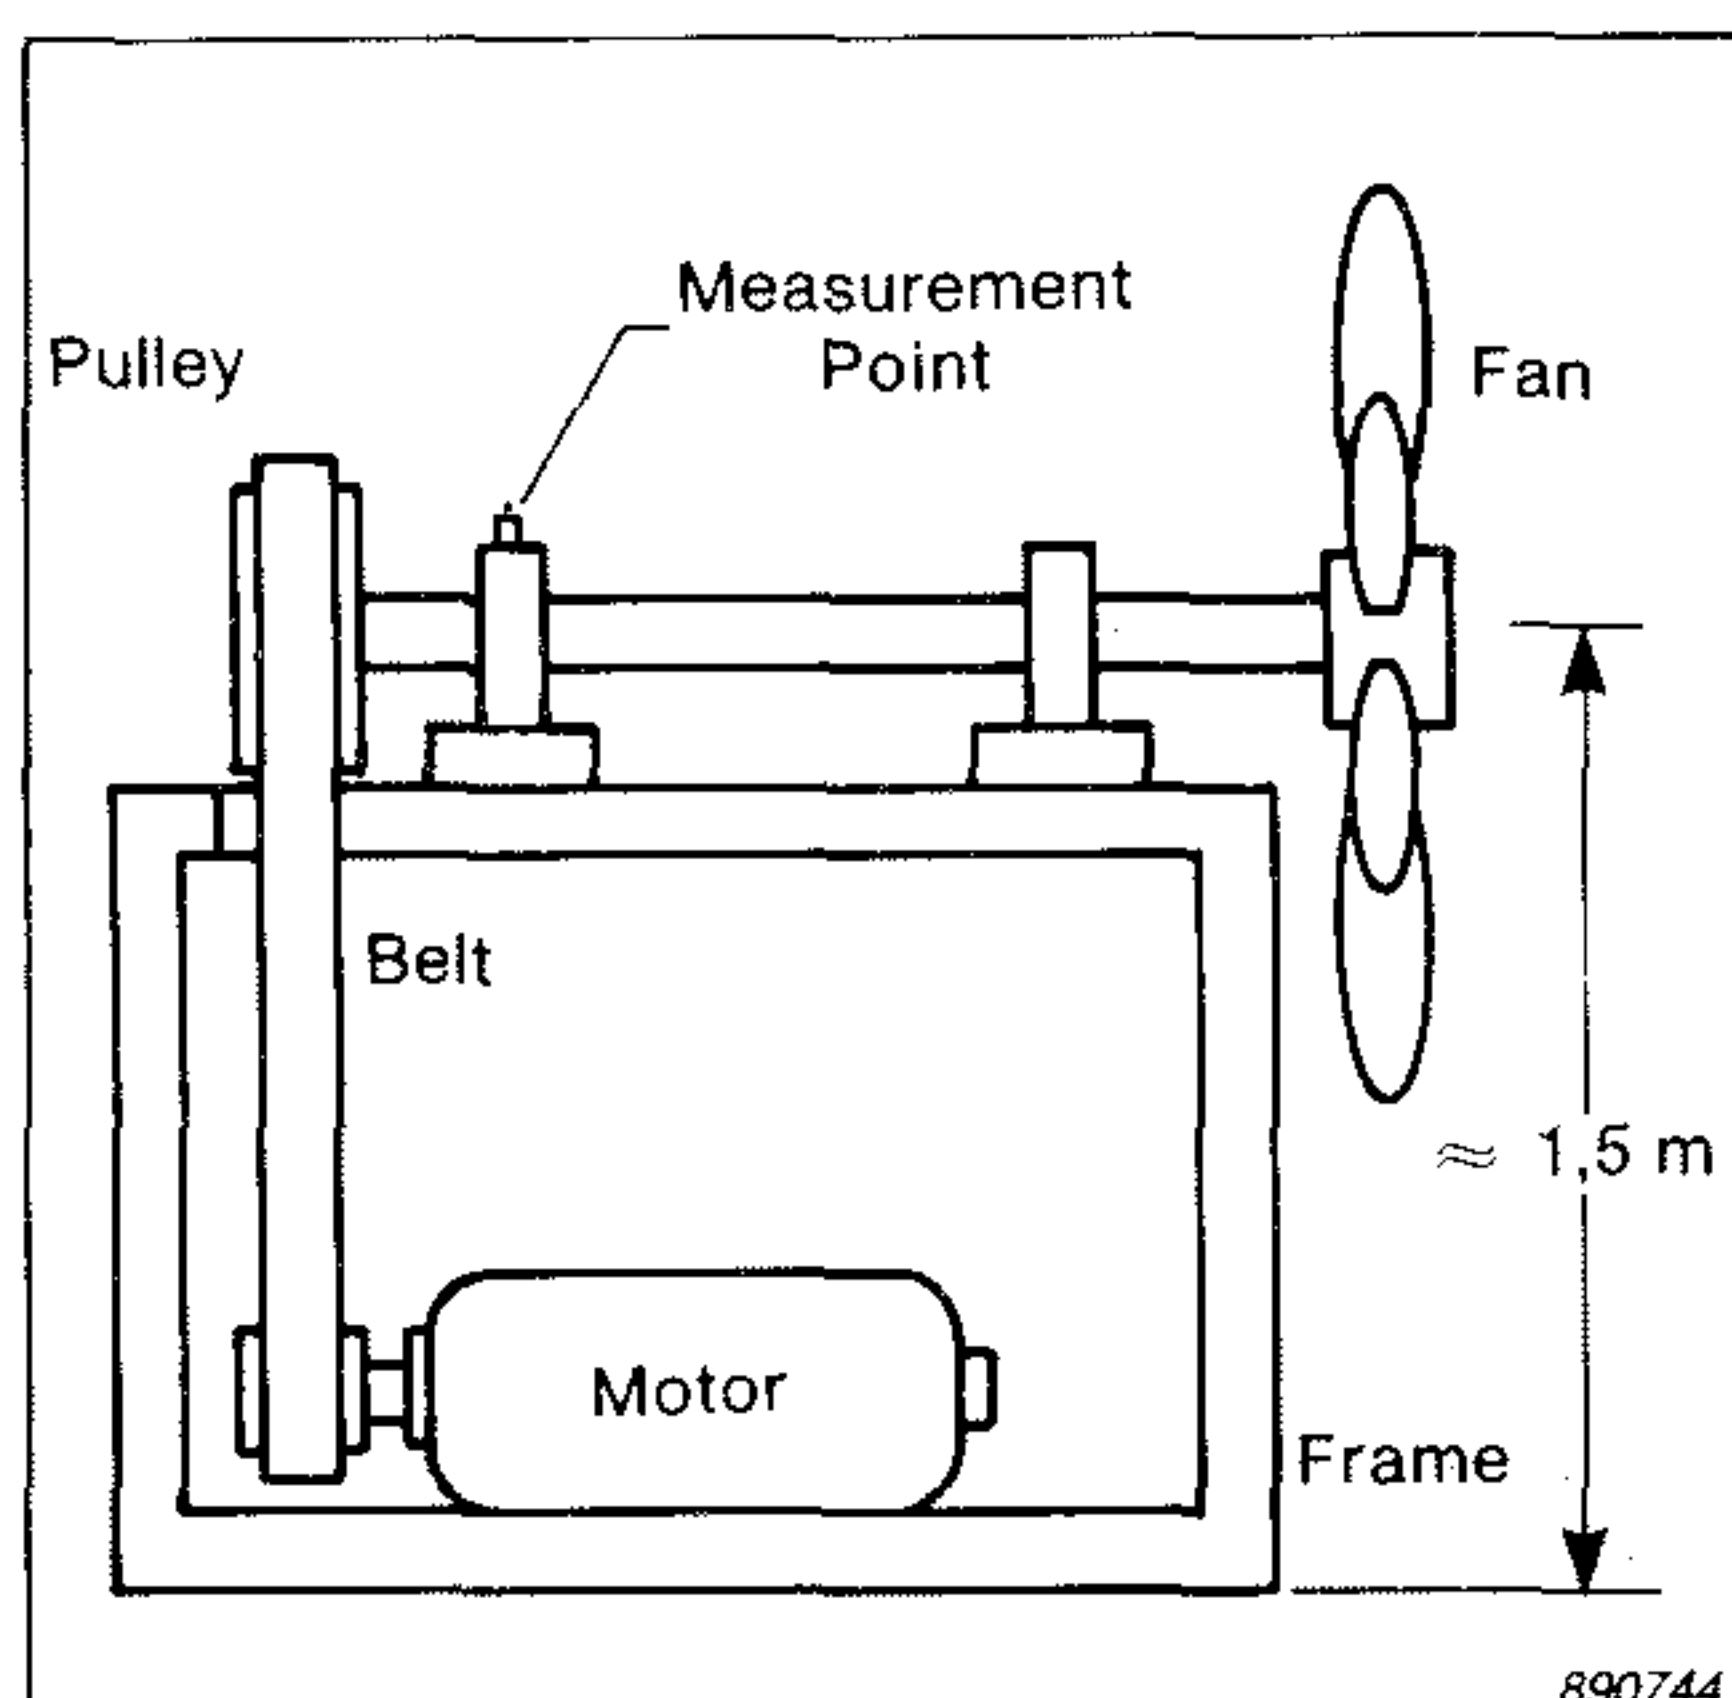
The company in this case manufactures Tarmacadam for road surfacing. The faulty fan is used to extract dust from the manufacturing area. It was located about 1.5 m from ground level, on top of a steel frame which stood unbolted to the floor, see Fig. 9.

Fig. 9. The motor drives the fan through a belt drive as shown. The frame sits loose on the floor

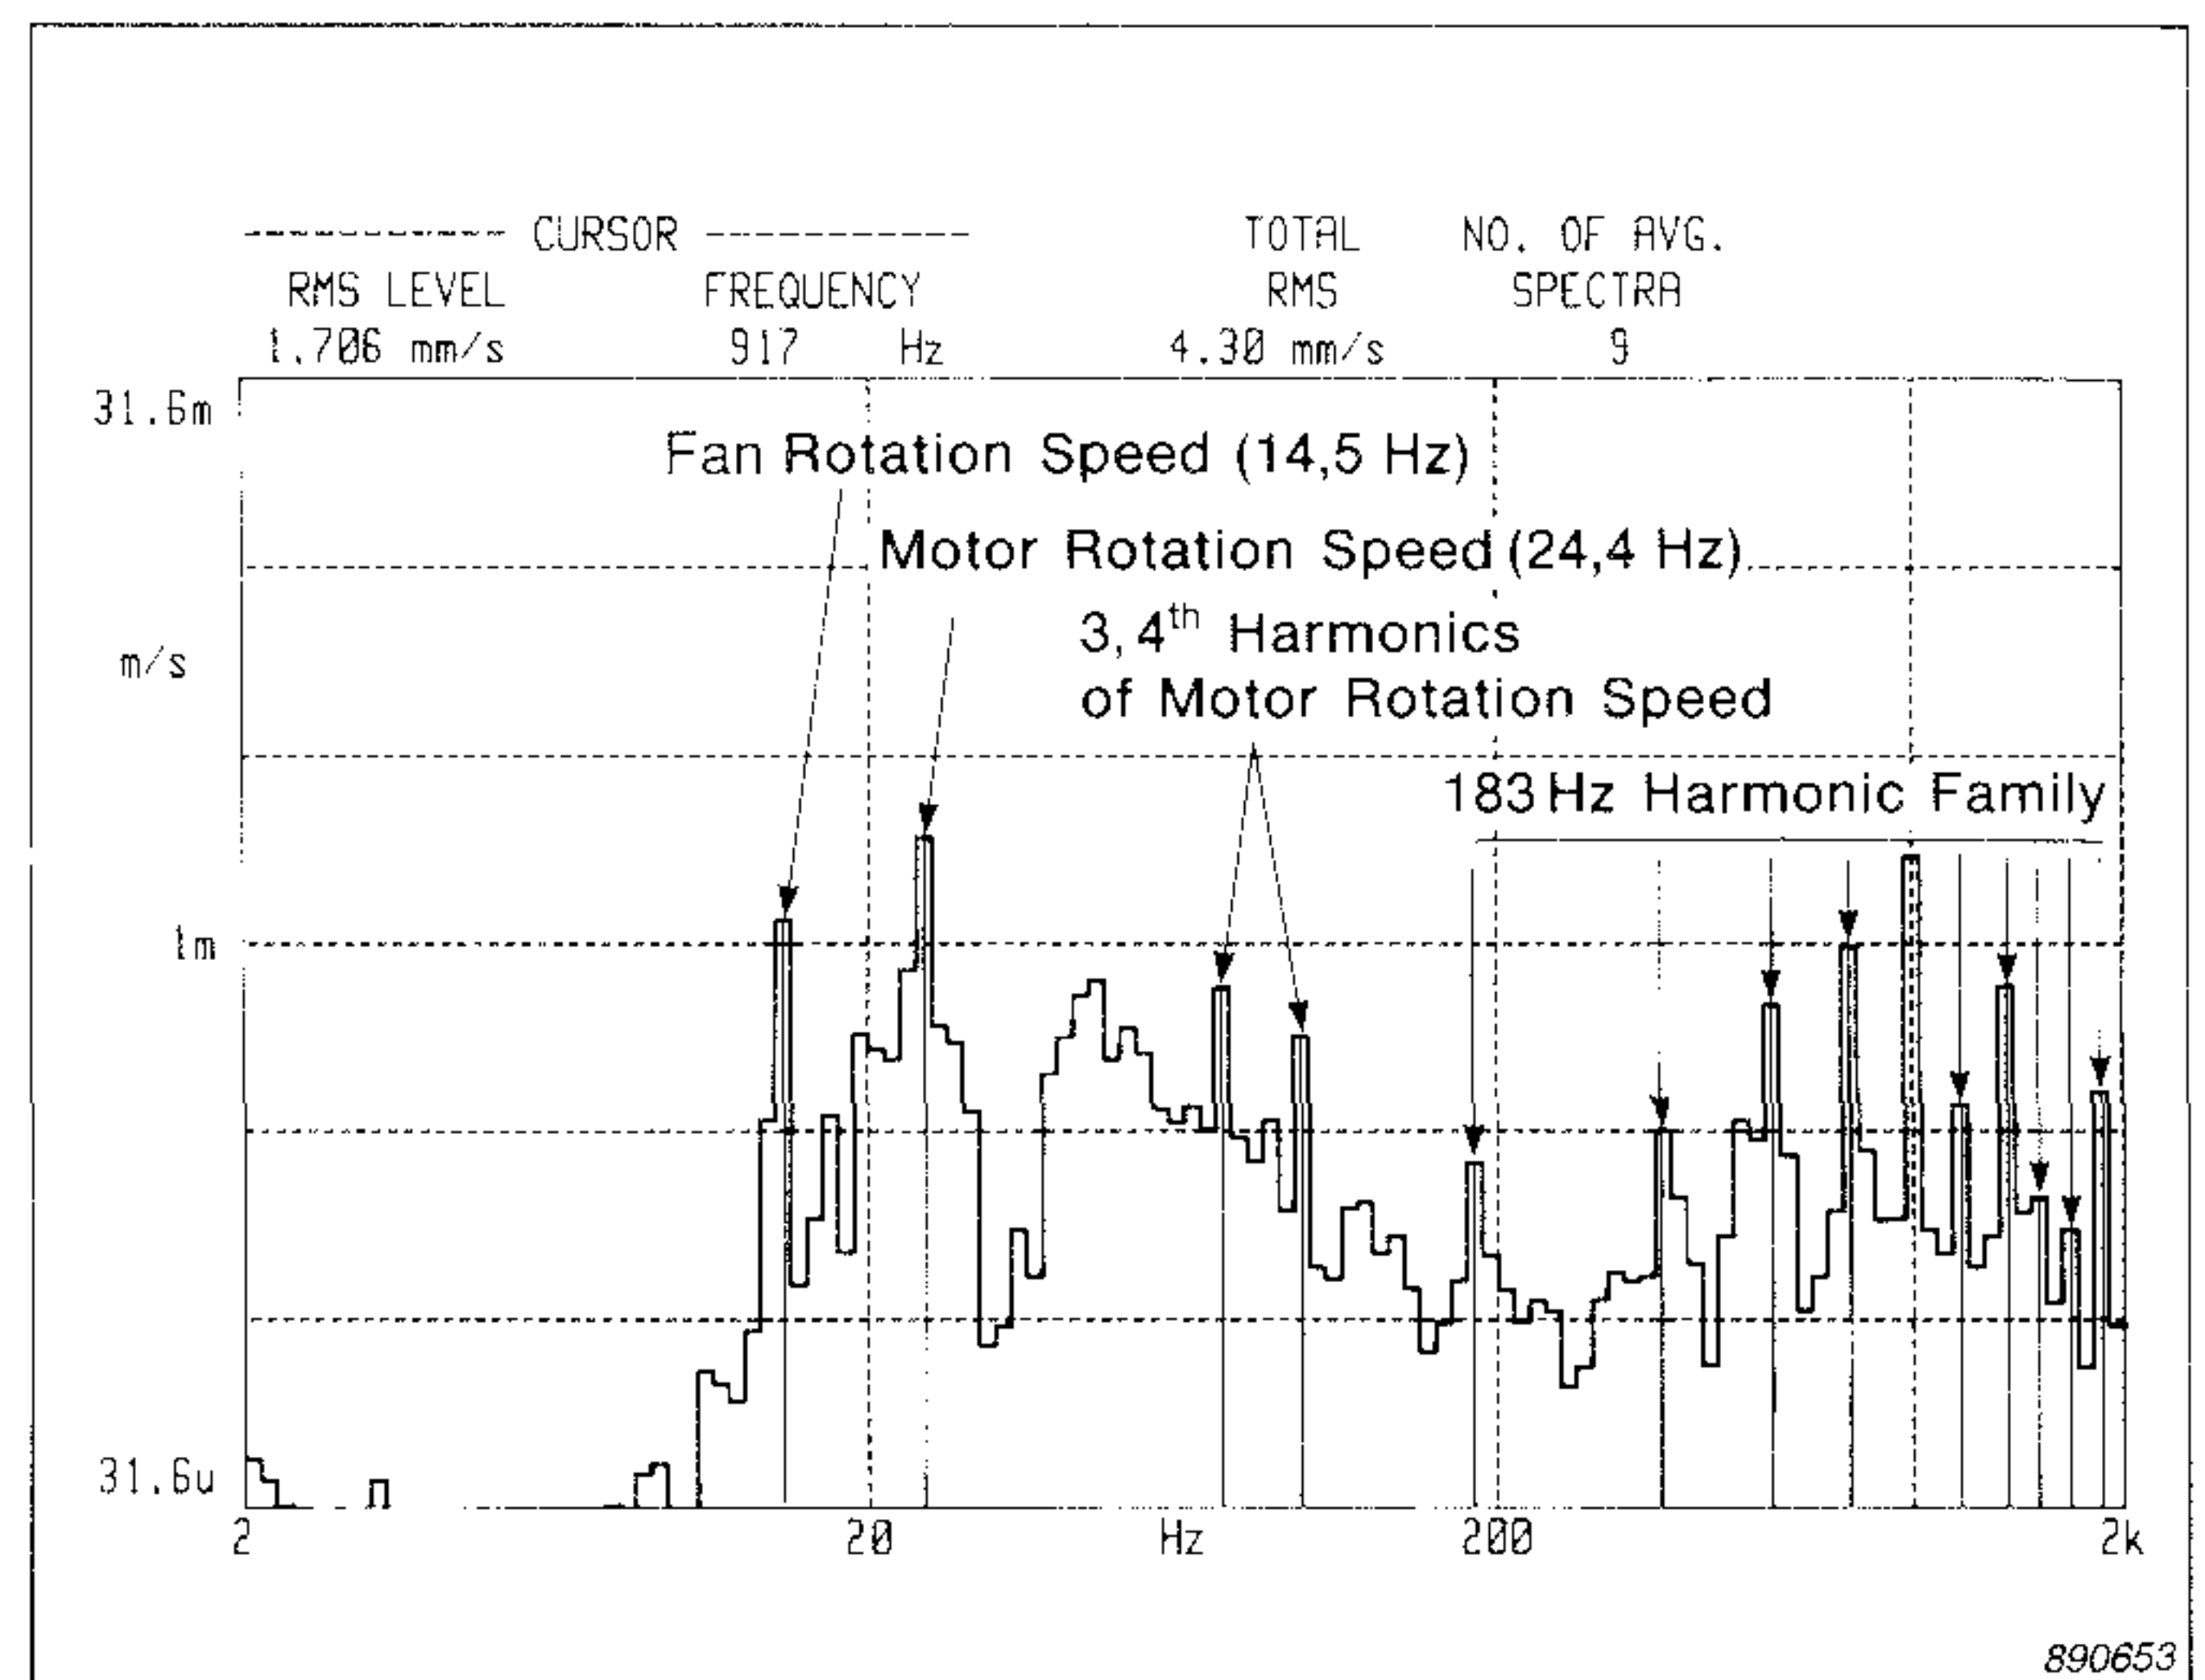
After the repairs were finished, Groenpol measured a horizontal, 2 kHz, 6% CPB spectrum at the bearing casing, at the driven end of the fan, see Fig. 12. The overall RMS level of 4.3 mms^{-1} was acceptably low. The origin of the main peaks in the spectrum is as follows:

Peak 1 is the fan rotation speed. This indicates residual unbalance in the fan.

Peaks 2, 3 and 4 are harmonics of the motor rotation speed. They are probably caused by the motor exciting the loose frame.

Peaks 5 to 11 are also members of a harmonic family. Peak 5 is the fundamental with a frequency of 183 Hz. This does not correspond to any shaft rotation speeds. Instead it is probably

a characteristic ball-passing frequency of a roller element bearing, which indicates bearing fault. The harmonic family is prominent because it is amplified by resonances in the machine.

Fig. 12. Horizontal, 2kHz, 6% CPB spectrum. This was measured at the bearing casing, at the driven end of the fan shaft, after the frame was repaired. Note the two harmonic families
