Early Detection of Gear Faults Using Vibration Analysis in a Manufacturer's Test Department

Better Axle Gears on RABA Trucks:-

by Laszlo Boros, RABA, Győr, Hungary and Glenn H. Bate, Brüel & Kjær, Denmark

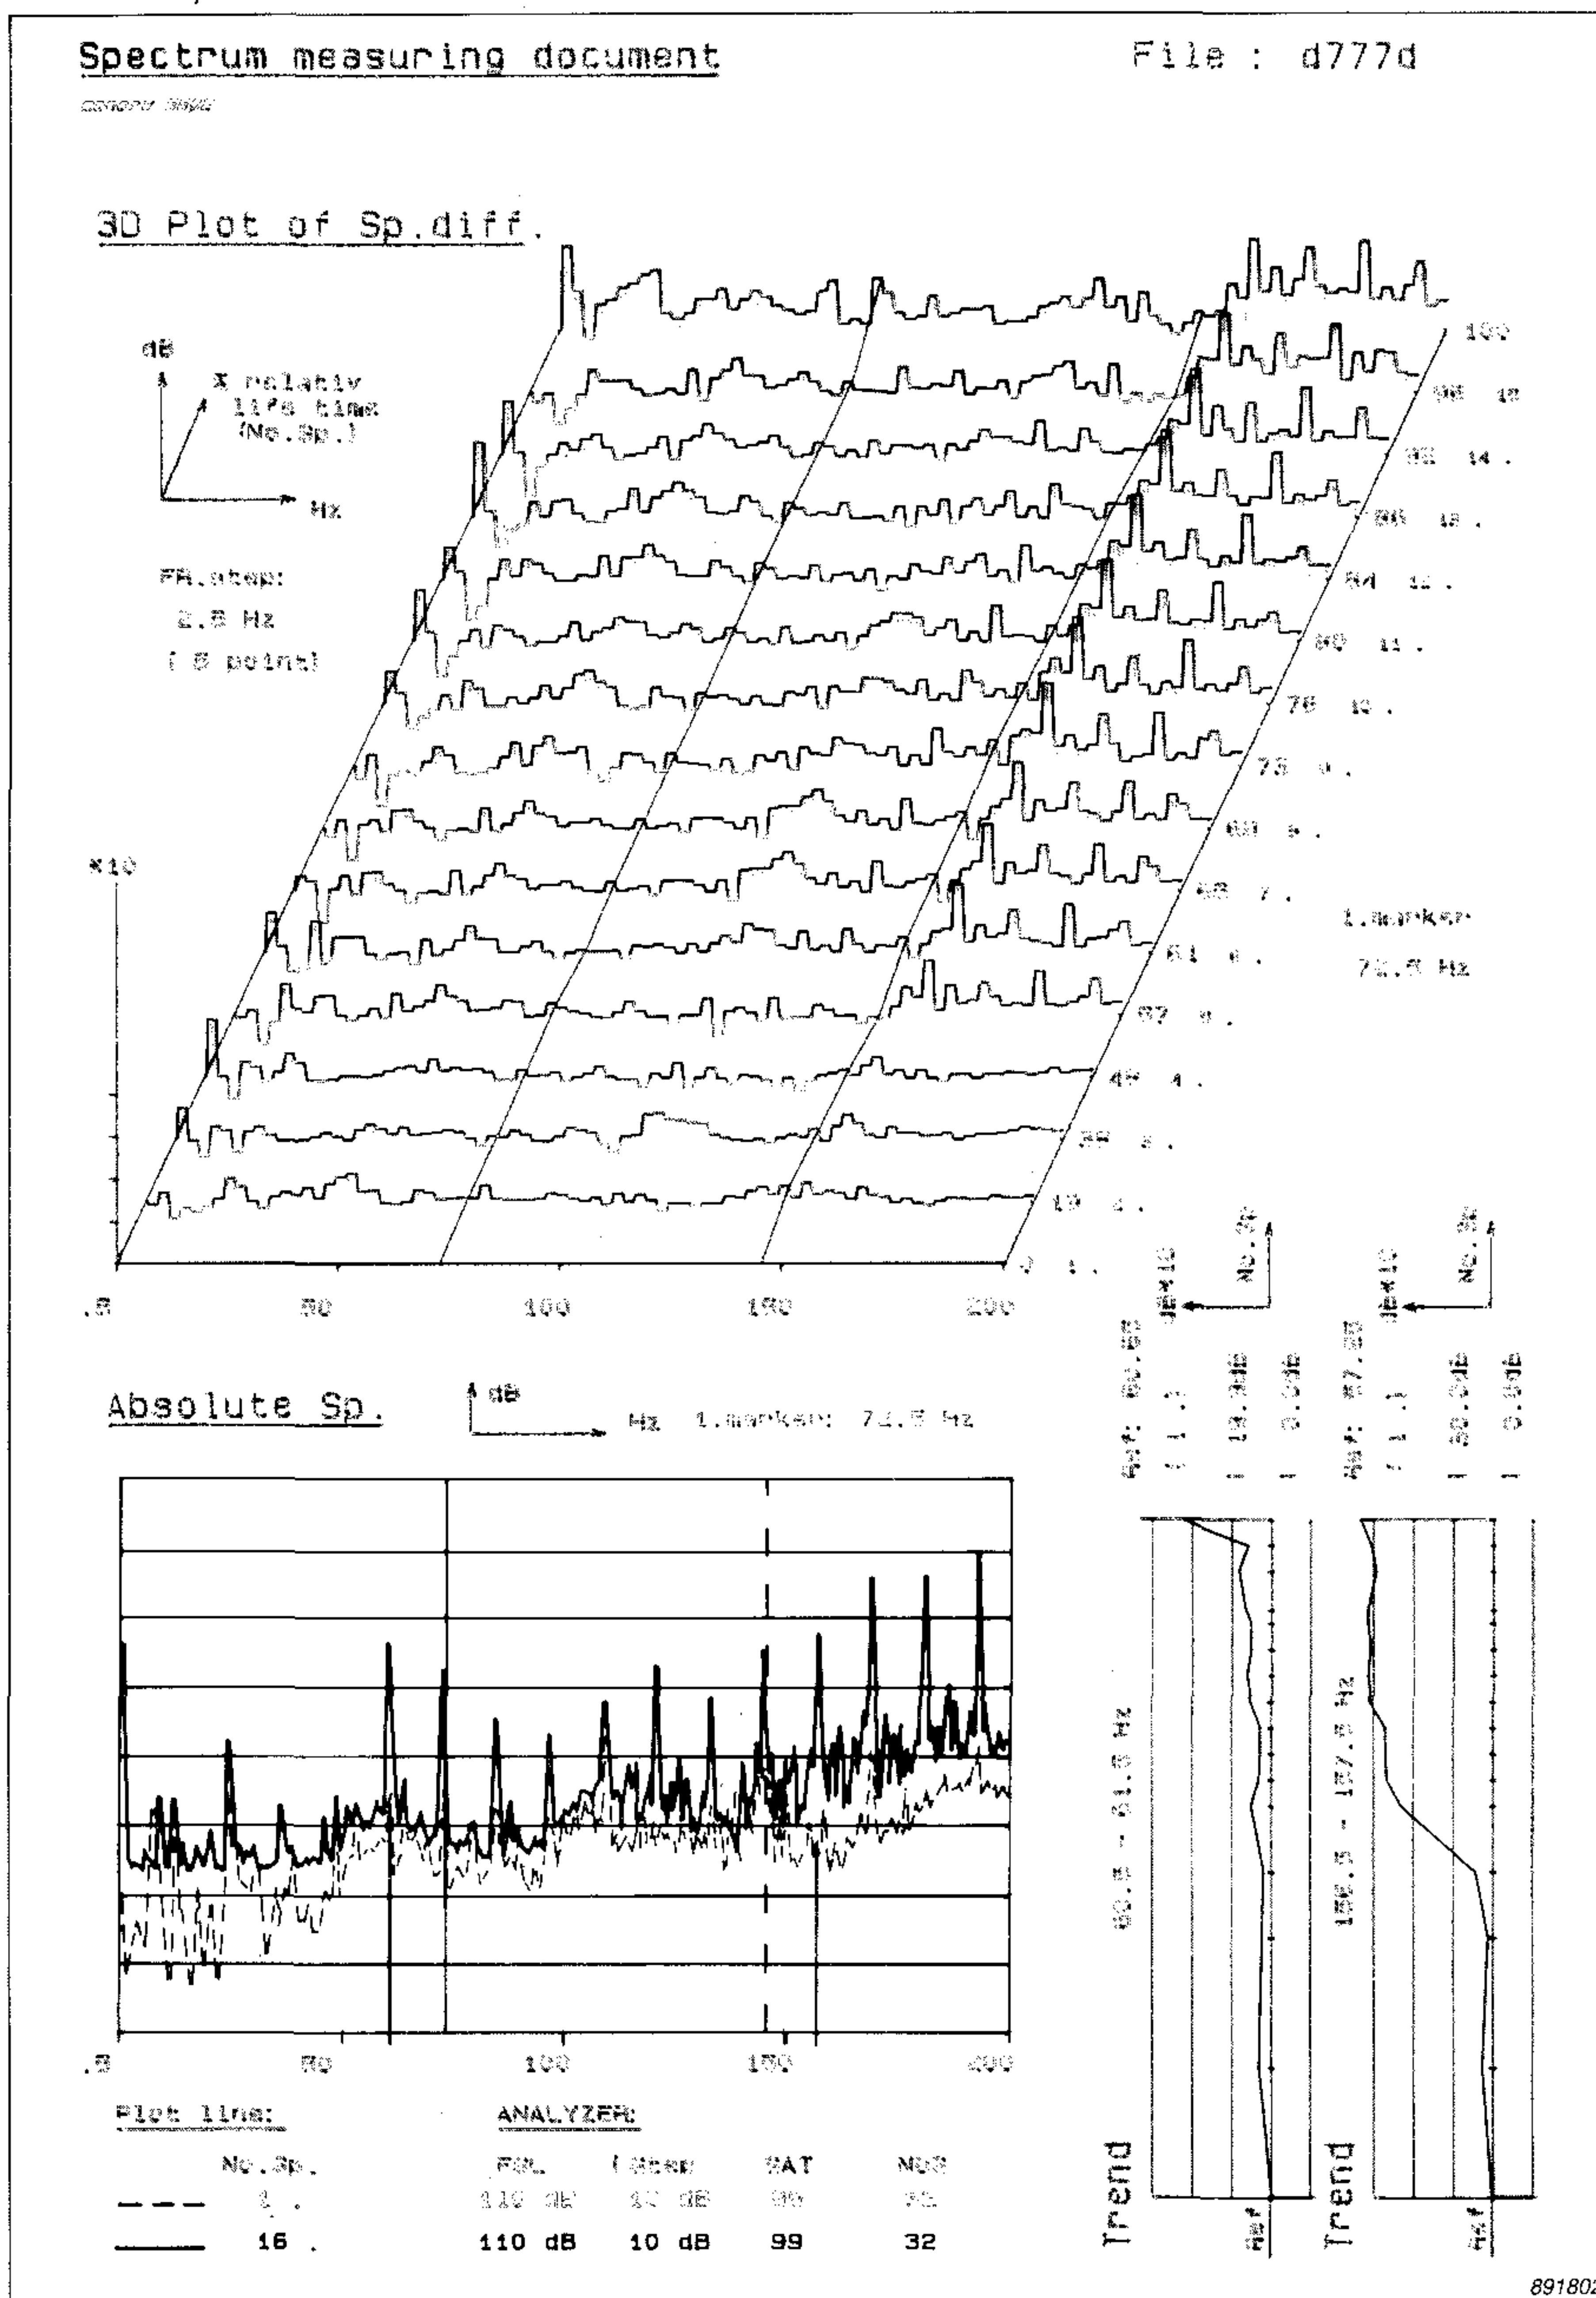
A typical plot produced on Laszlo's system as part of the test documentation. It shows a 3D plot of 16 spectral records (difference spectra with the first record as the reference spectrum), the actual spectra for the 1st and 16th records and, finally, trend plots of vibration amplitude growth across two narrow frequency intervals.

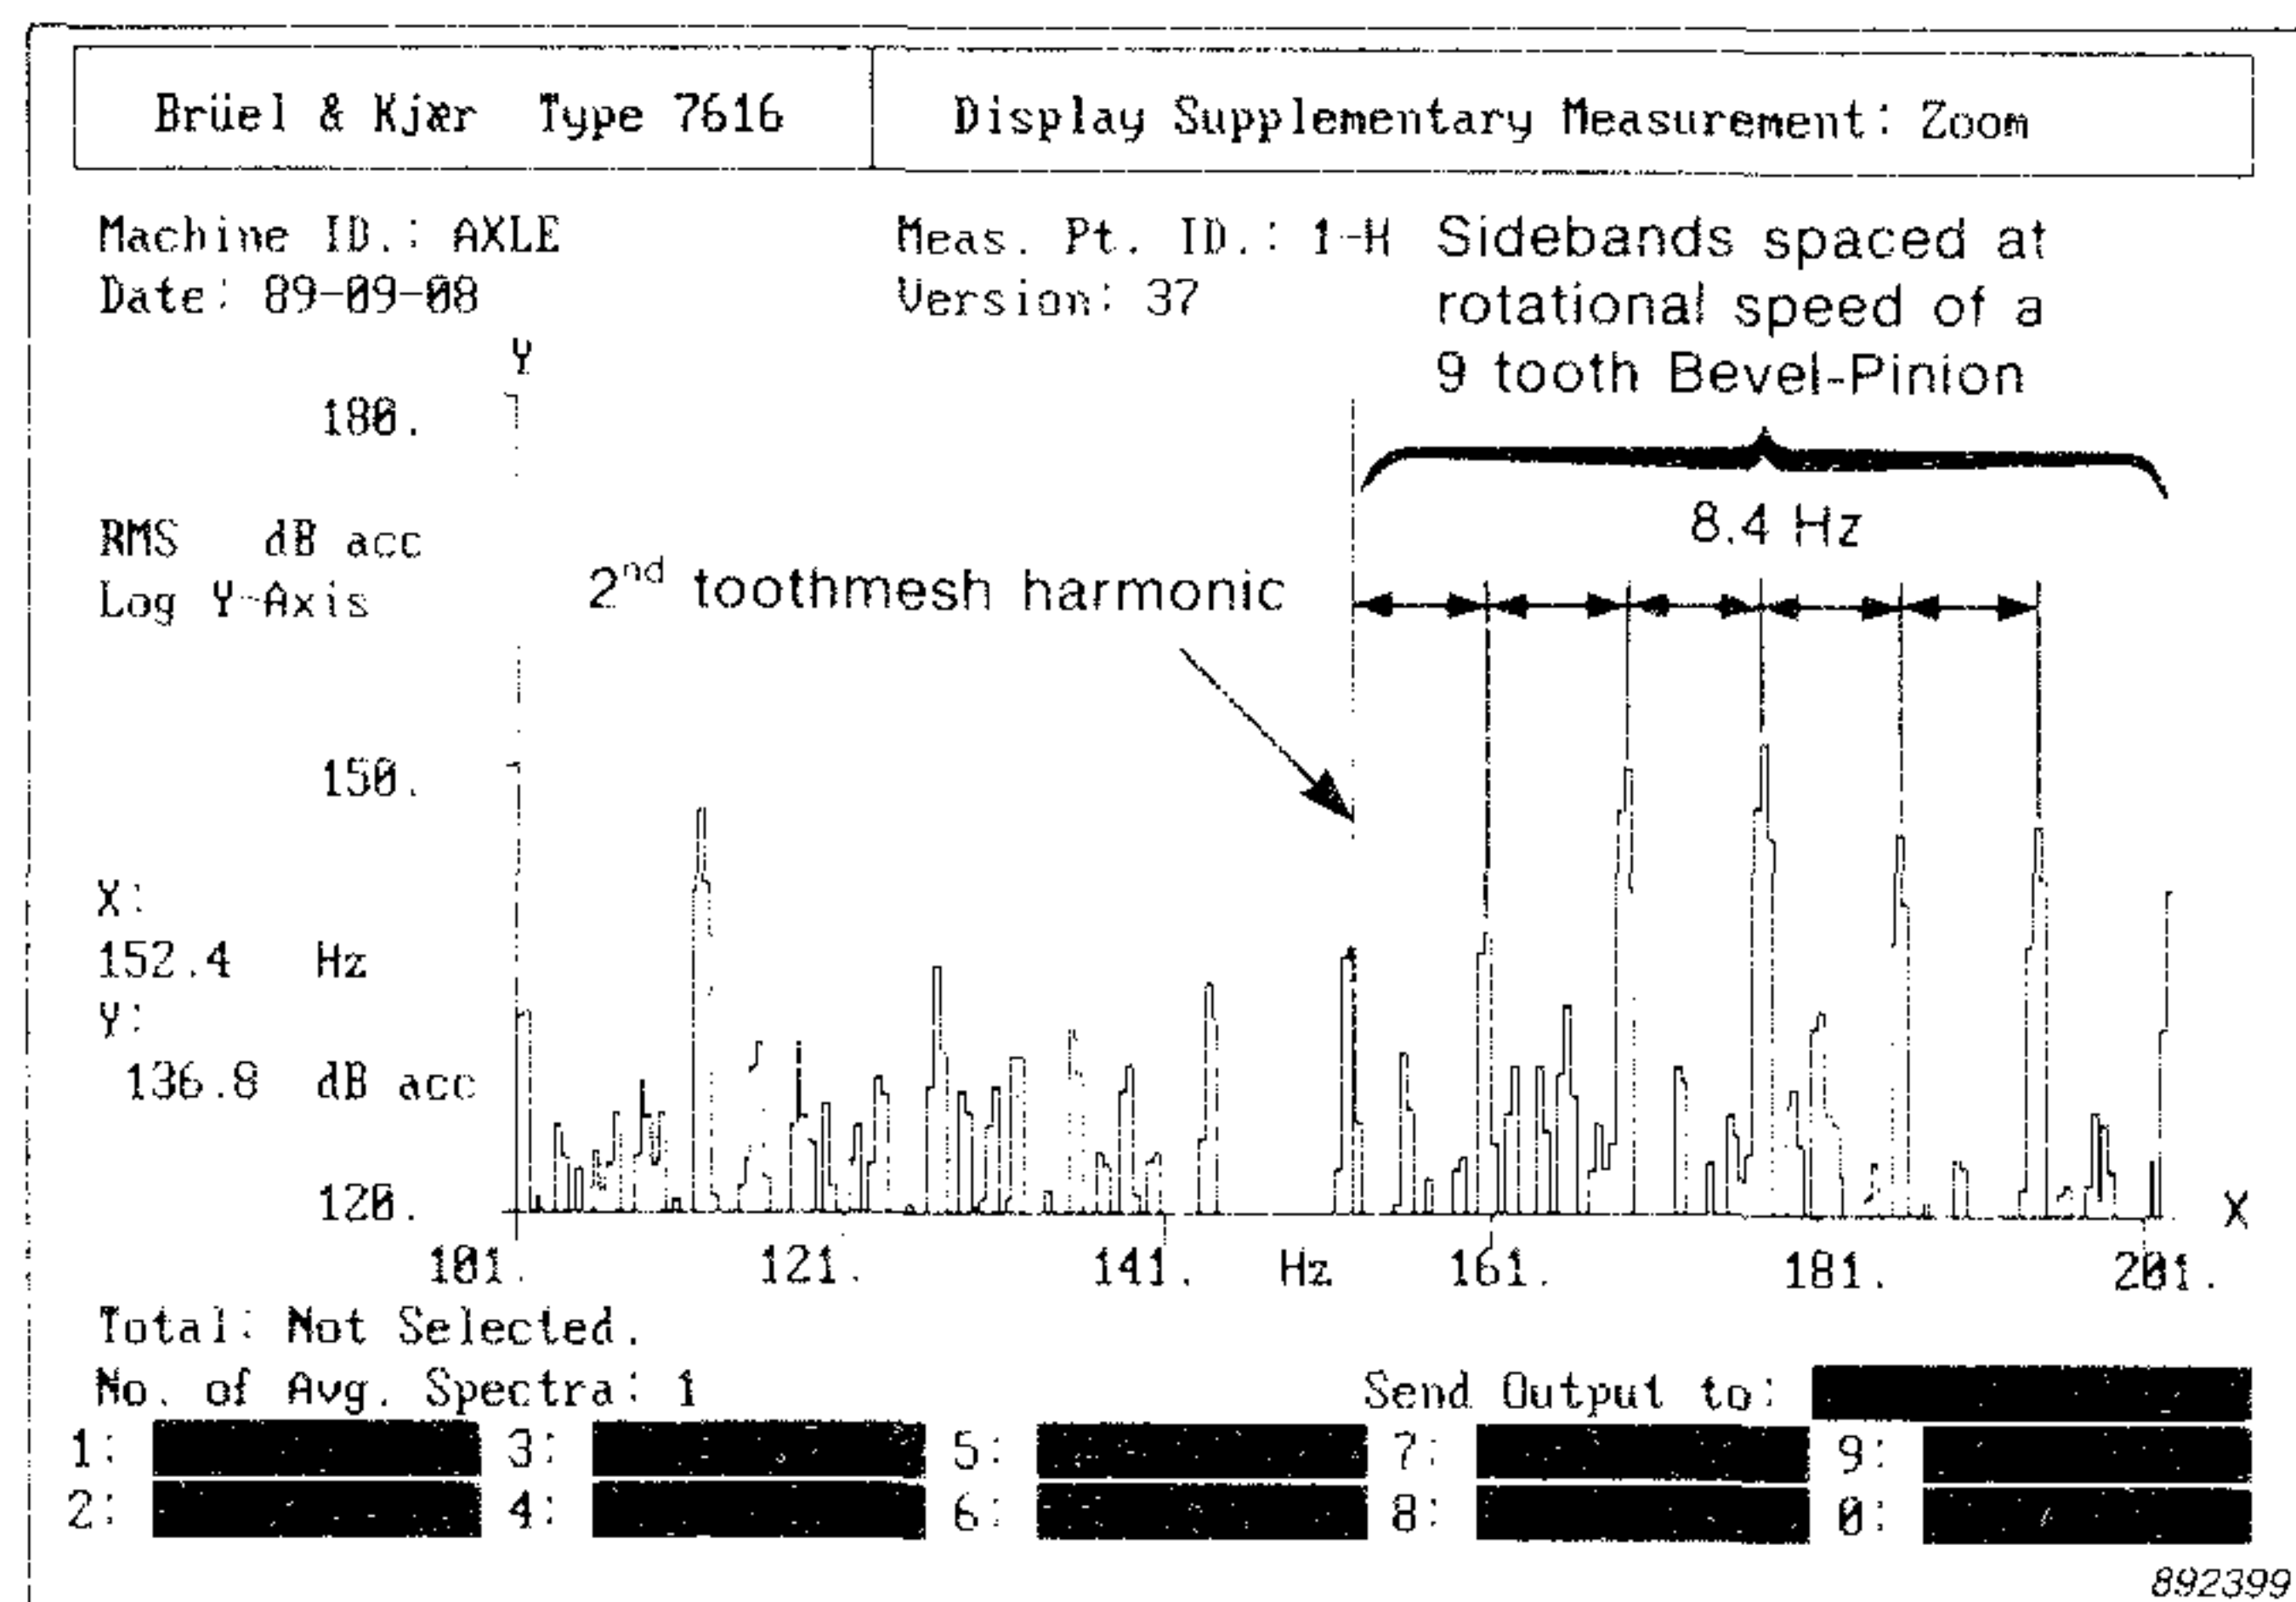
The vibration monitoring began with an investigation of the vibration spectra to identify the changes caused by failures occurring. The vibration was recorded on a Brüel & Kjær tape recorder at regular intervals during each test. This taped vibration was subsequently analyzed on the Type 2033 to compare spectrum information with the notes from the tests and establish how faults could be identified in the vibration signal. It was found that the growth of sidebands, spaced by the rotational speeds of either the crown-wheel or bevel-pinion (depending on which gear-wheel the fault occurred), indicated the fault development. The sidebands were always centred around one of the toothmesh harmonics, and would occur in the spectrum within the range of the first 3 or 4 crown/pinion toothmesh harmonics, see Fig. 4.

Fig. 4. Growing sidebands of bevel-pinion rotational frequency indicate a fault on a 9 tooth bevel-pinion

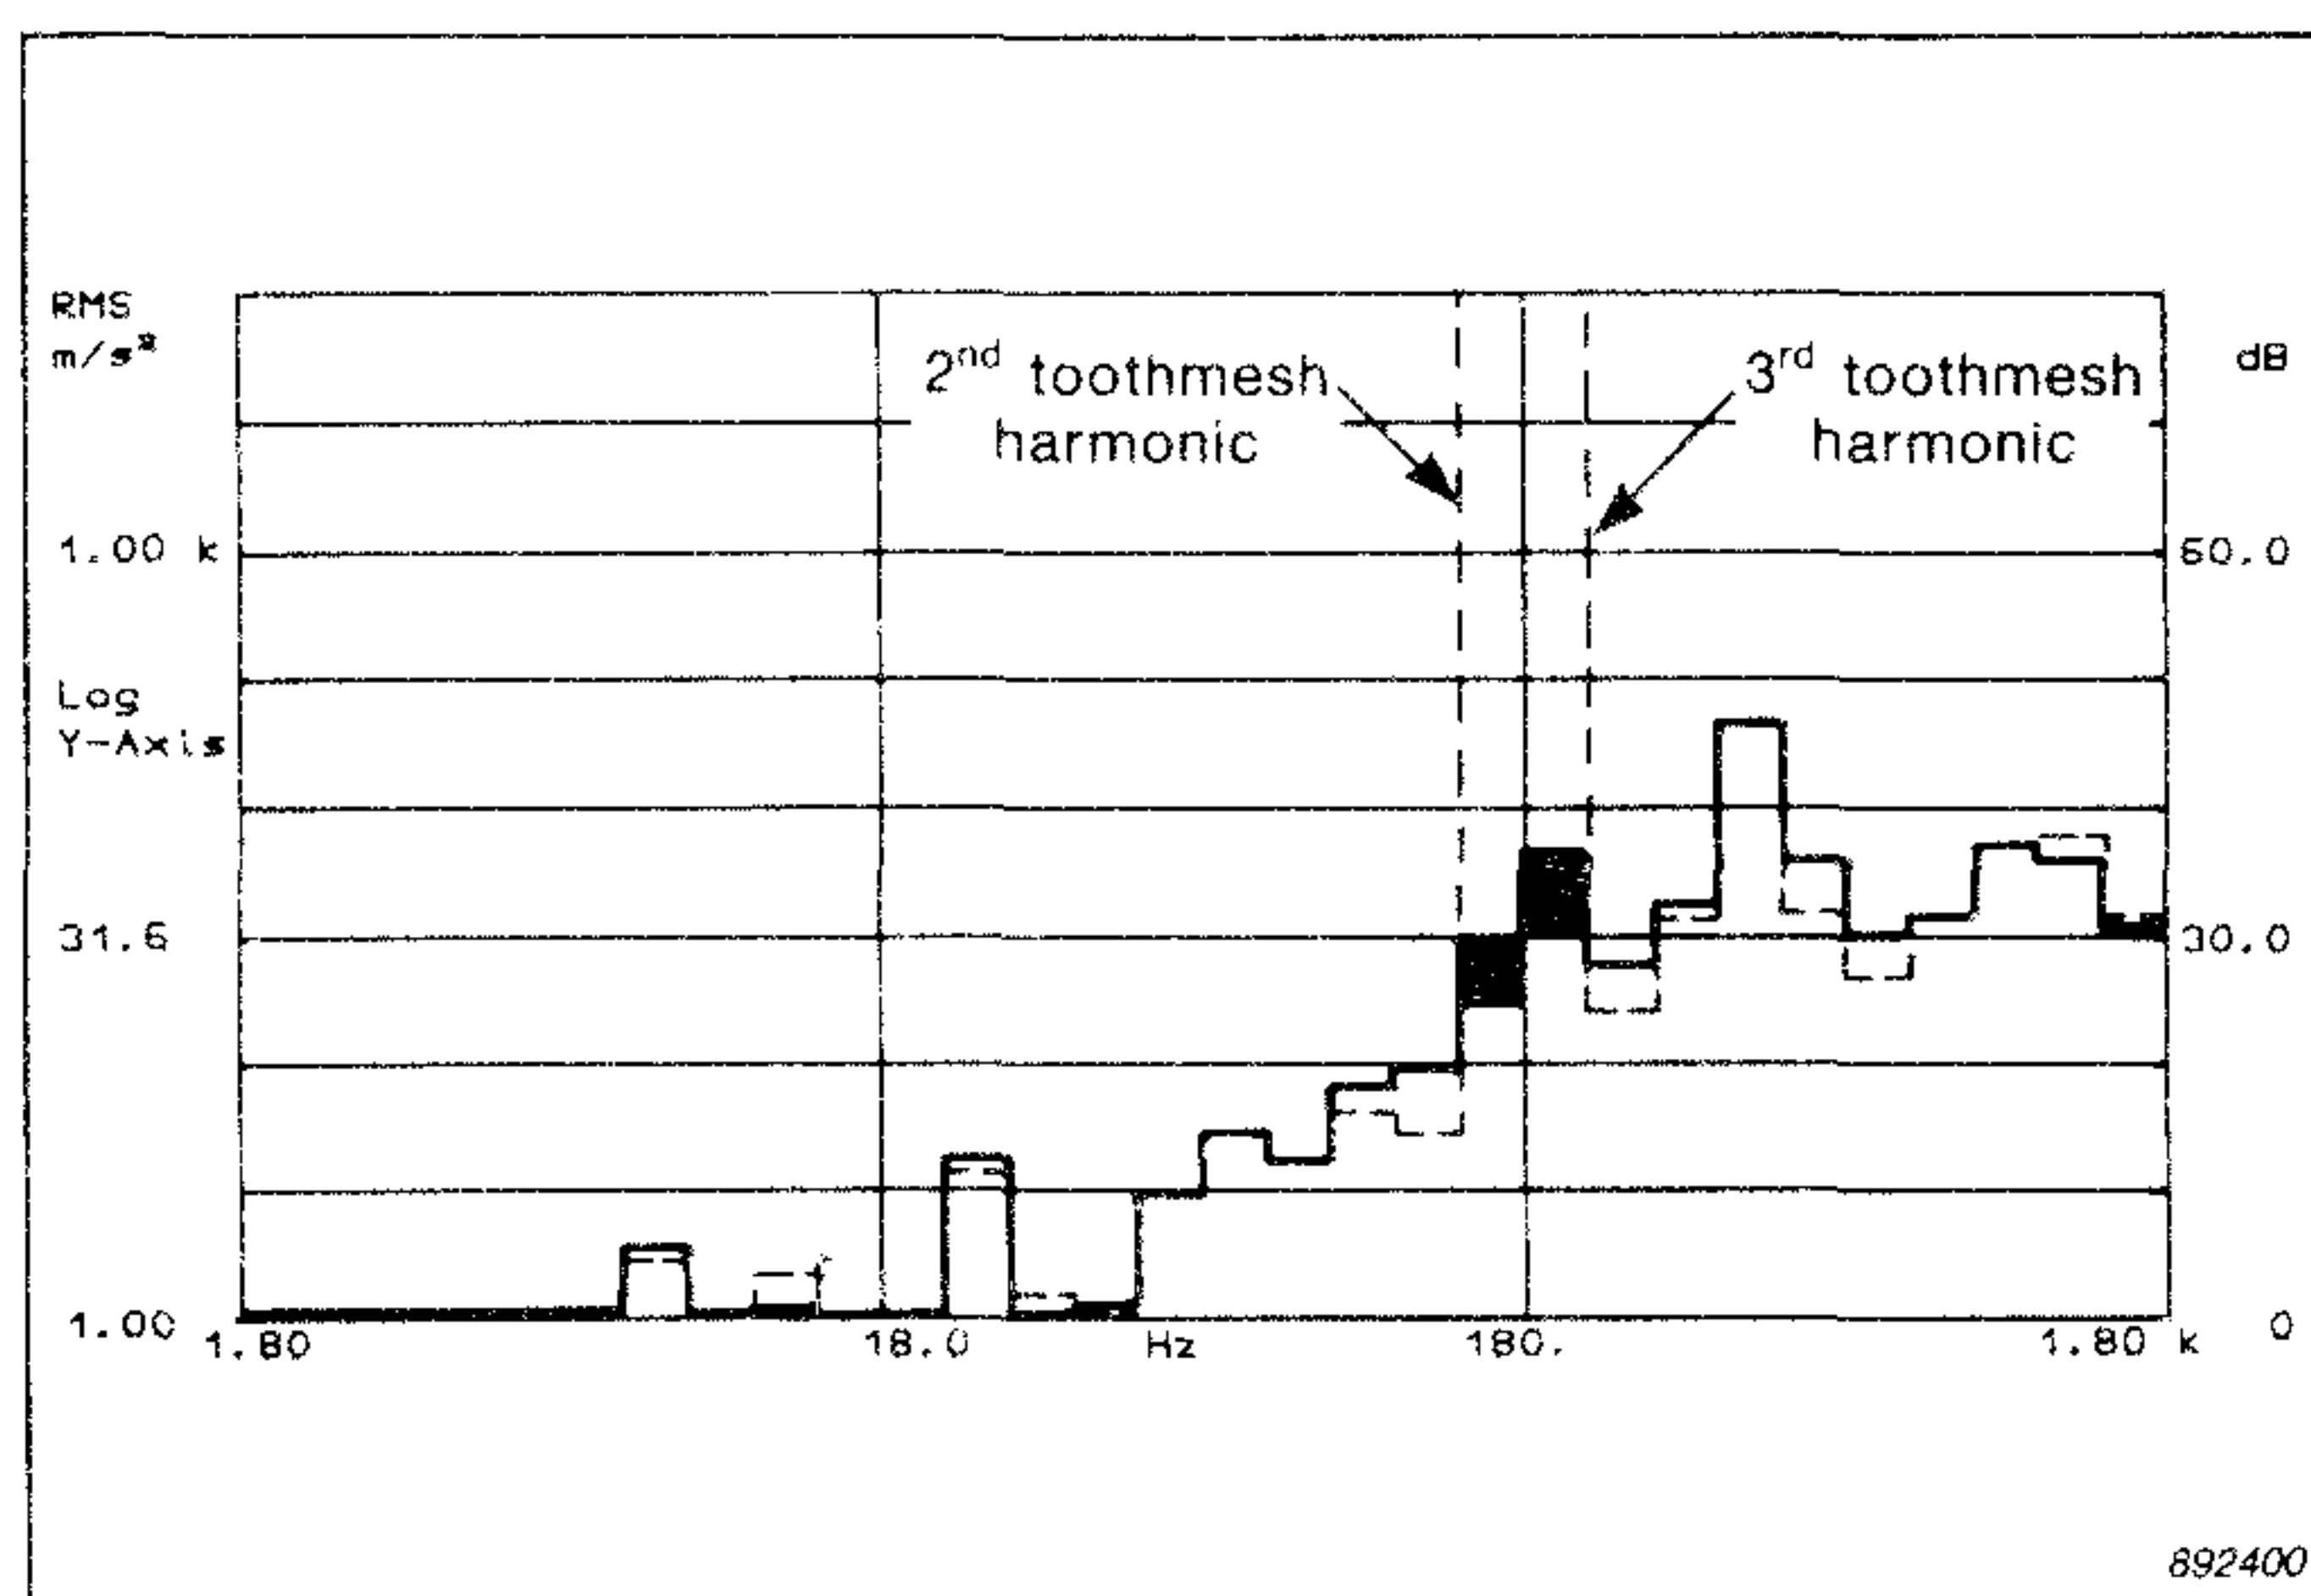
Fig. 5. Spectrum Comparison plot showing how the region (shown shaded), between the 2nd and 3rd toothmesh harmonics, rises as tooth pitting starts to occur (the solid curve is the sixth spectral record and the dotted curve is the fourth)

The evidence of pitting appears in the spectrum in the region between the 2nd and 3rd toothmesh harmonics, appearing first at the 5th spectral record. Fig. 5 shows a spectrum-comparison-plot of the 4th and 6th spectral records. This plot extends to 2 kHz and shows that frequencies above the 3rd tooth-

mesh harmonic show no significant change.
