Early Detection of Gear Faults Using Vibration Analysis in a Manufacturer's Test Department

Better Axle Gears on RABA Trucks:-

by Laszlo Boros, RABA, Győr, Hungary and Glenn H. Bate, Brüel & Kjær, Denmark

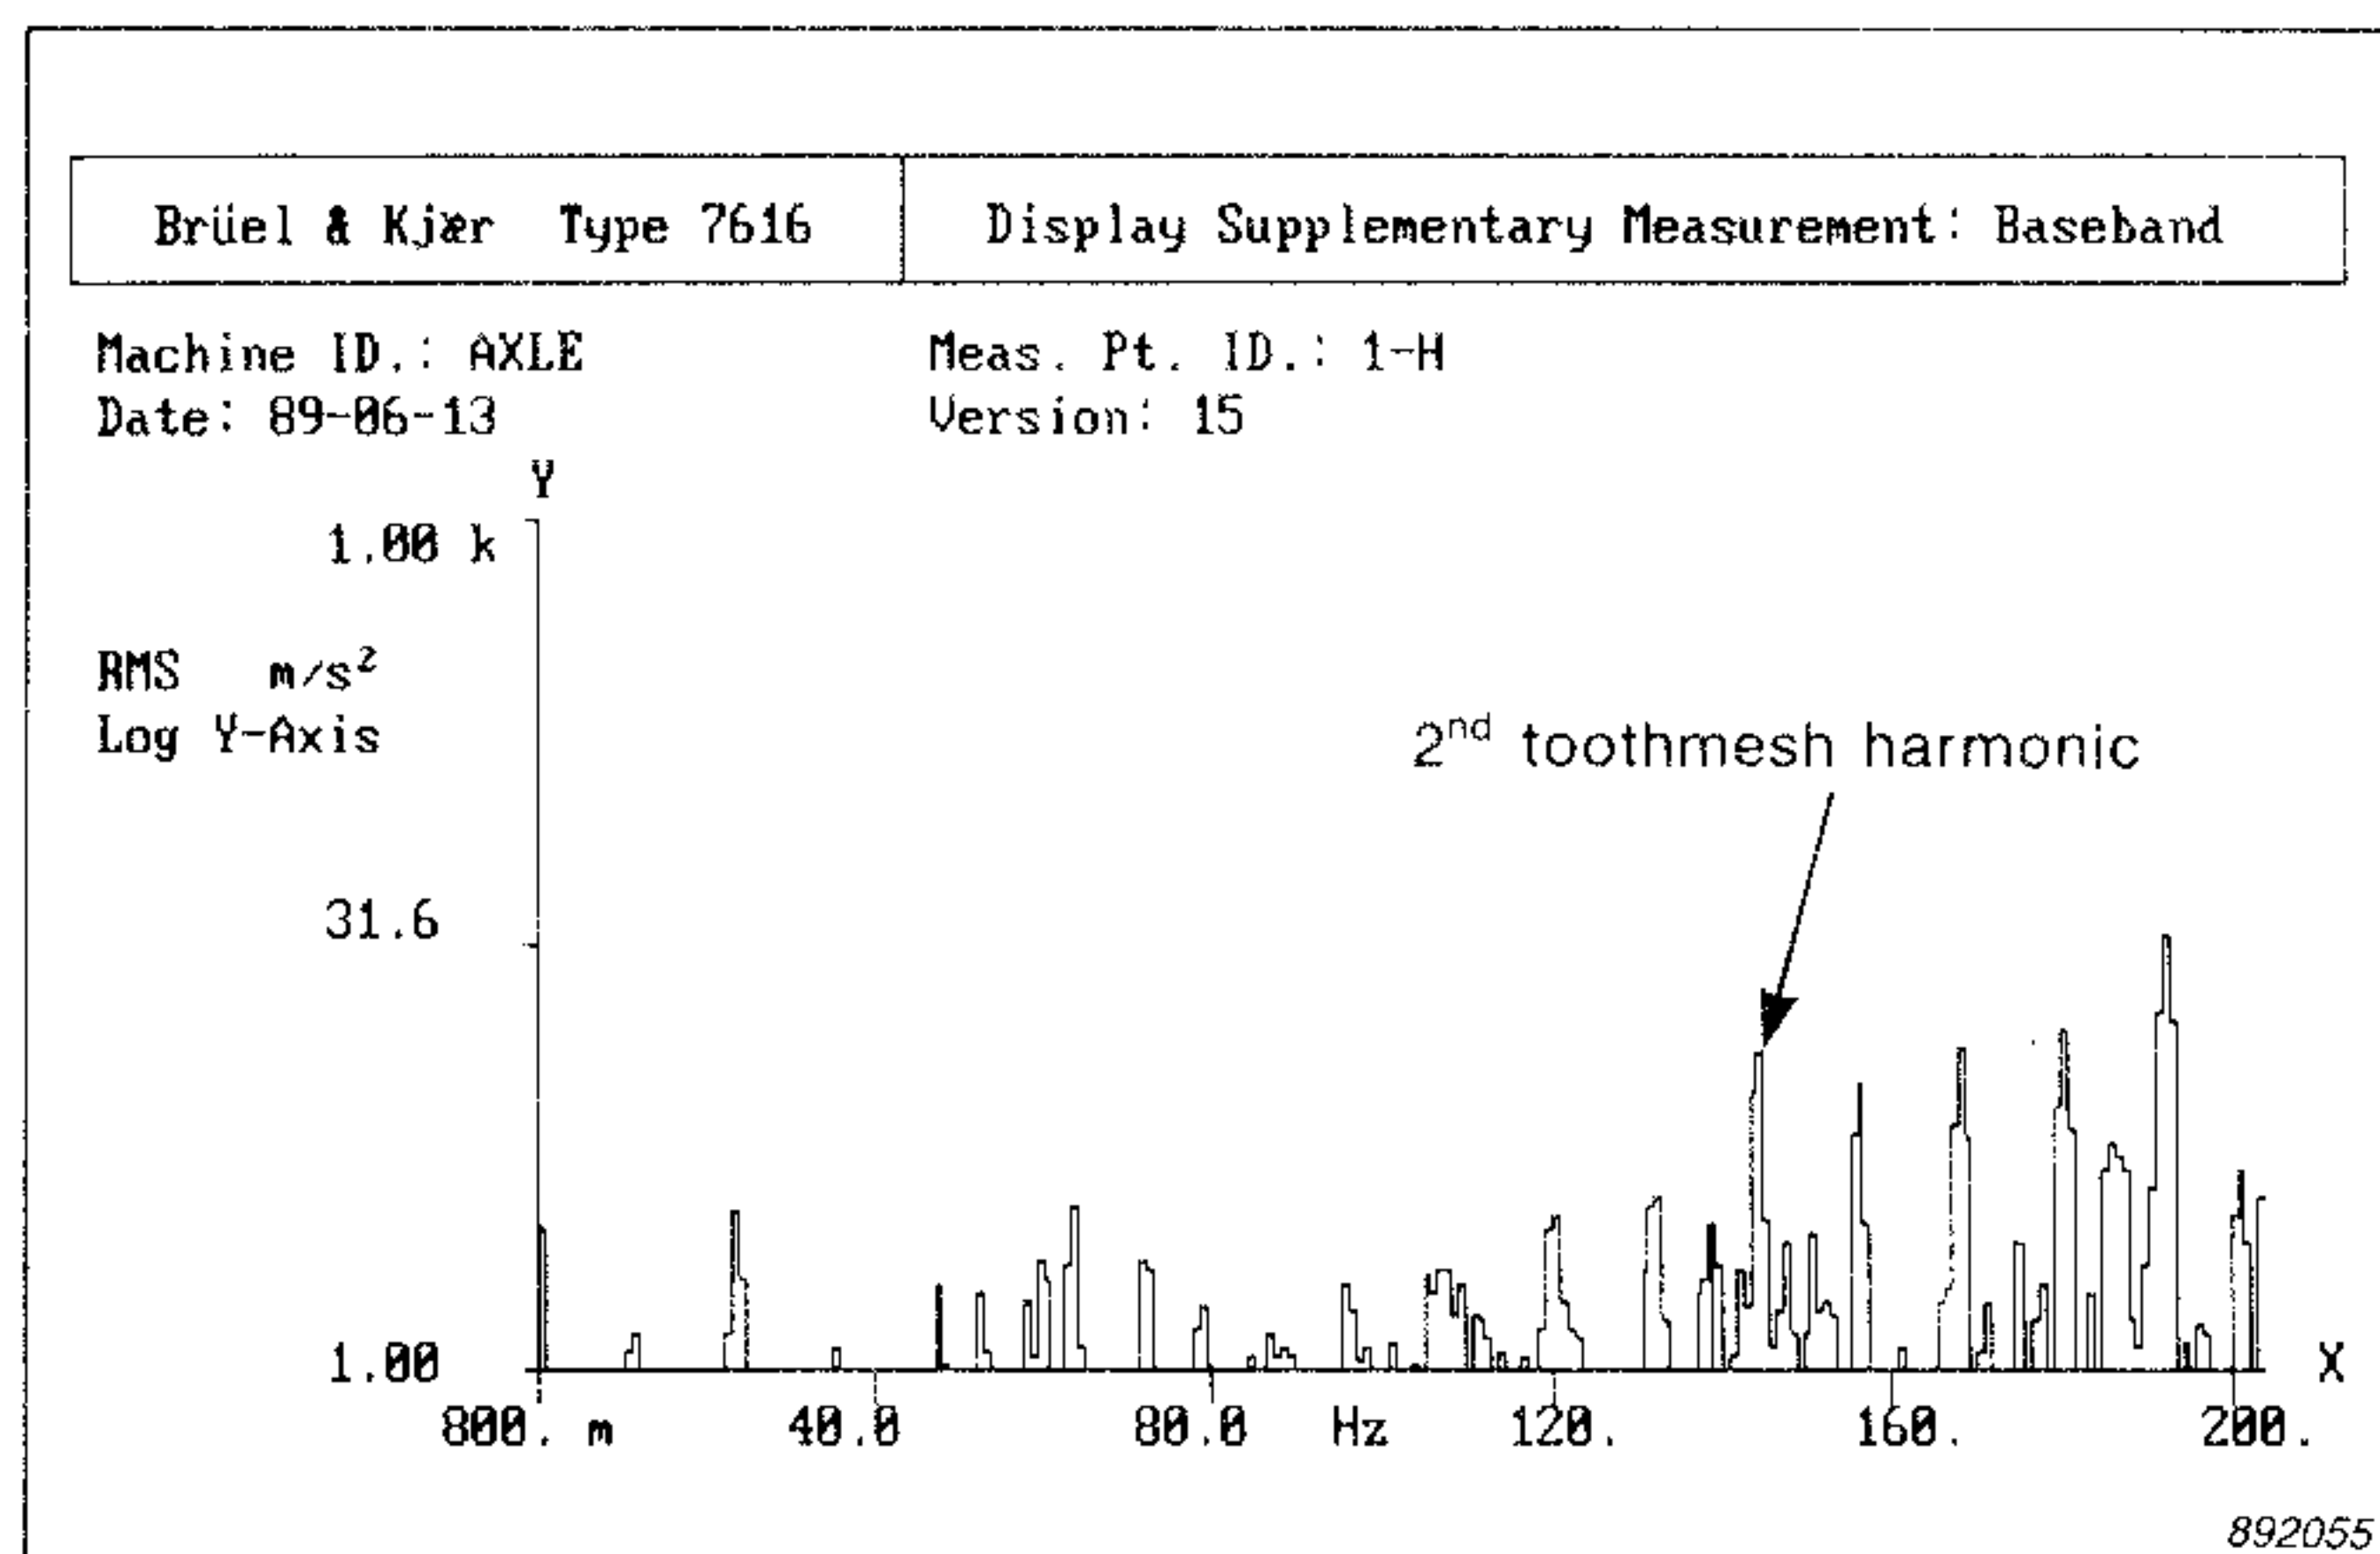
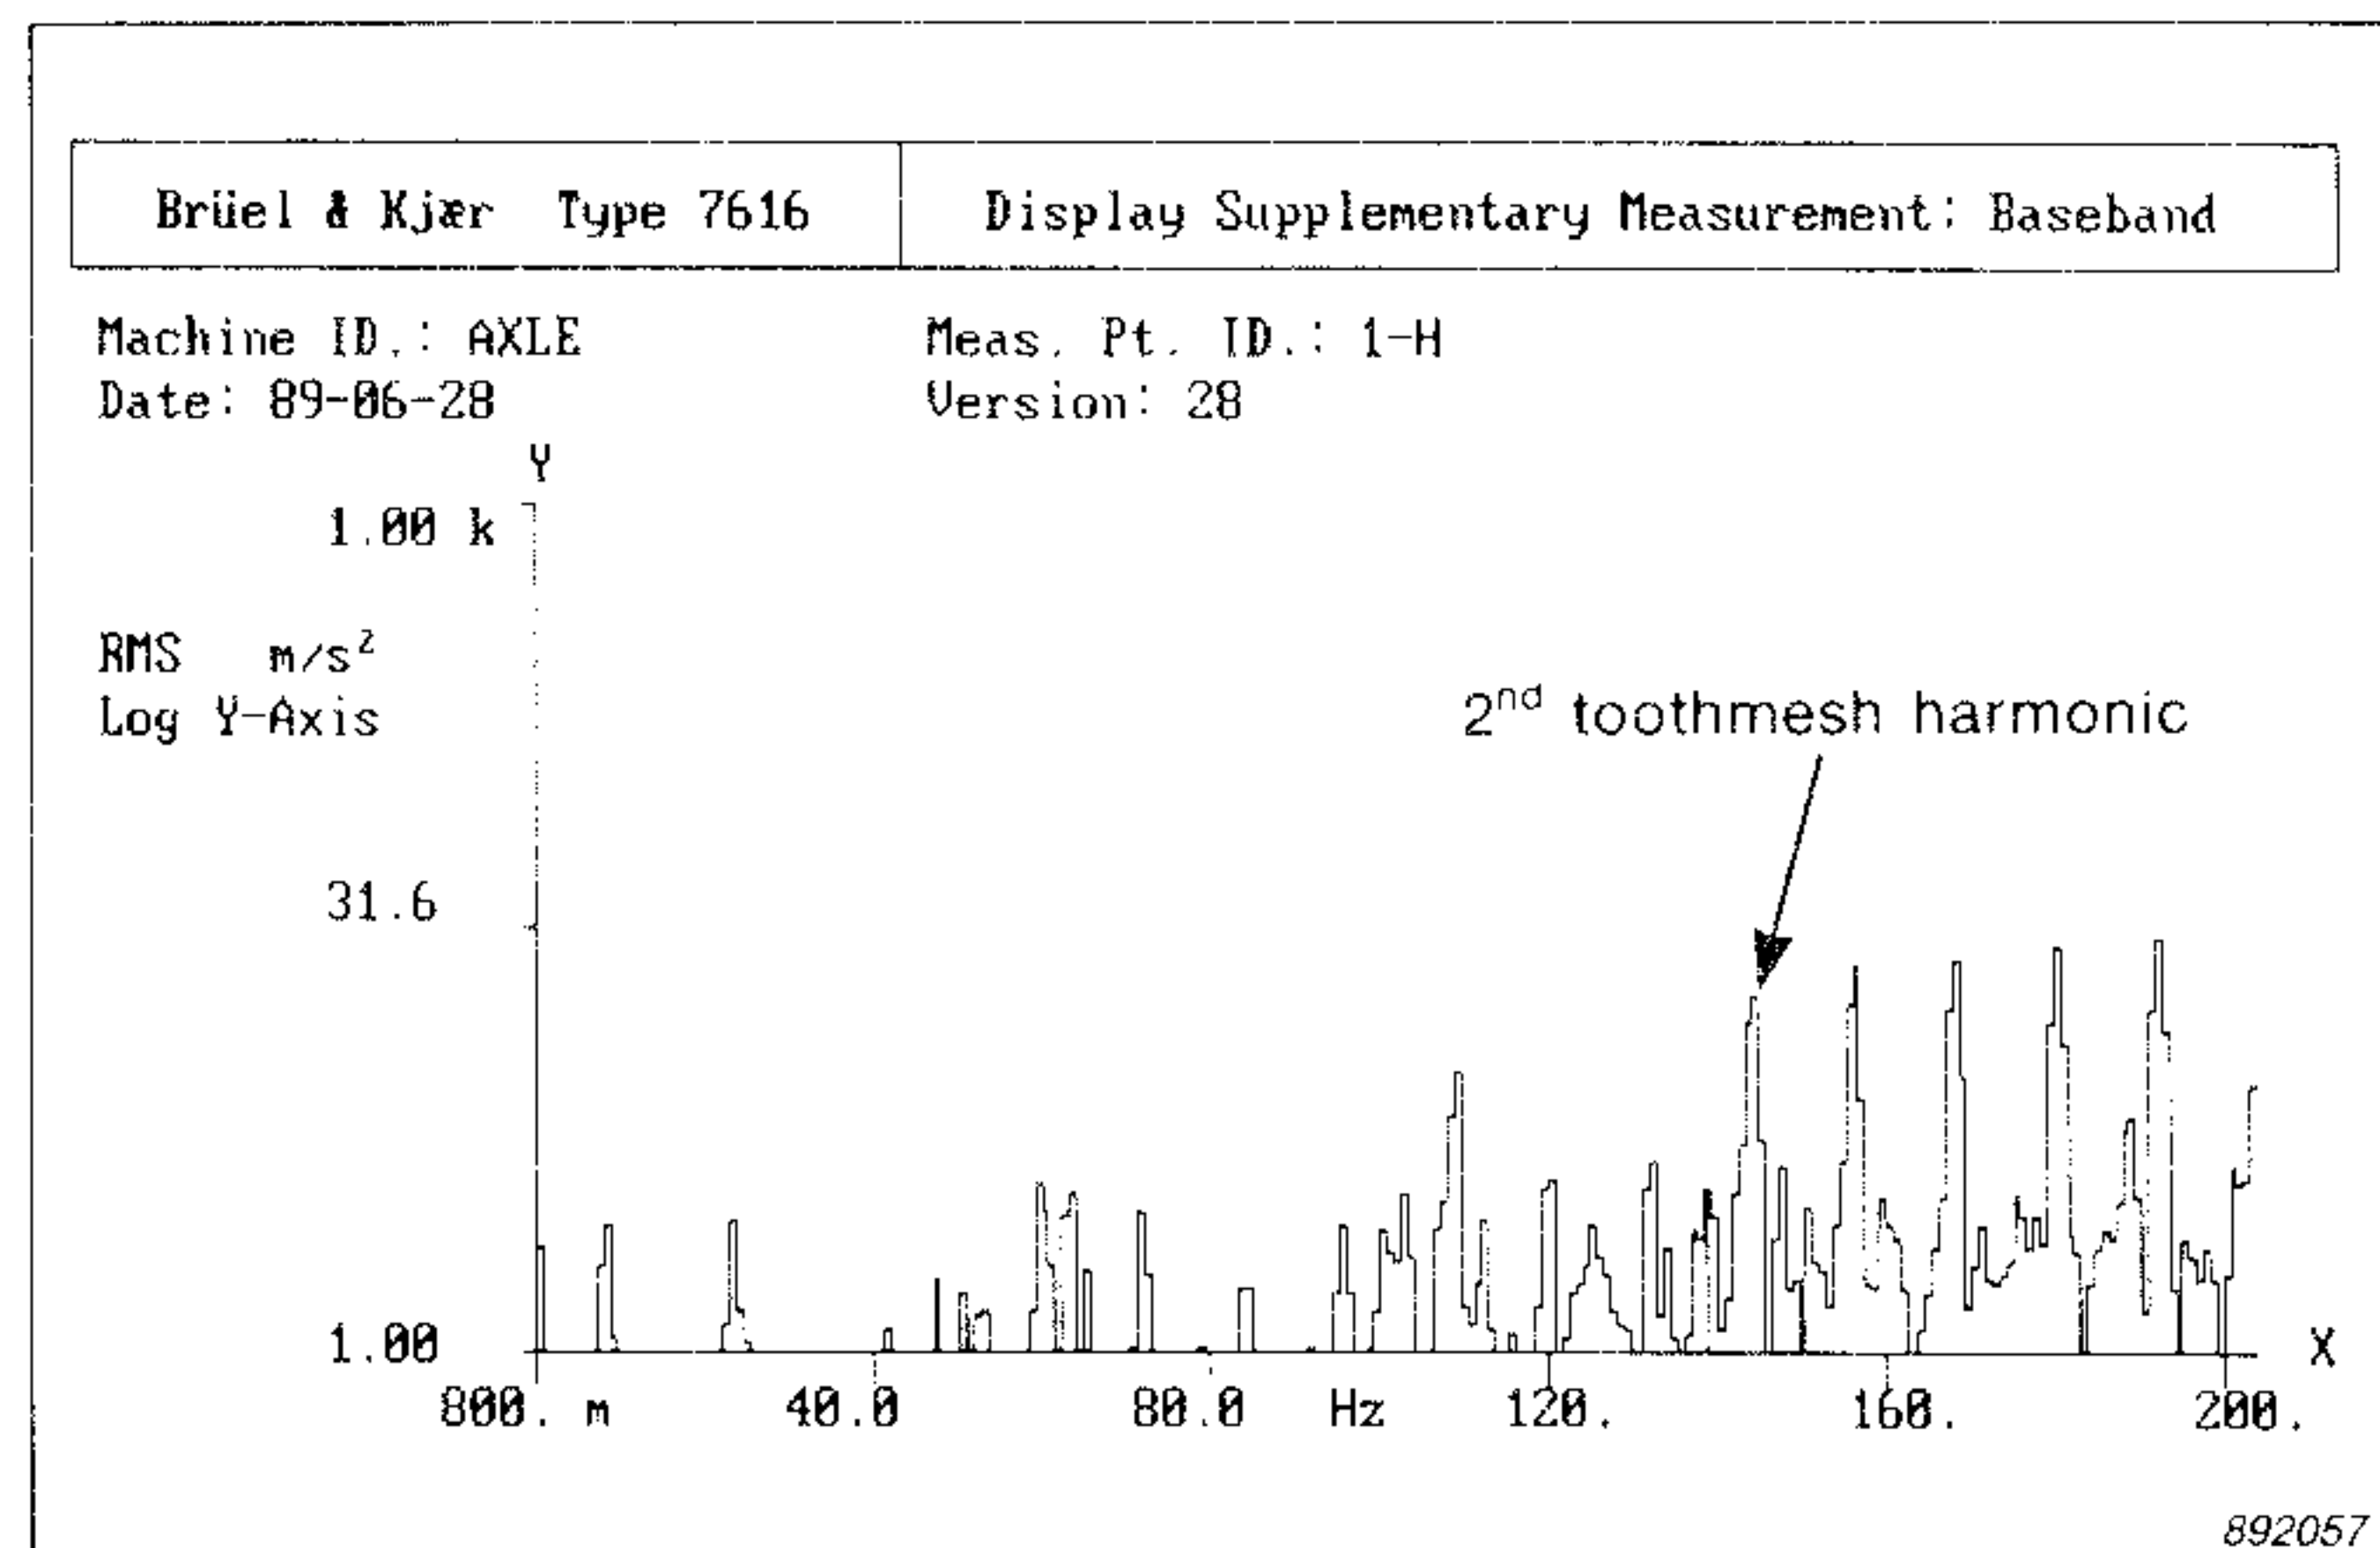
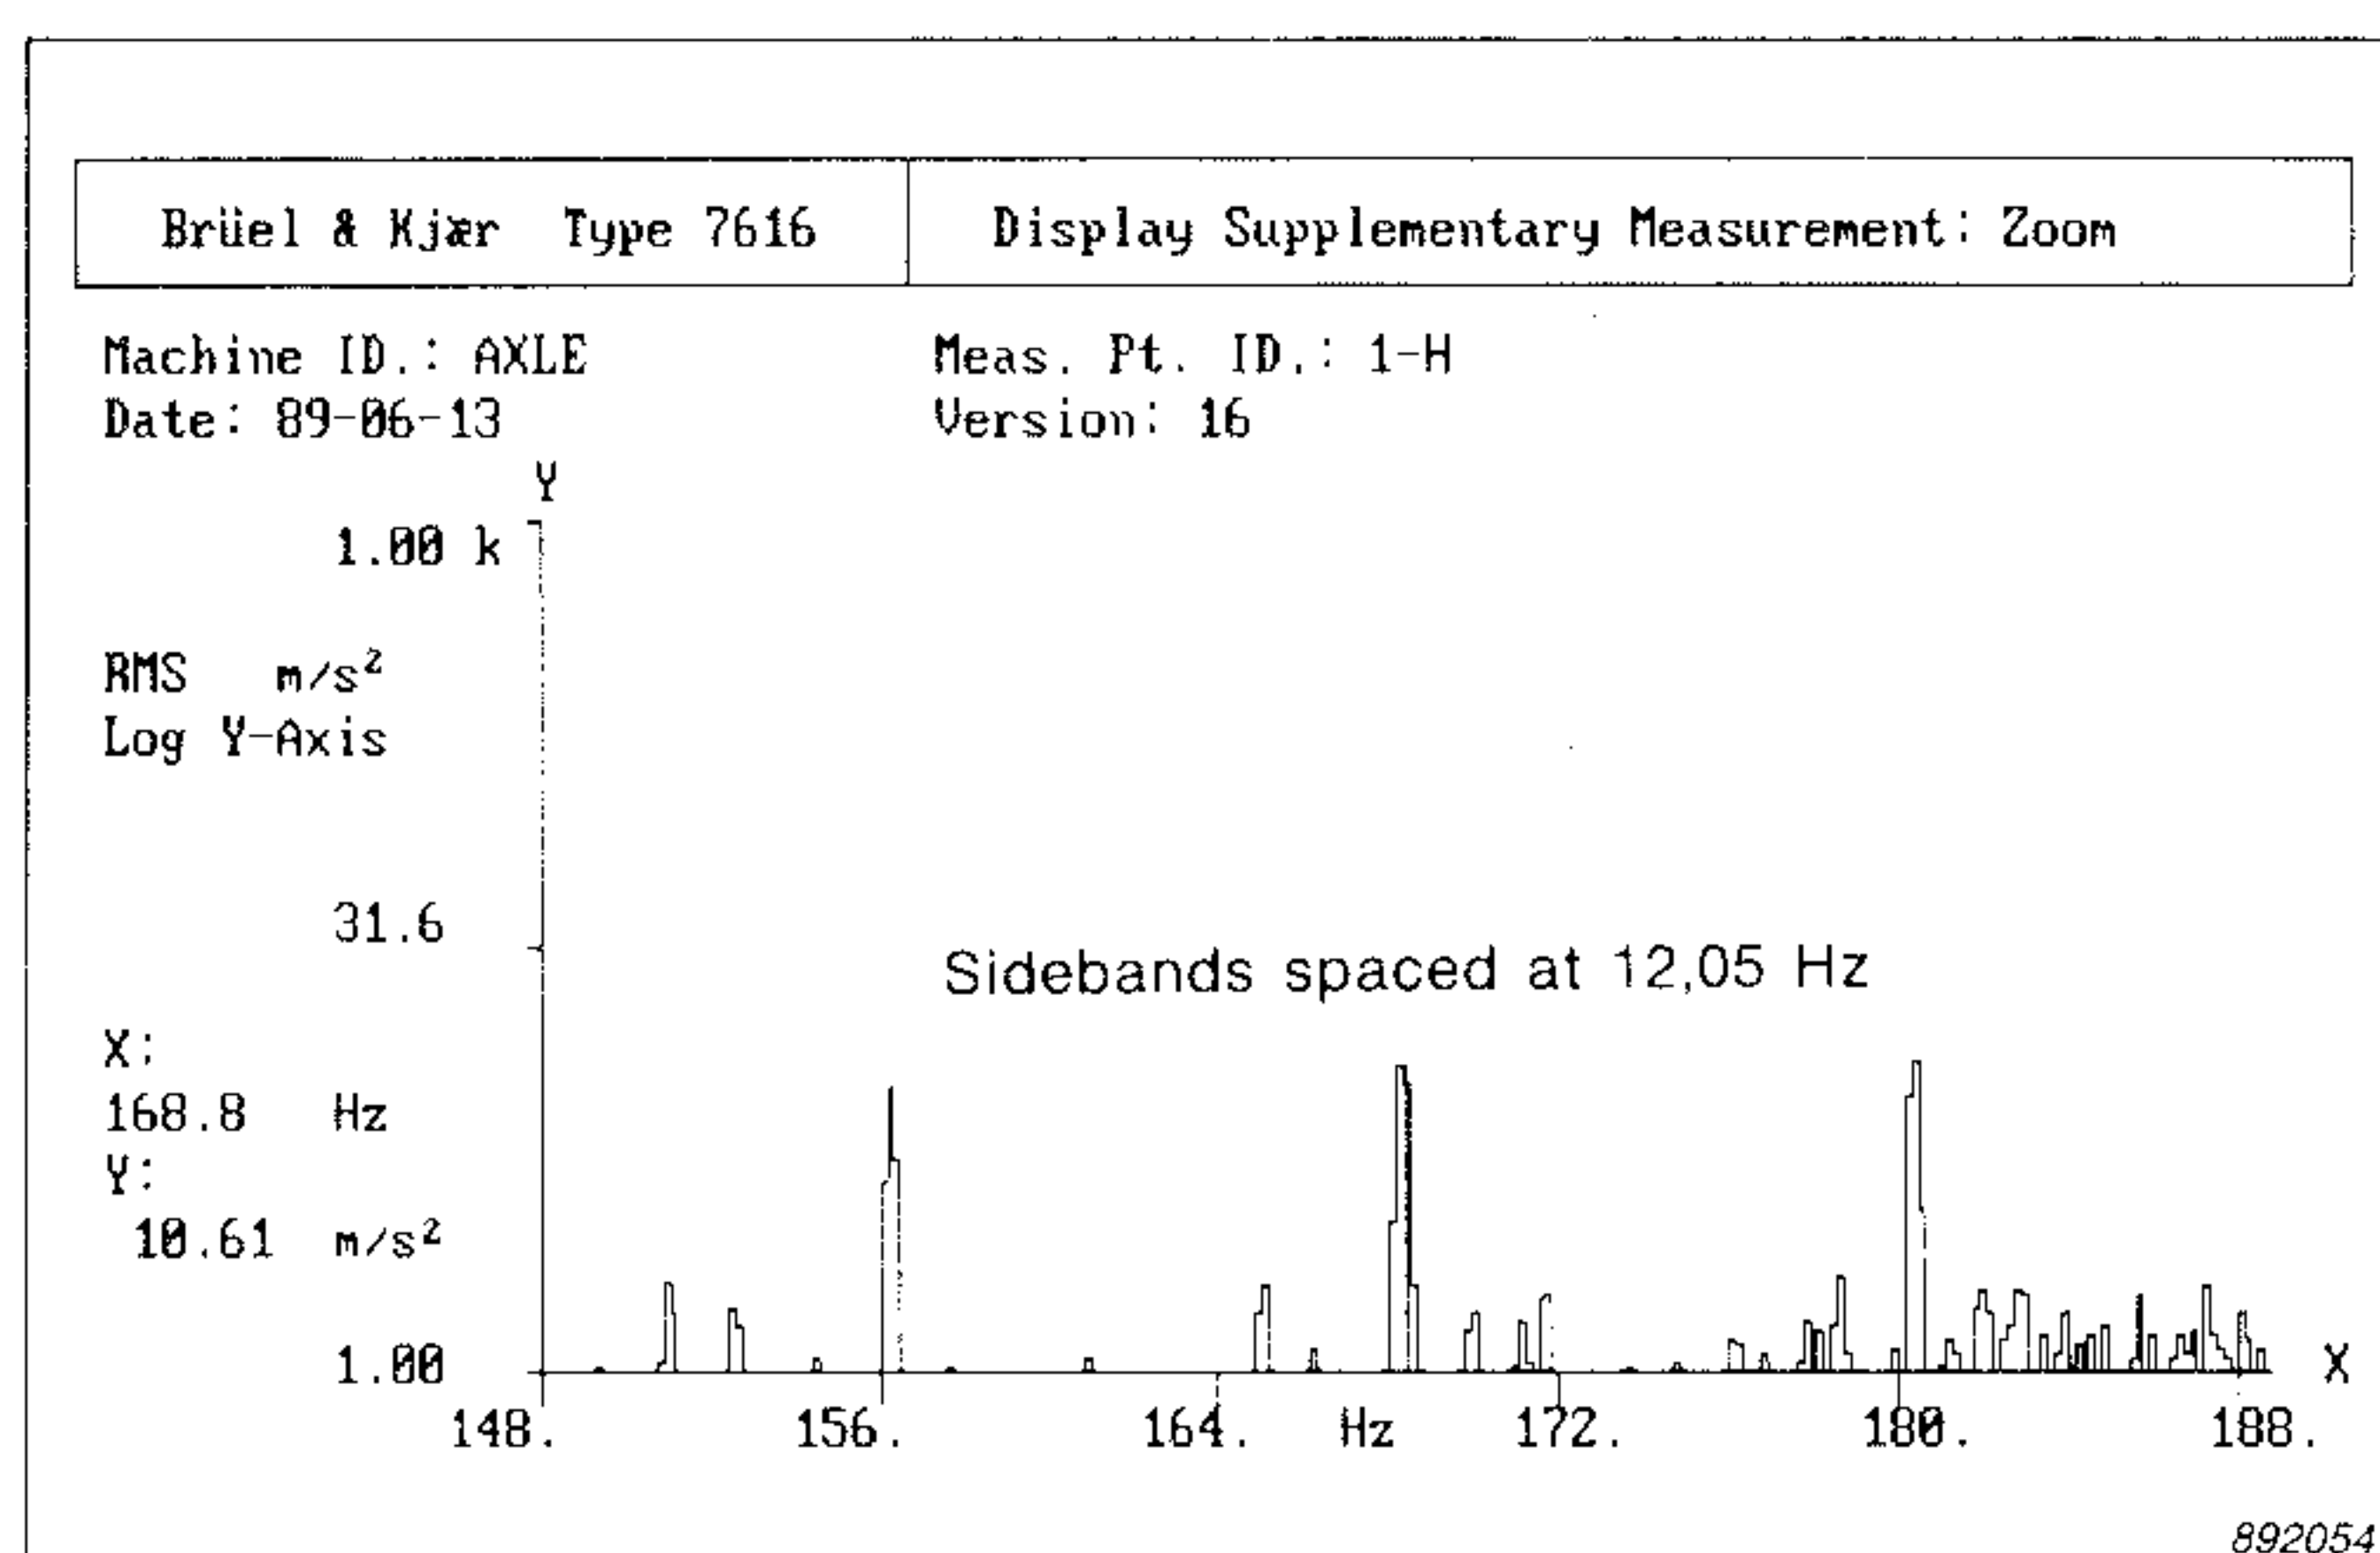
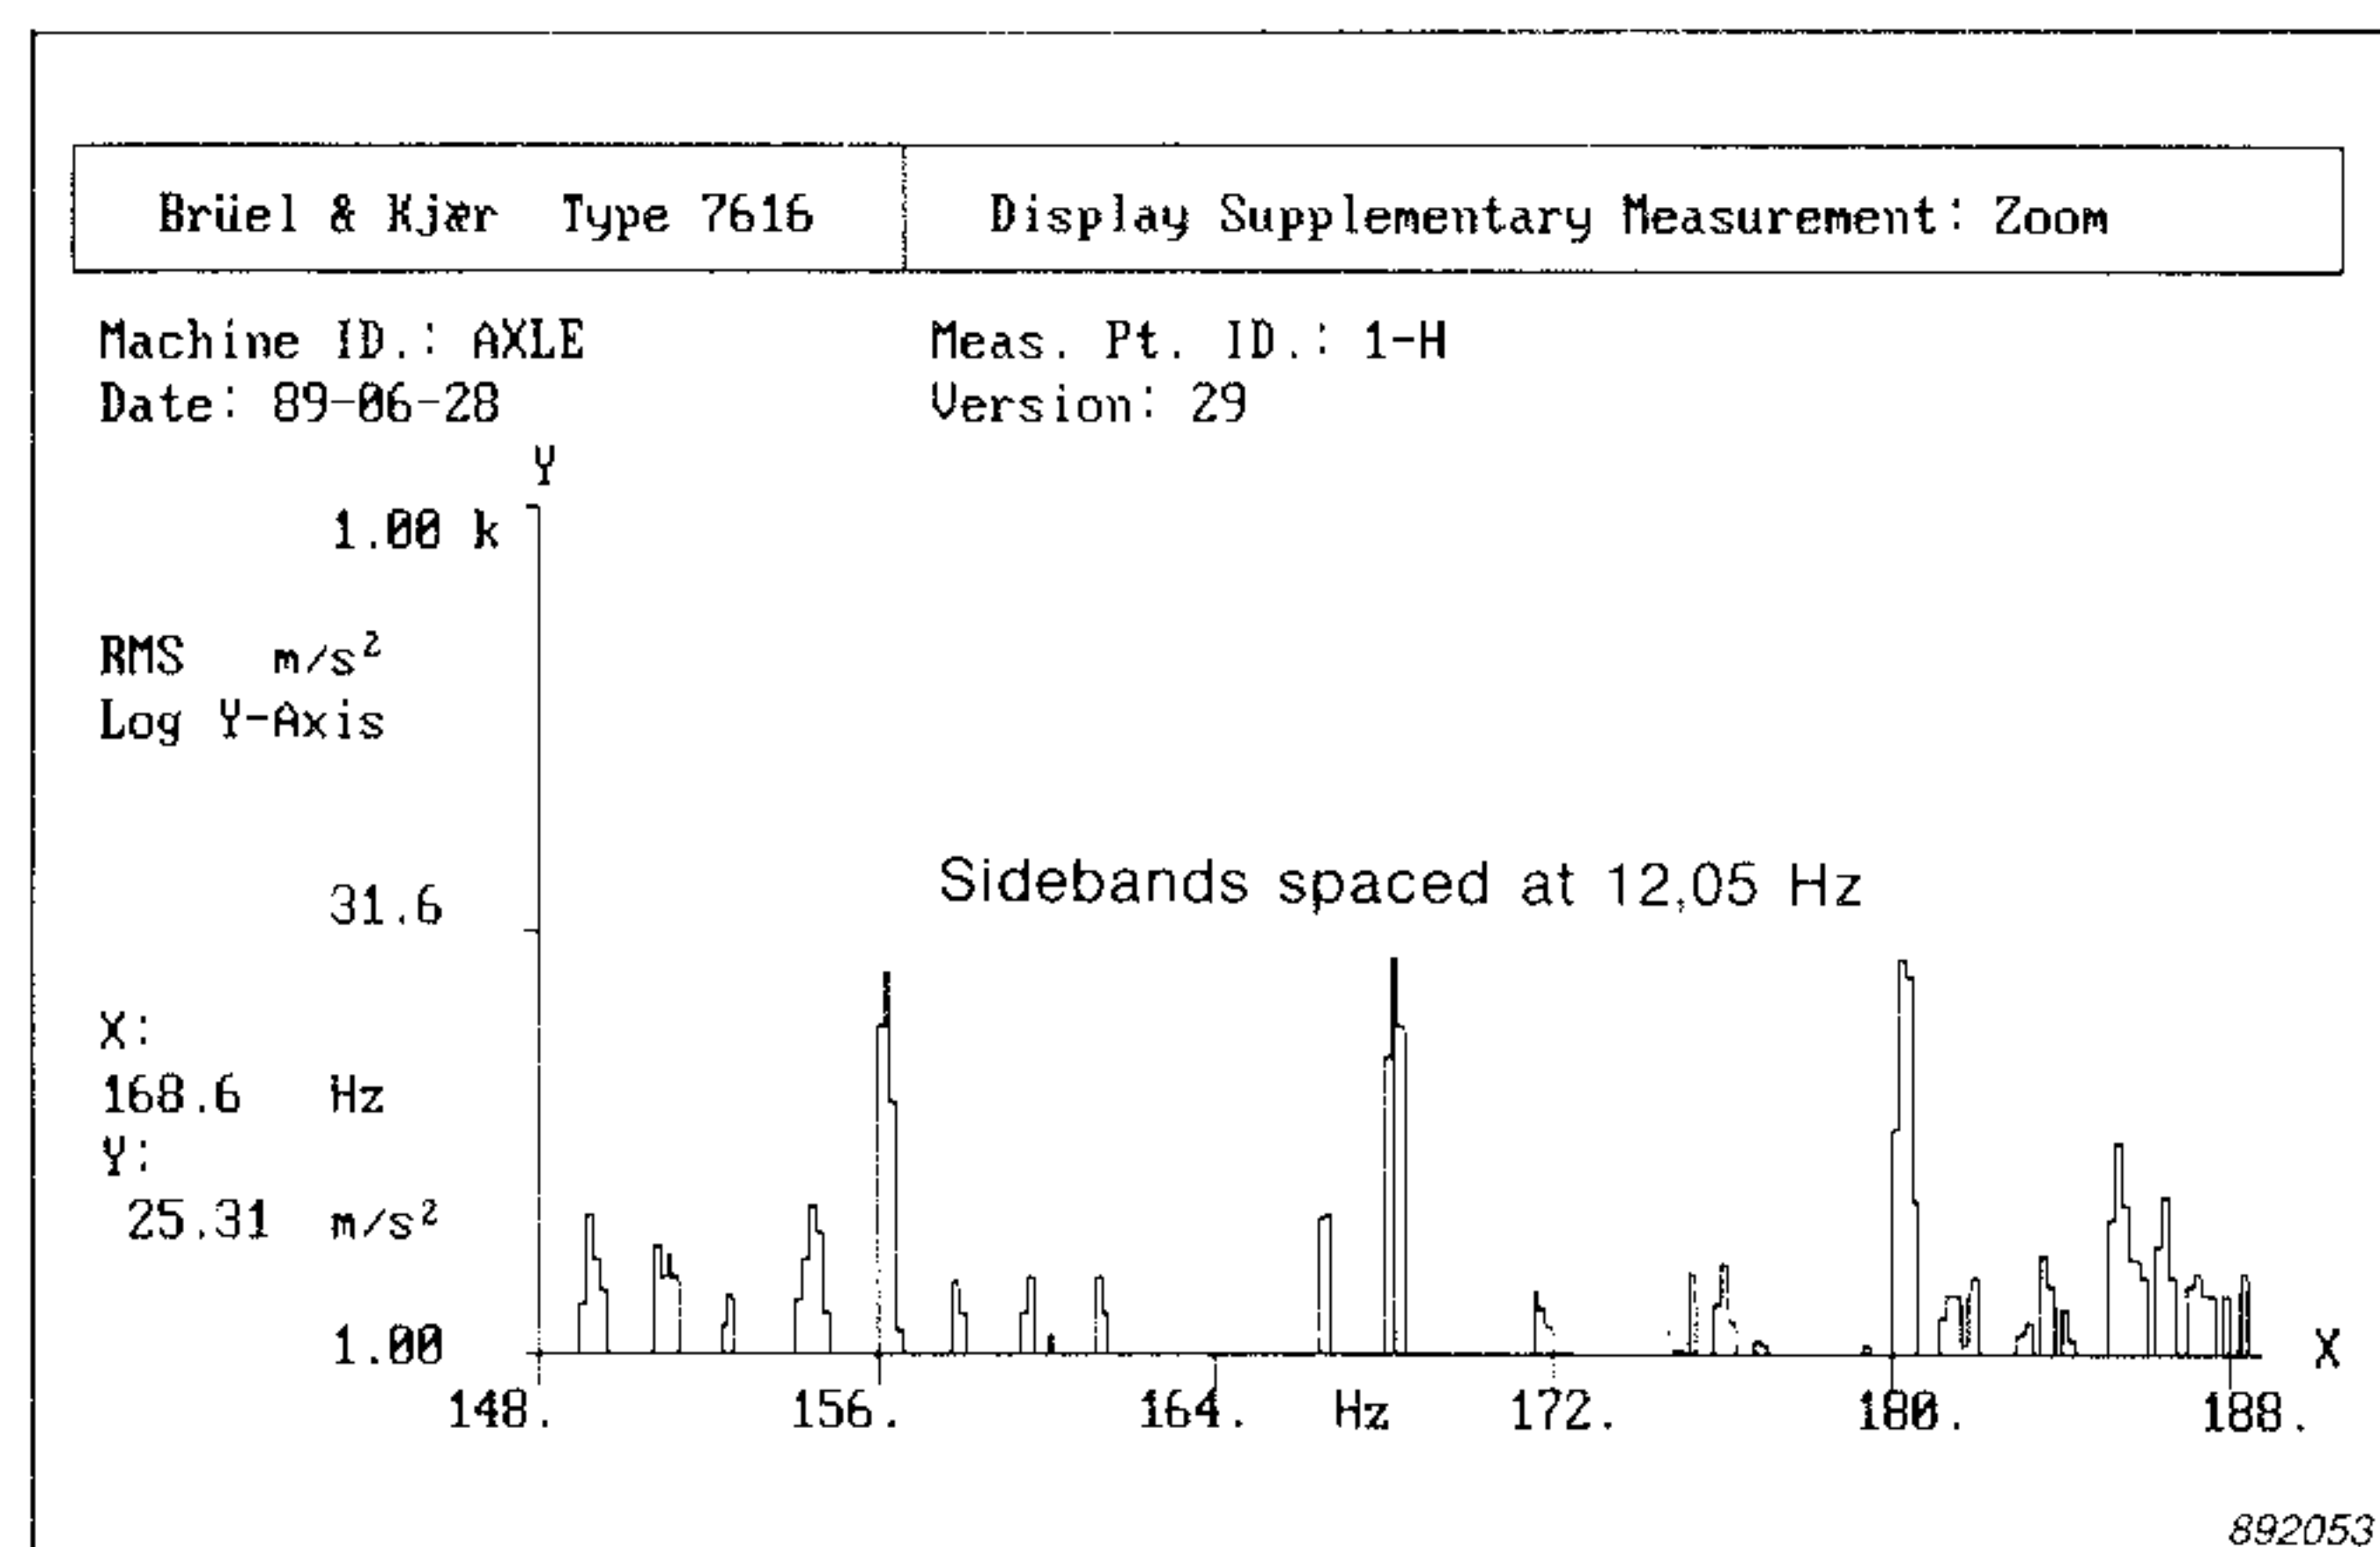
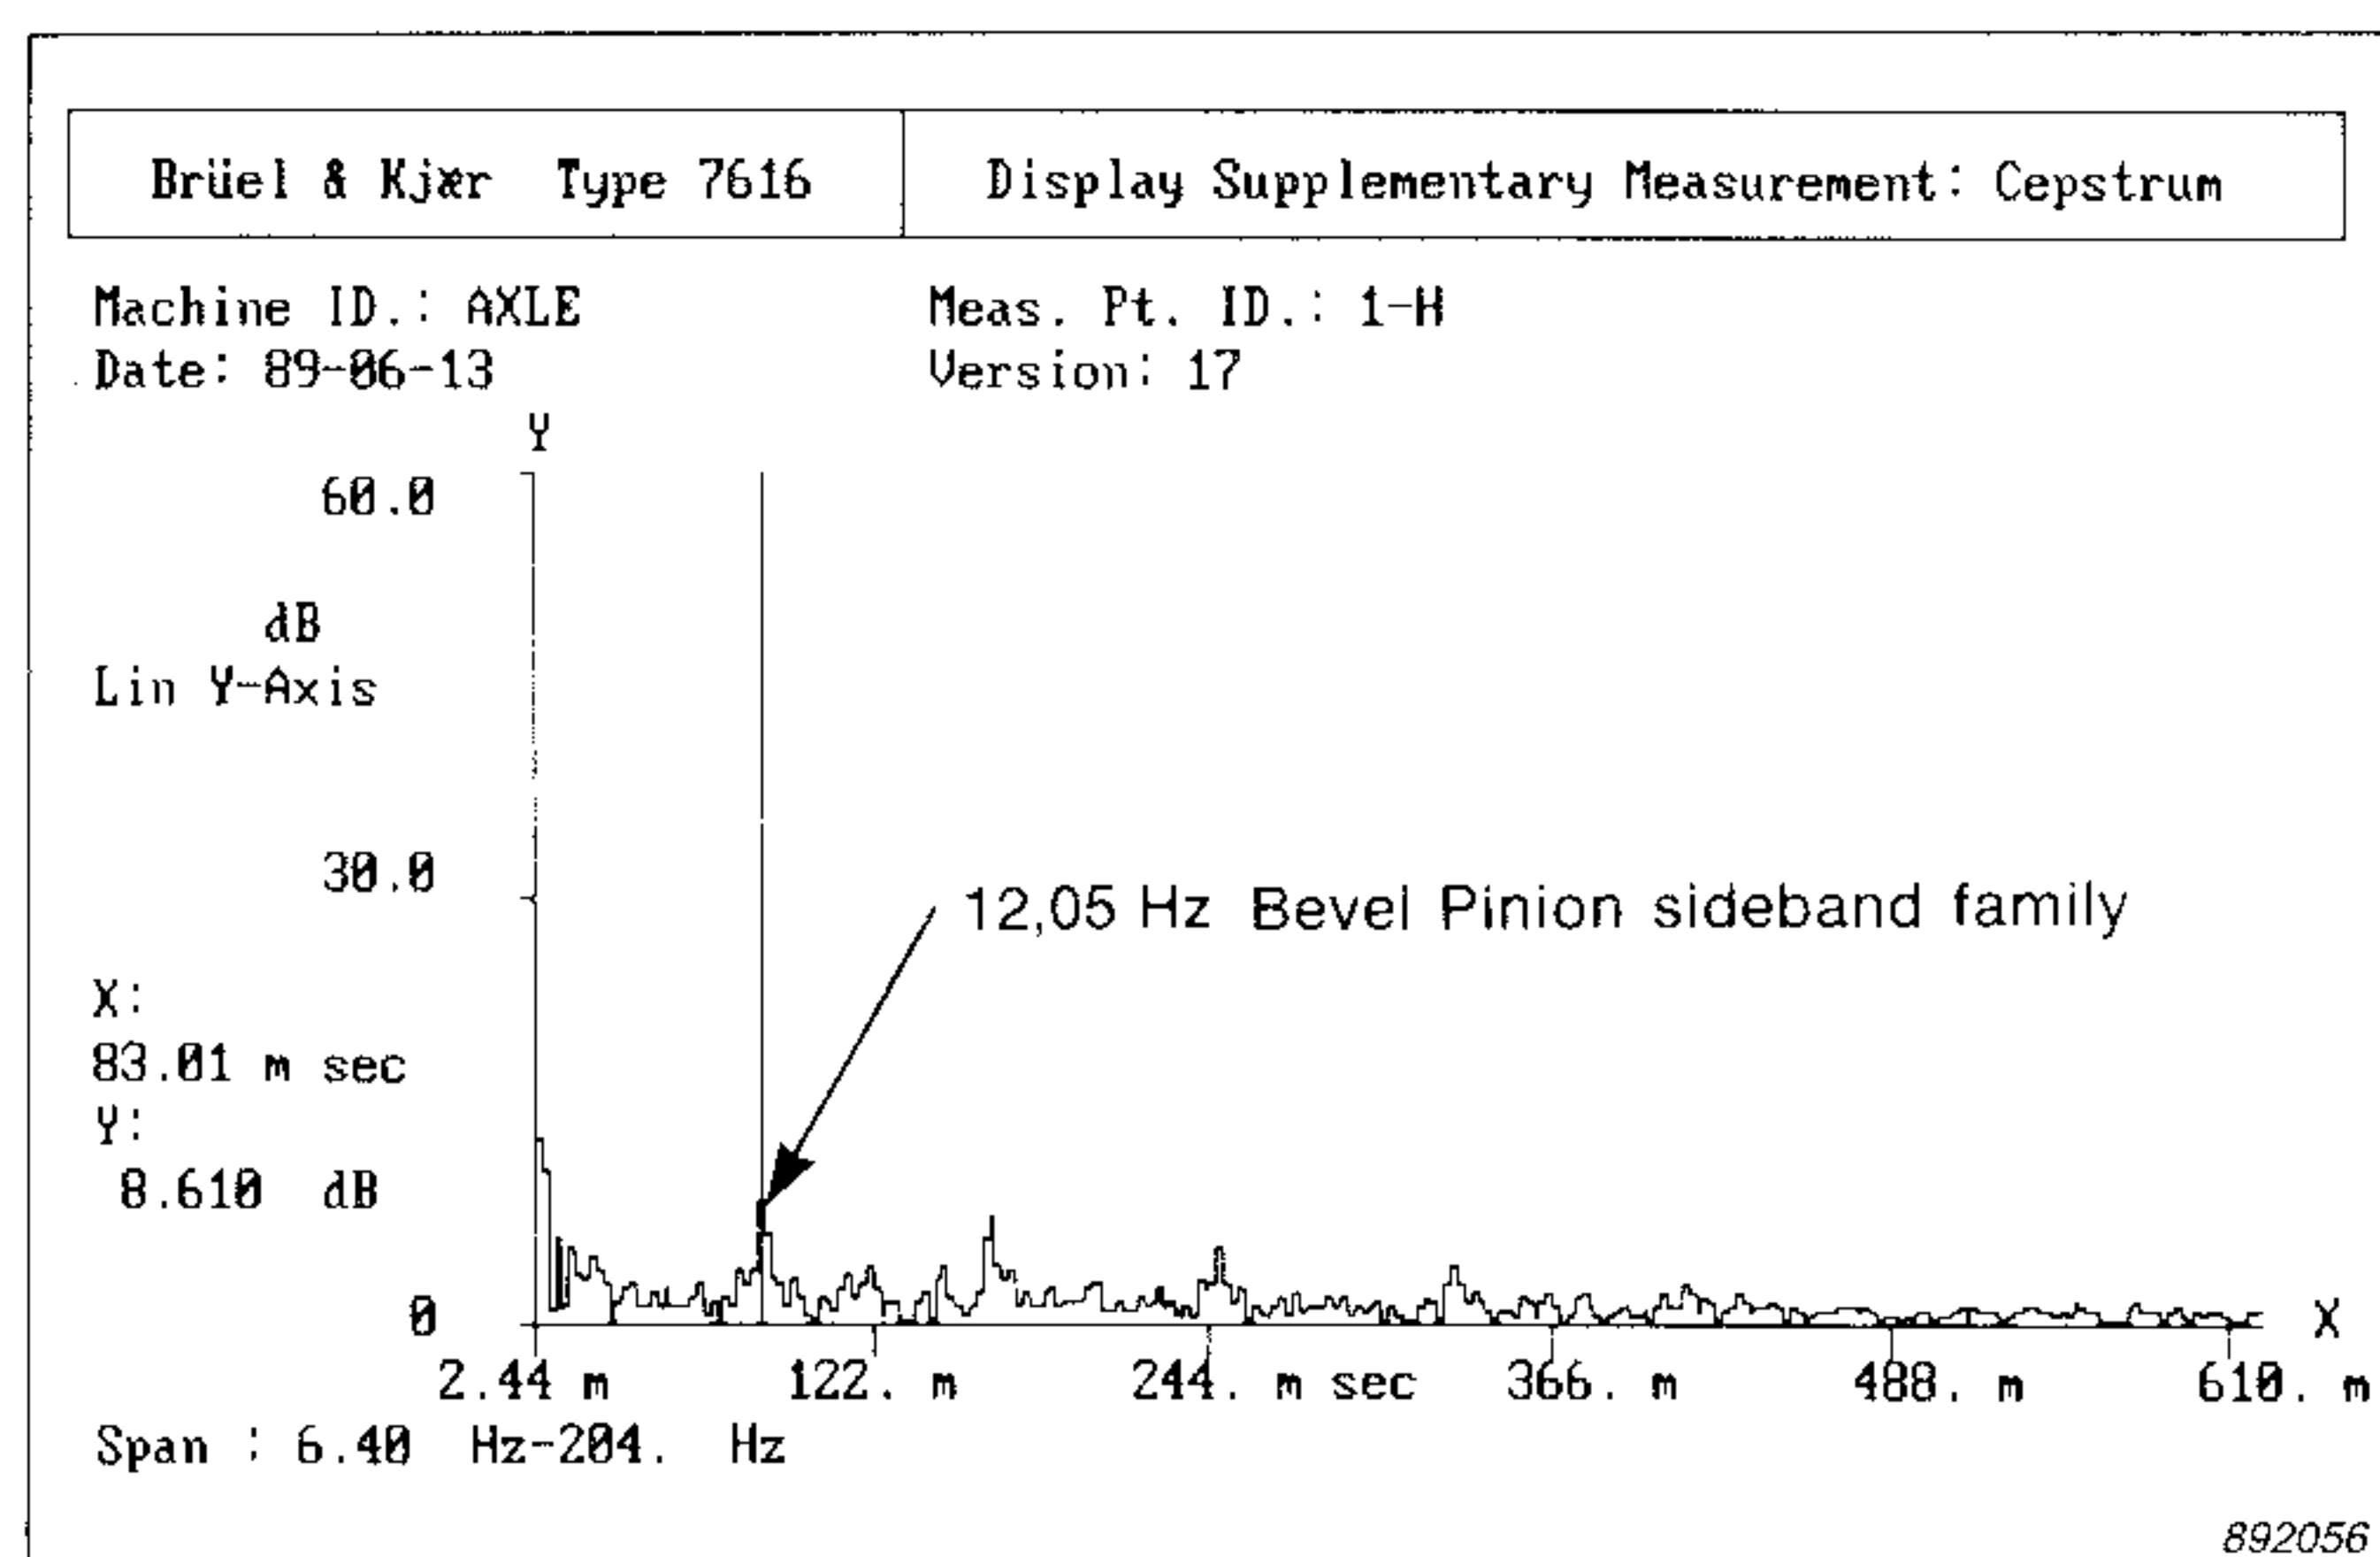
The test was stopped after the 5th spectral record and the pitting on one of the teeth visually examined. This was repeated after the 10th record, where the pitting was observed to be much more widespread. Baseband, zoom and cepstra taken at the 5th and 10th records are shown in Fig. 6. These plots clearly illustrate the growing sidebands.

Fig. 6. Baseband, zoom and cepstra taken at the 5th and 10th records in the columns to left and right respectively, showing the growing sidebands as pitting spreads from one to more teeth on the 6 tooth bevel-pinion
