Early Detection of Gear Faults Using Vibration Analysis in a Manufacturer's Test Department

Better Axle Gears on RABA Trucks:-

by Laszlo Boros, RABA, Győr, Hungary and Glenn H. Bate, Brüel & Kjær, Denmark

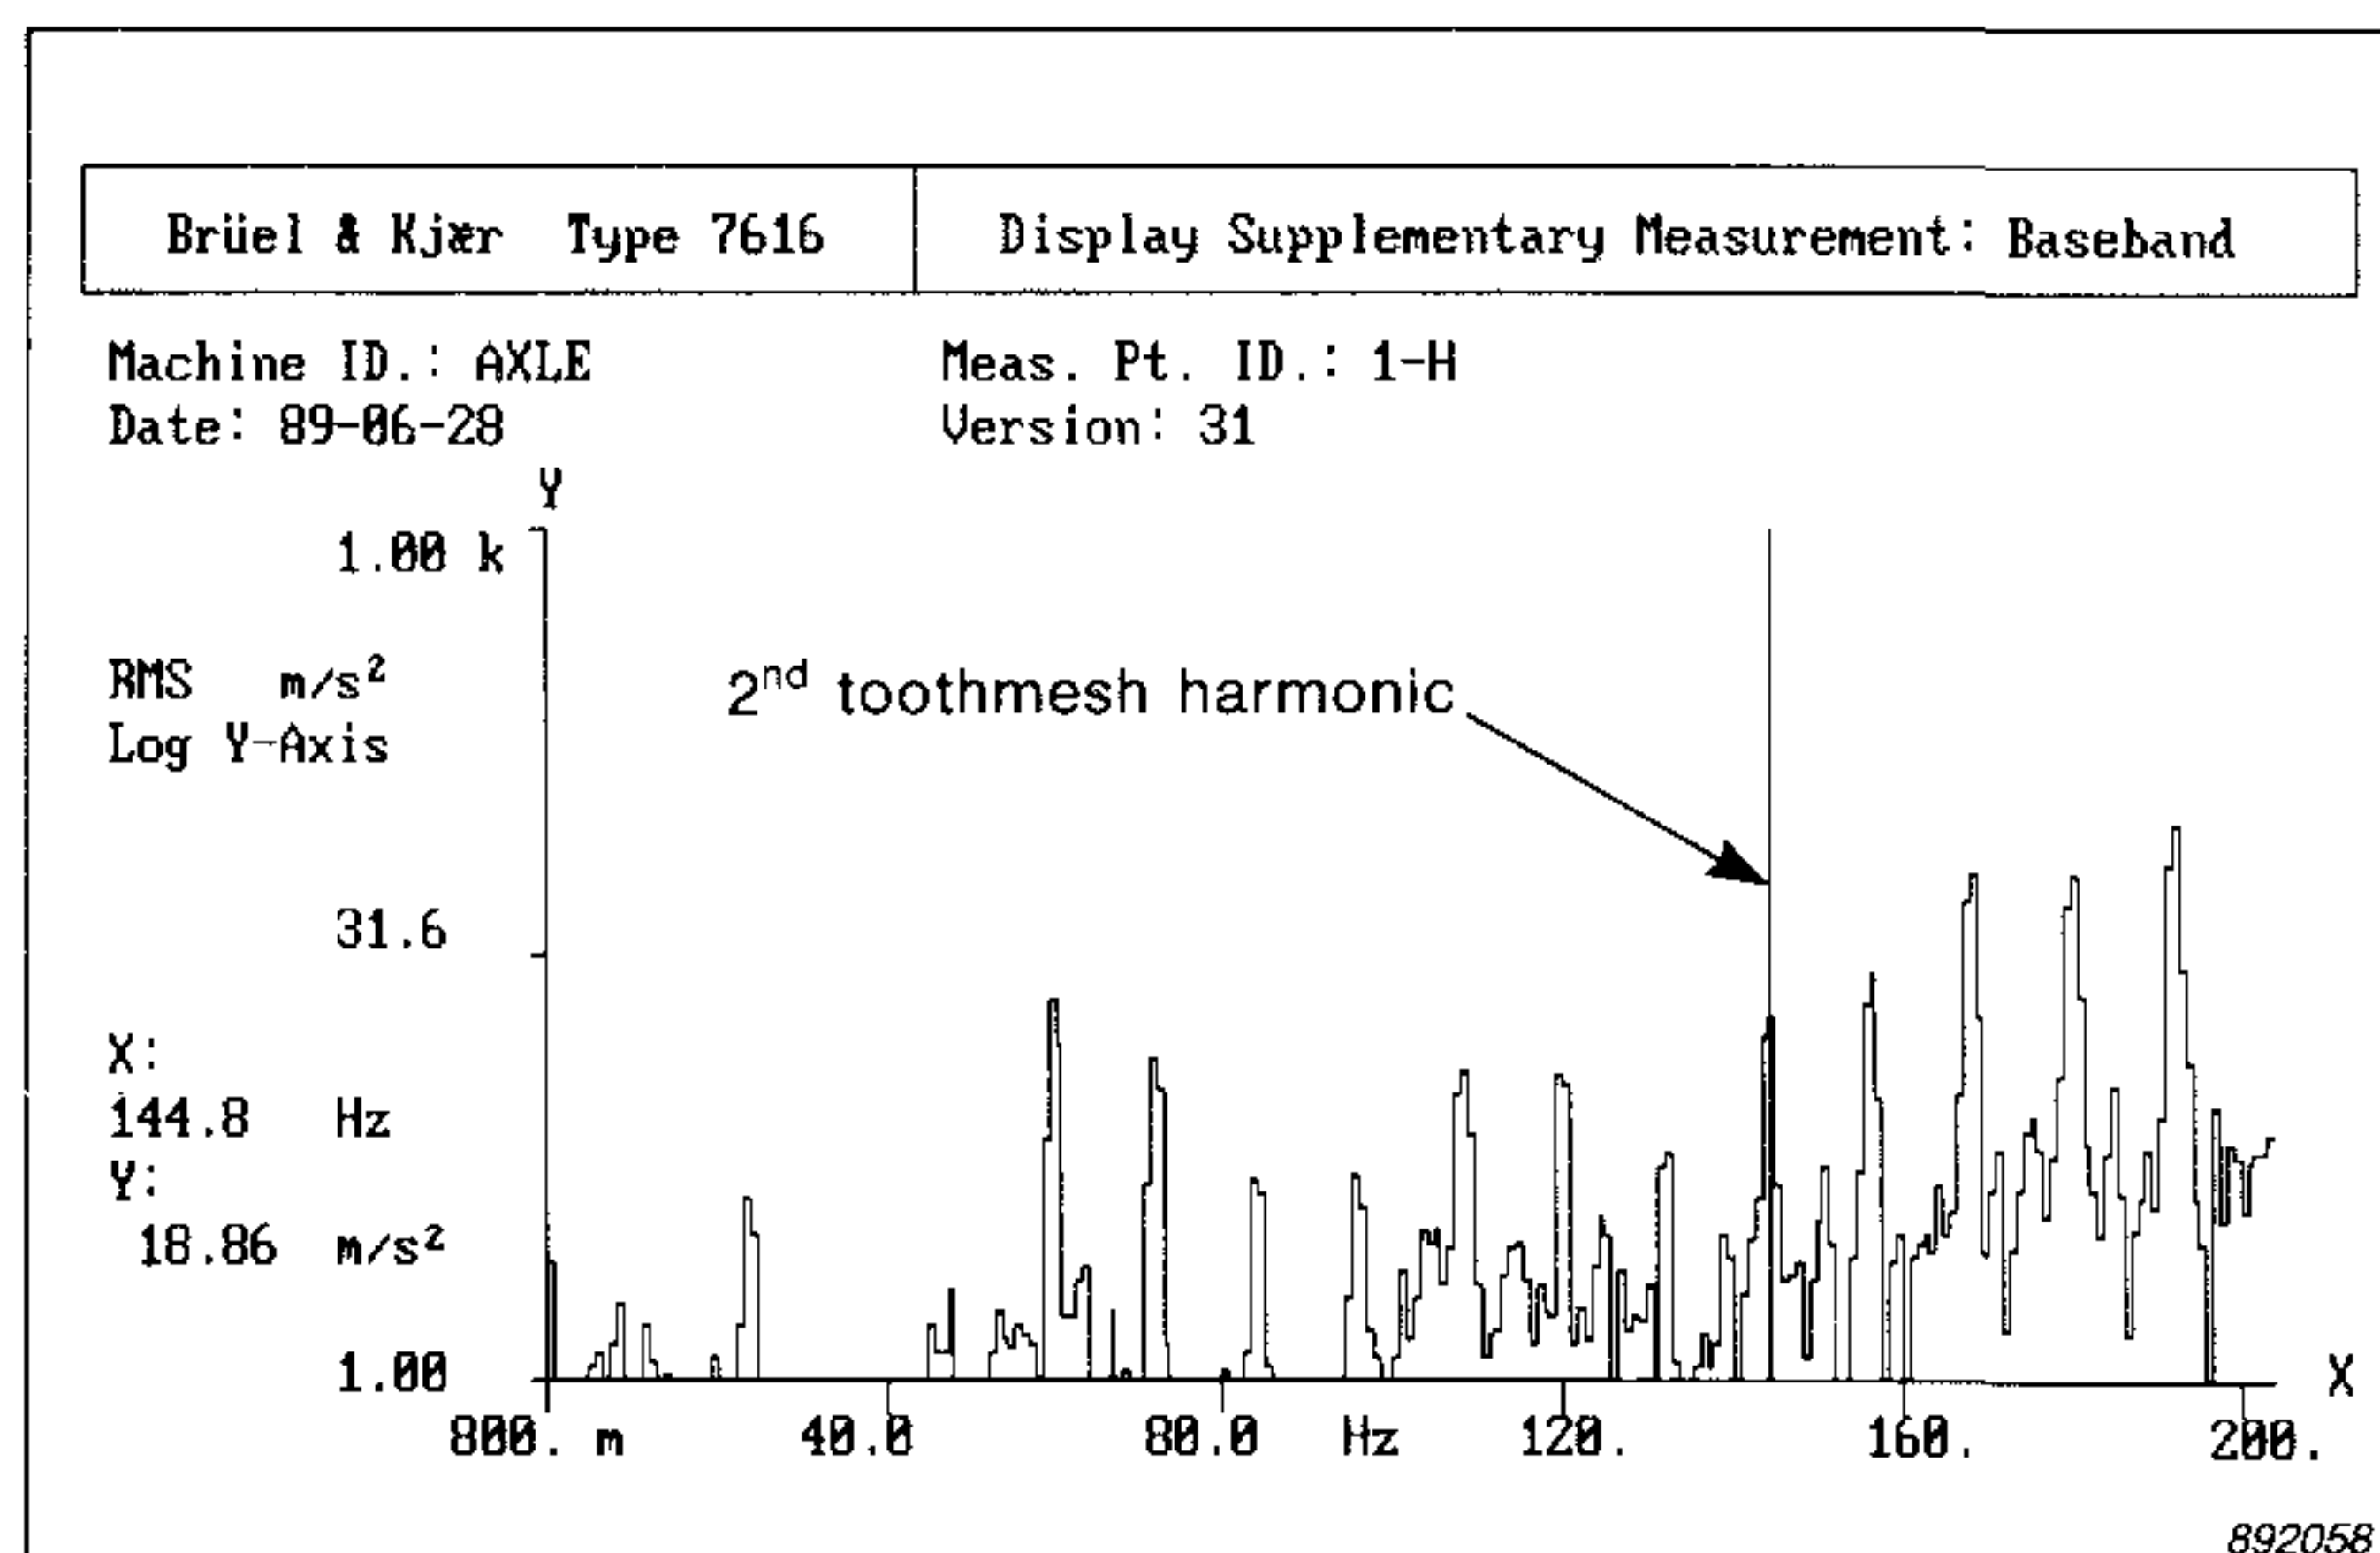
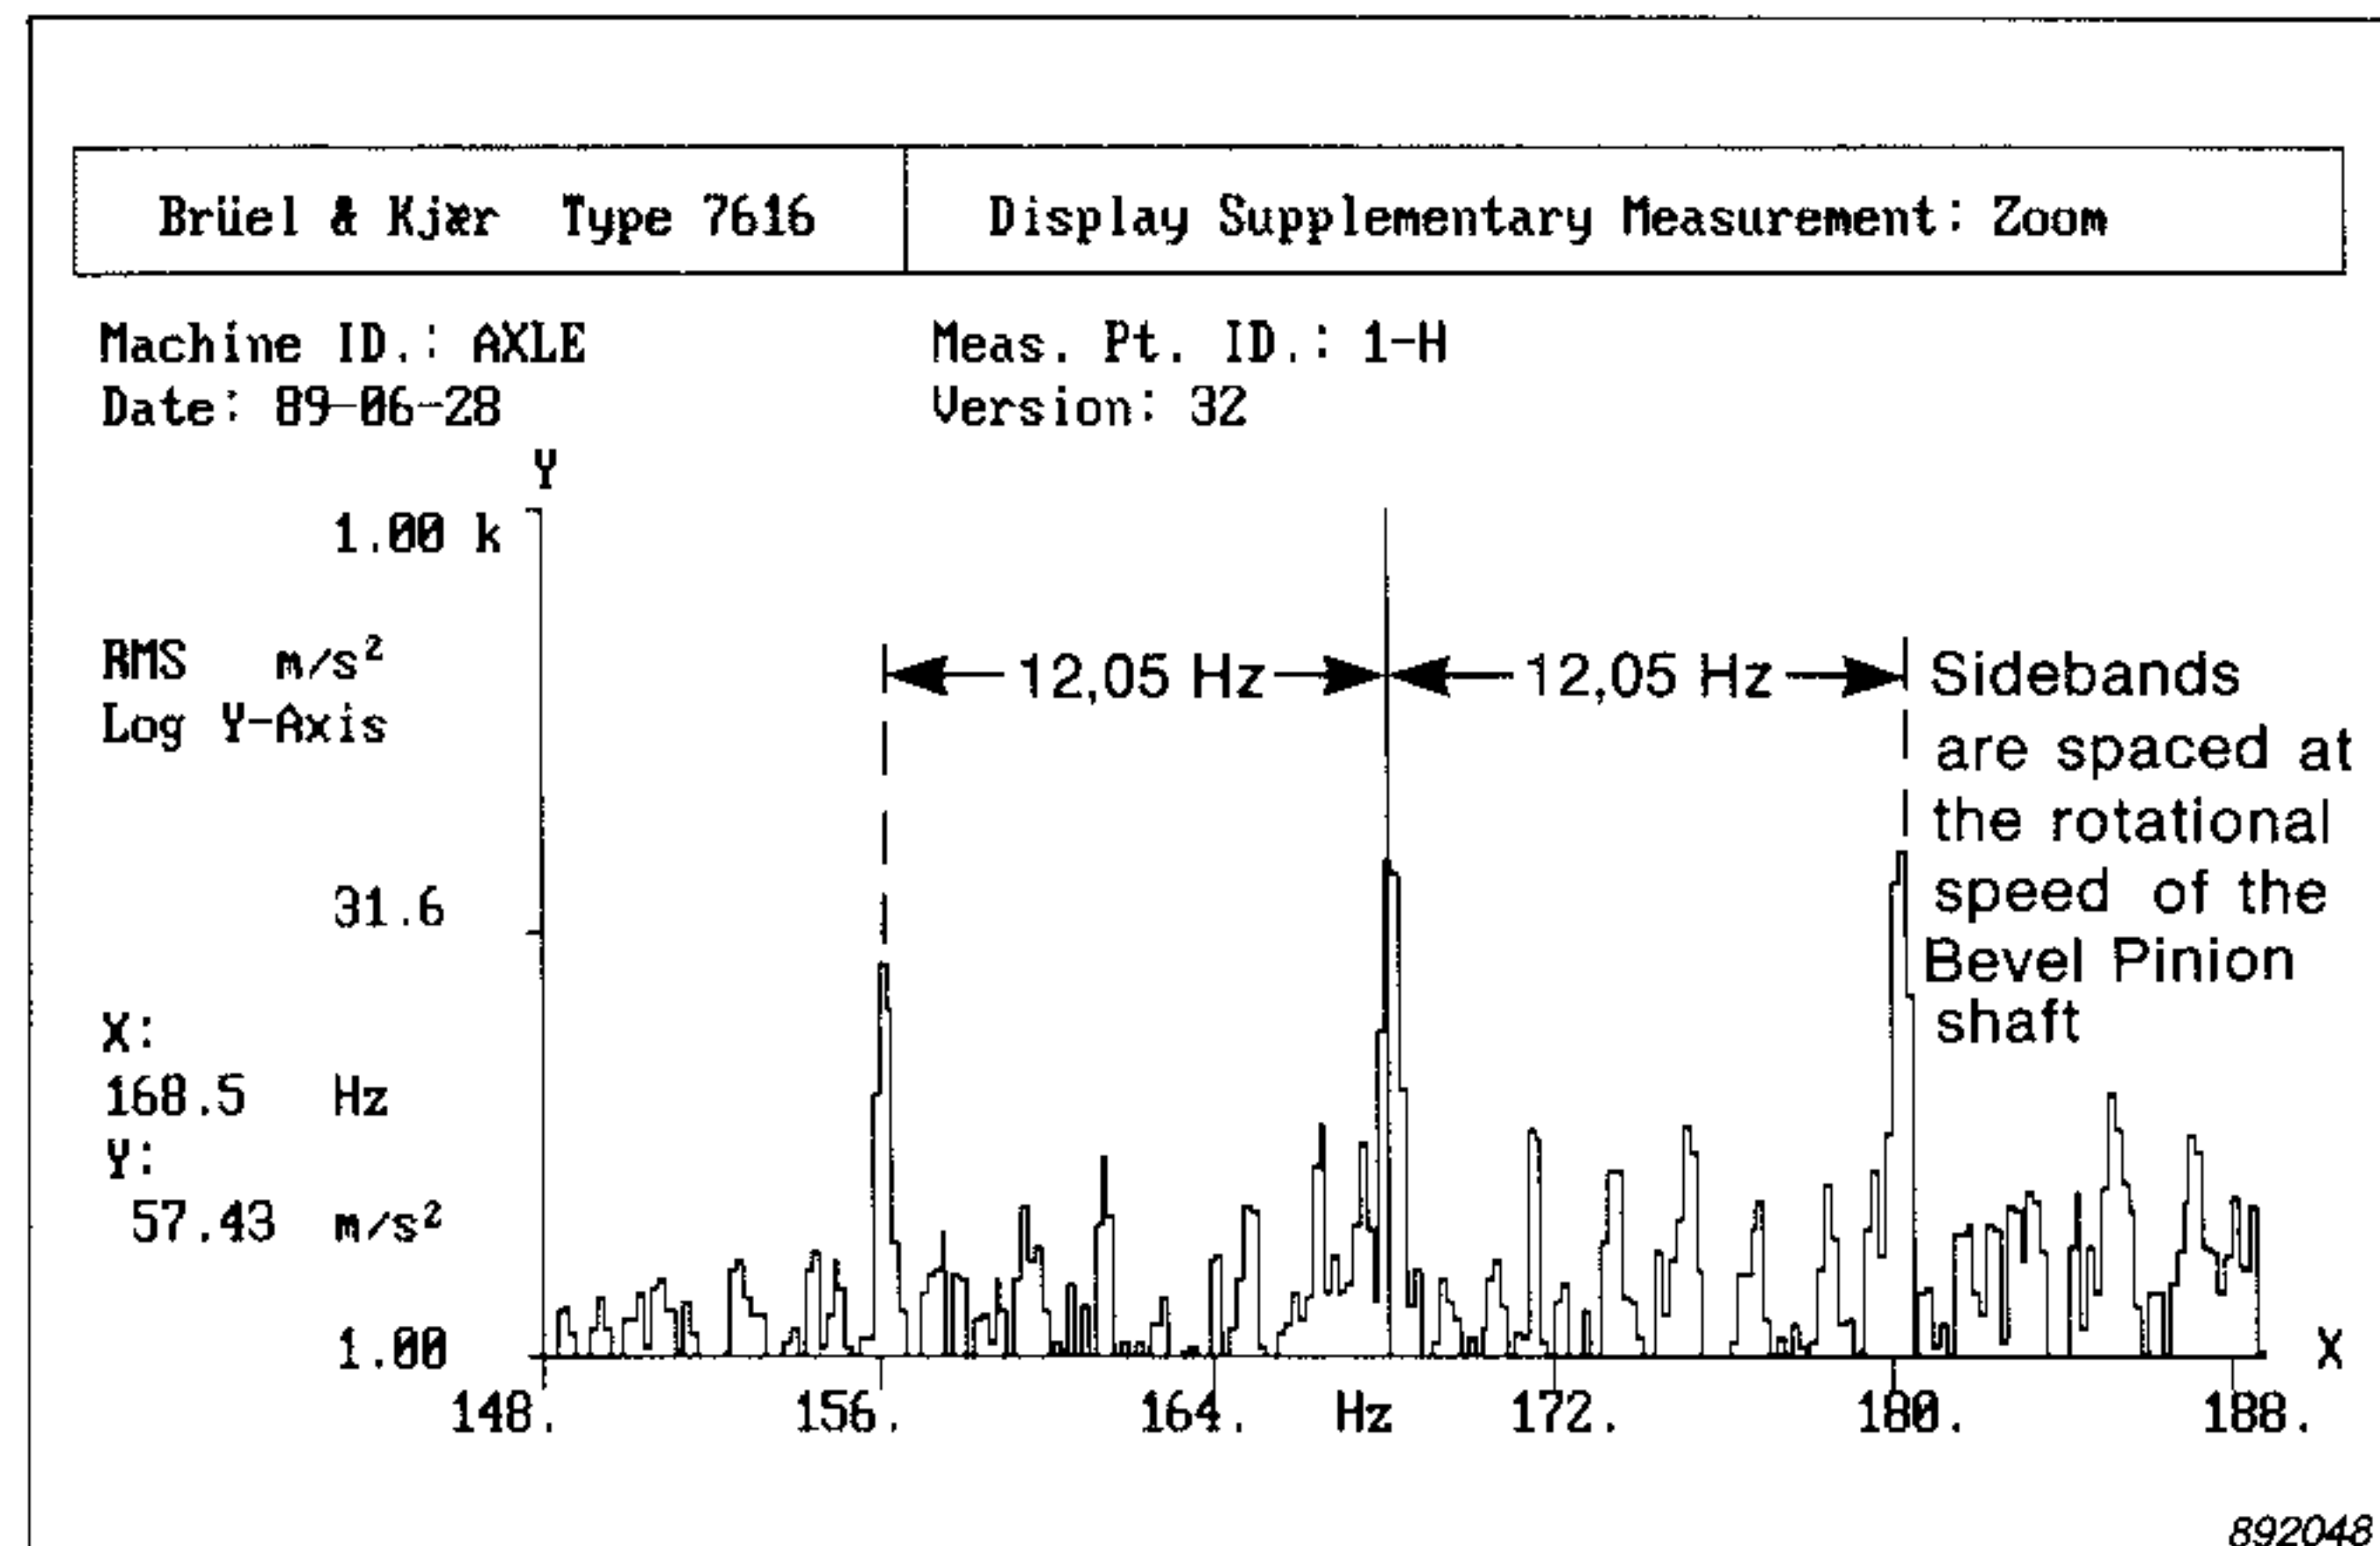
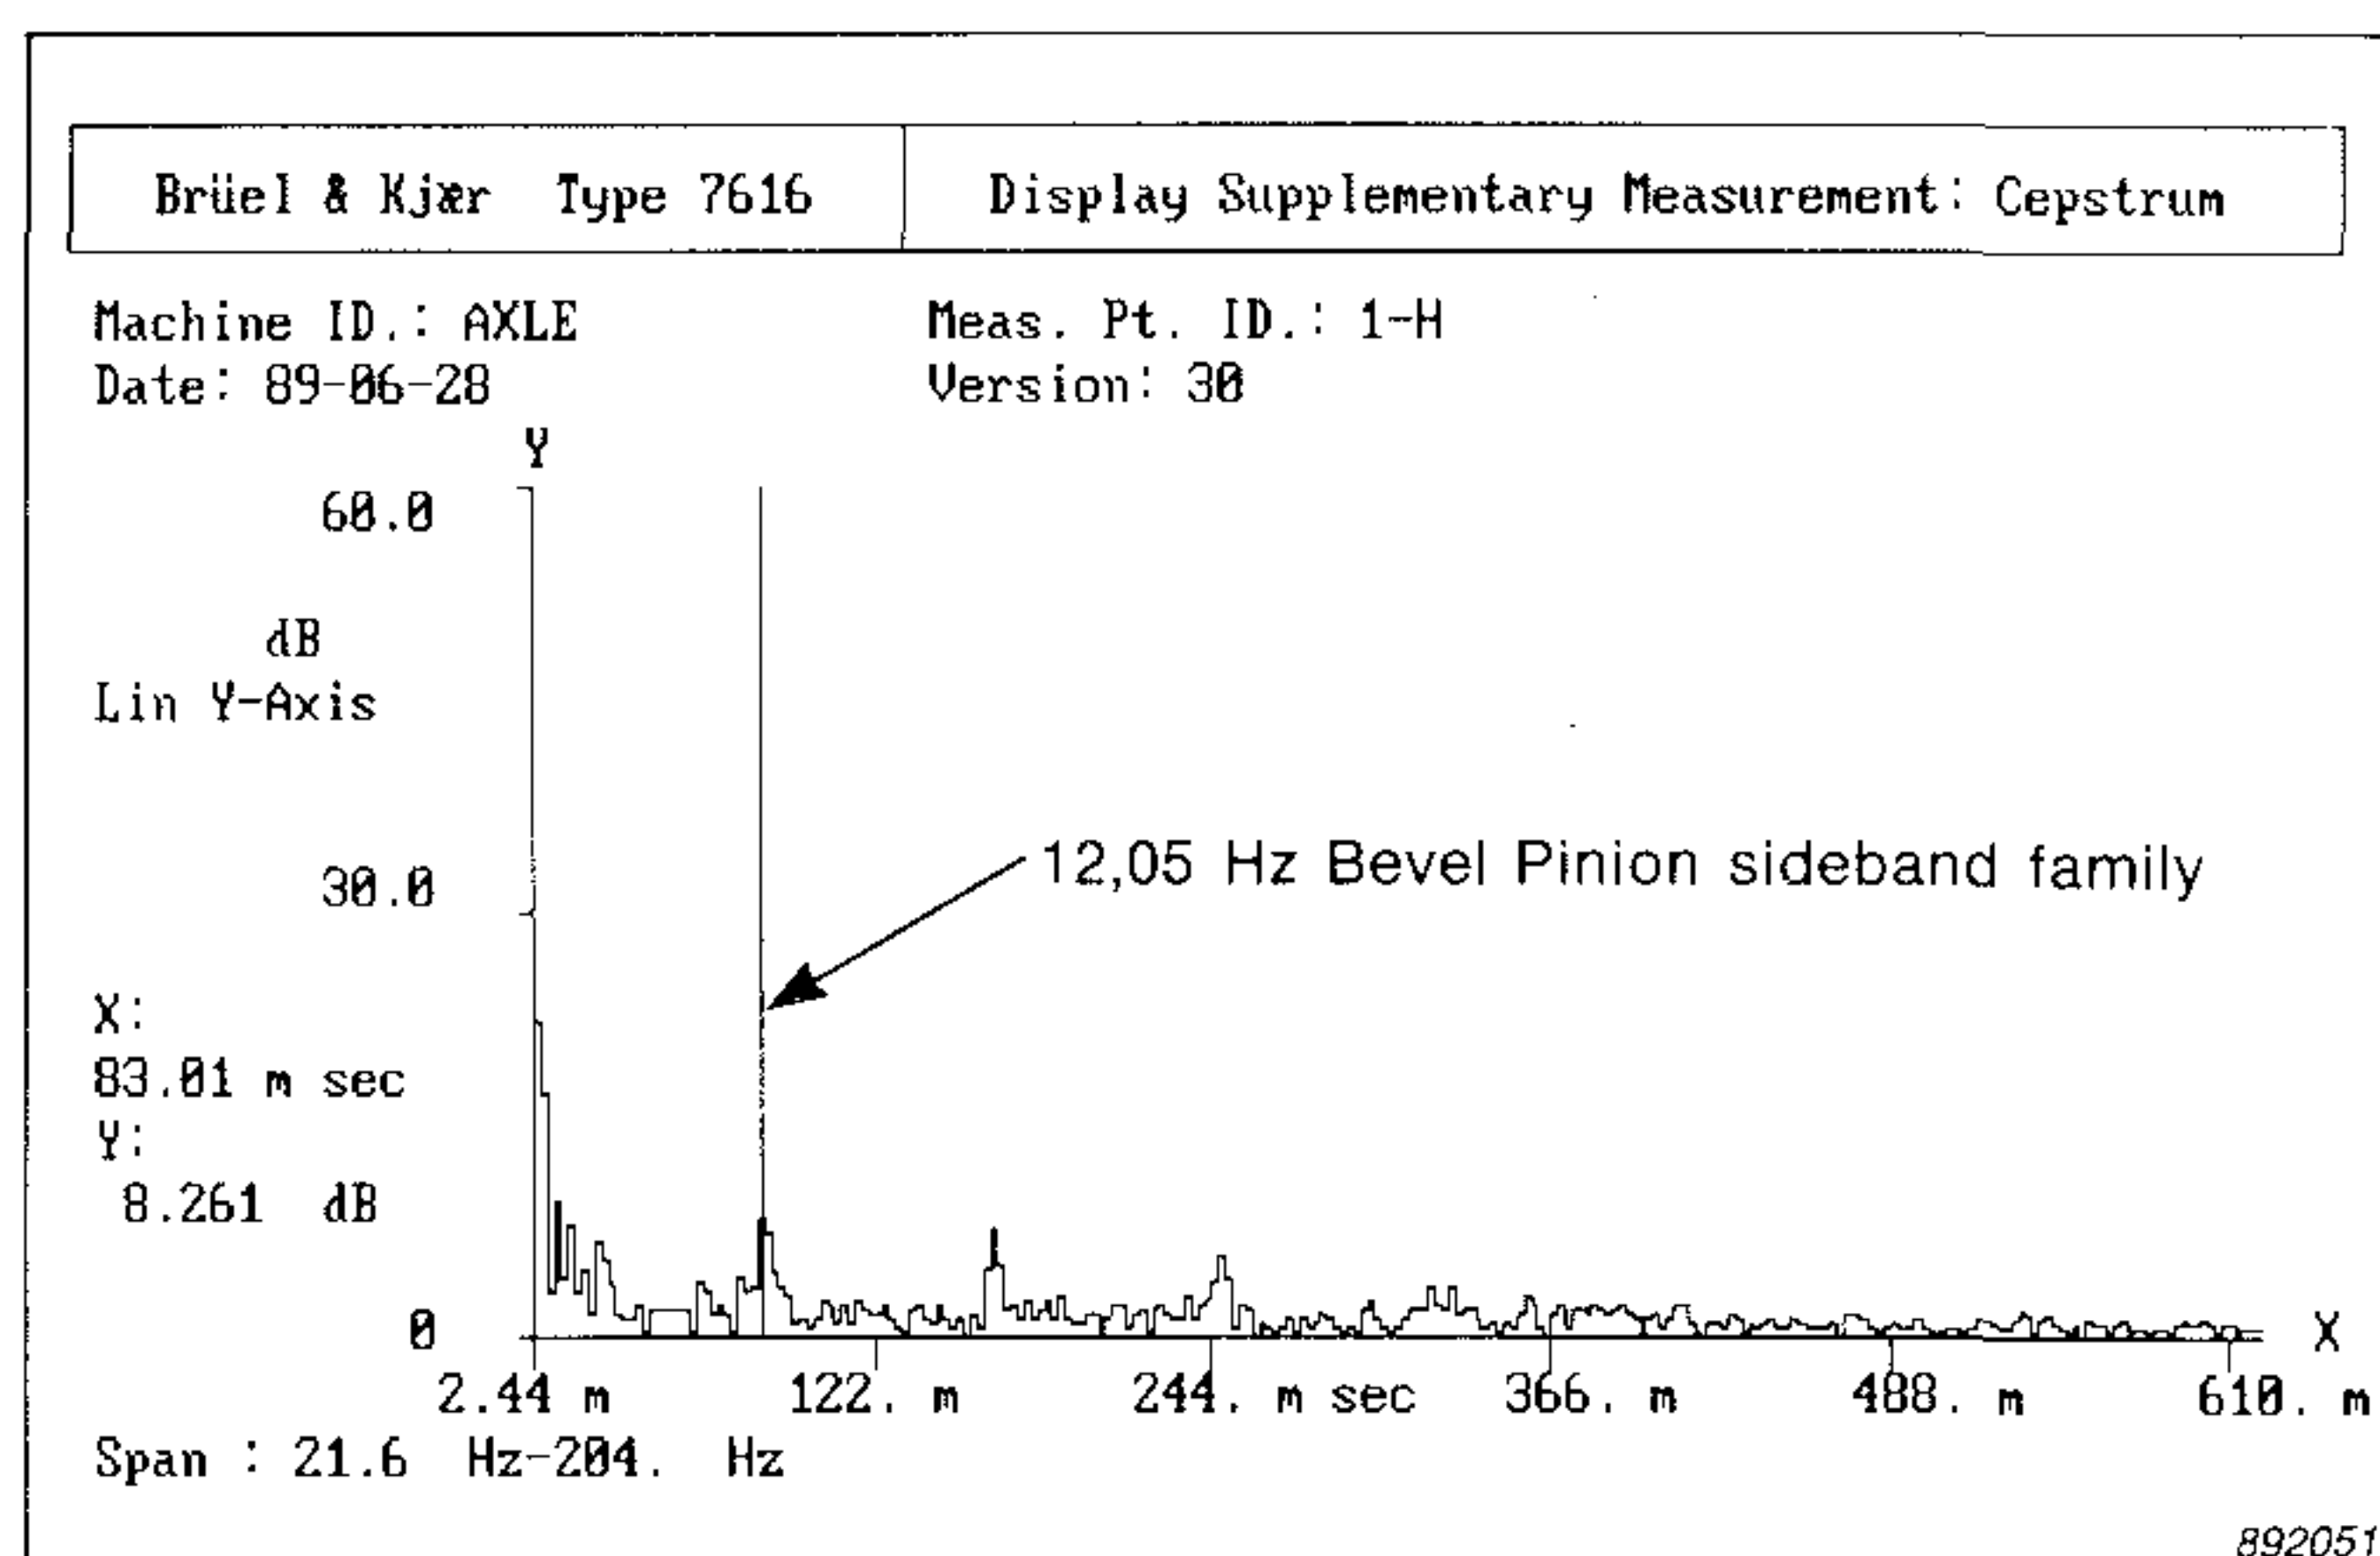
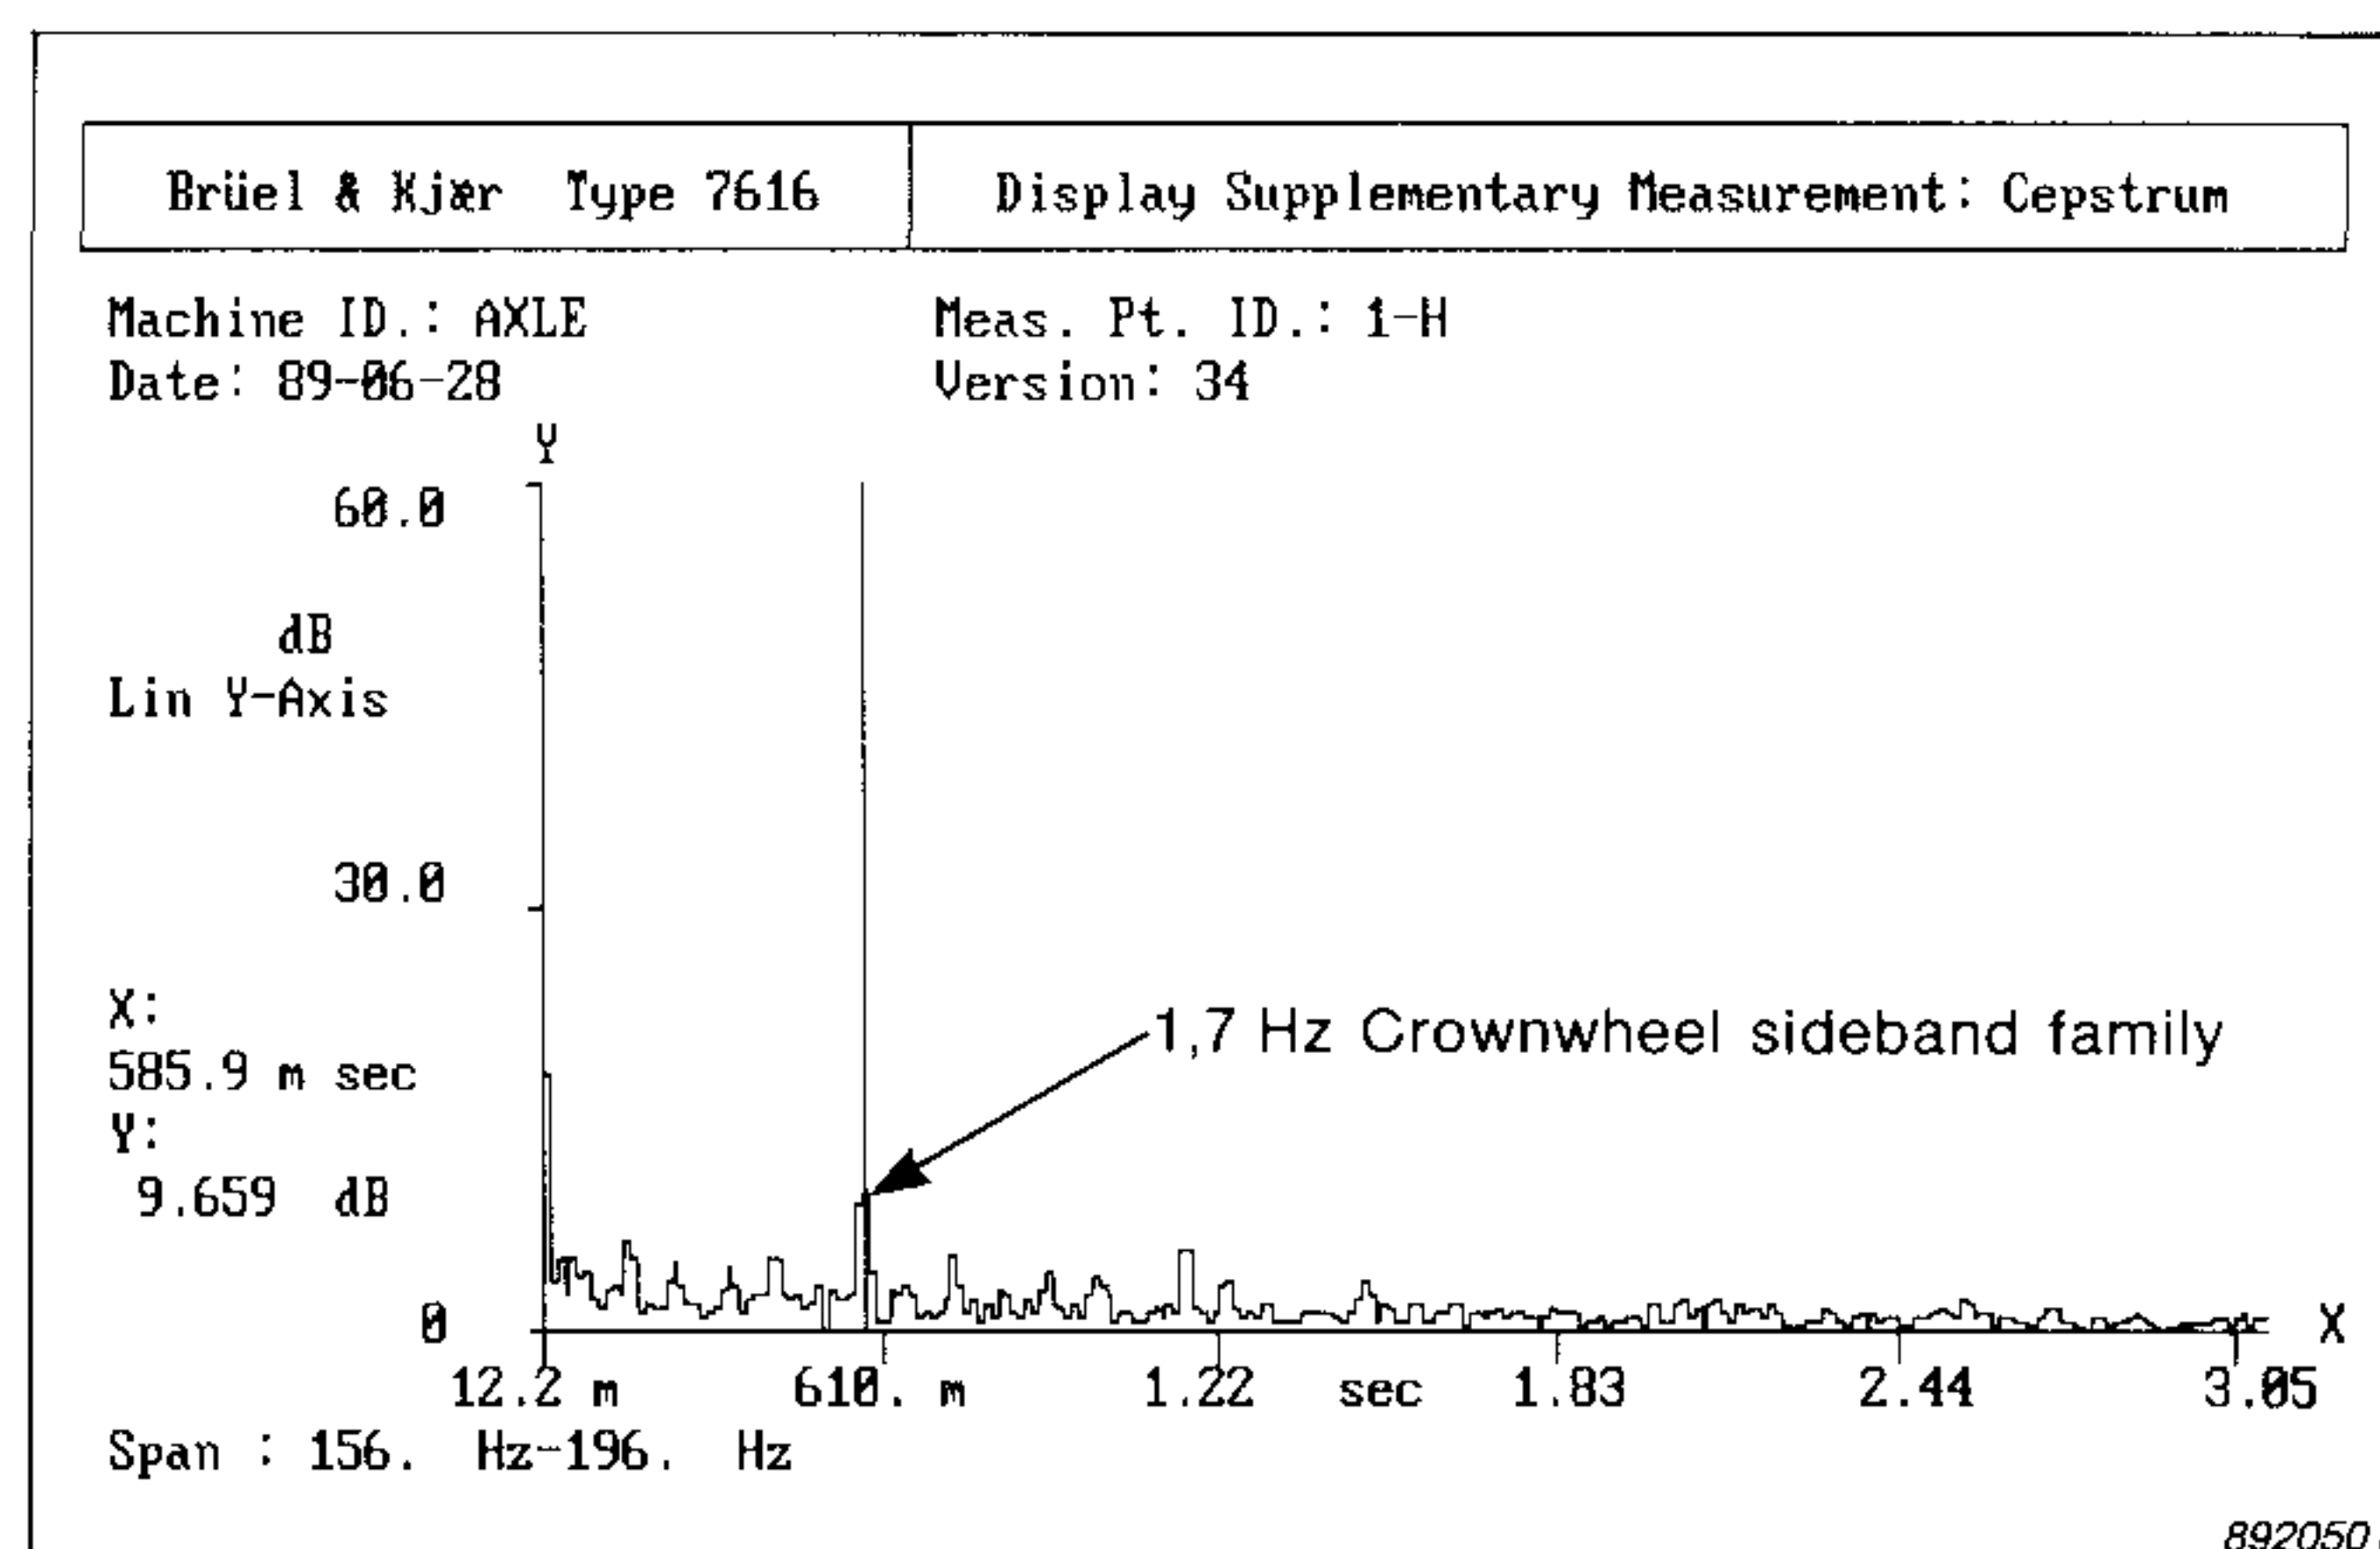
The 10th record corresponds to 75 % of the life of this particular gear set, which was actually run to destruction, when 2 teeth on the bevel-pinion cracked after the 16th record. This is seen in Fig. 7, which shows a rapid increase in the vibration spectrum of this record with sidebands coming up in amplitude also between the lower toothmesh harmonics, (Fig. 7 shows baseband, zoom, cepstrum and zoom cepstrum of the 16th record). As before, the growing sidebands of pinion-speed are clear, but the zoom cepstrum also indicates wear on the crown-wheel with the appearance of a sideband at crown-wheel-speed. (The opportunity to verify the crown-wheel wear was missed, as the test was allowed to continue).

Of the total life of this gear under test, the pinion fractured 0.7% of its lifetime after the 16th spectral record was taken. This particular test took place fairly early on in the development of the test program, and the warning apparent from the spectrum analyzer was not heeded before the fracture occurred.

Fig. 7. Baseband, zoom, cepstrum and zoom cepstrum of the 16th record, when a tooth cracked on the bevel-pinion
