# Machine-Condition Monitoring Using Vibration Analysis

A Case Study from a Nuclear Power-Plant

by *D.N.Brown*  
Brüel & Kjær

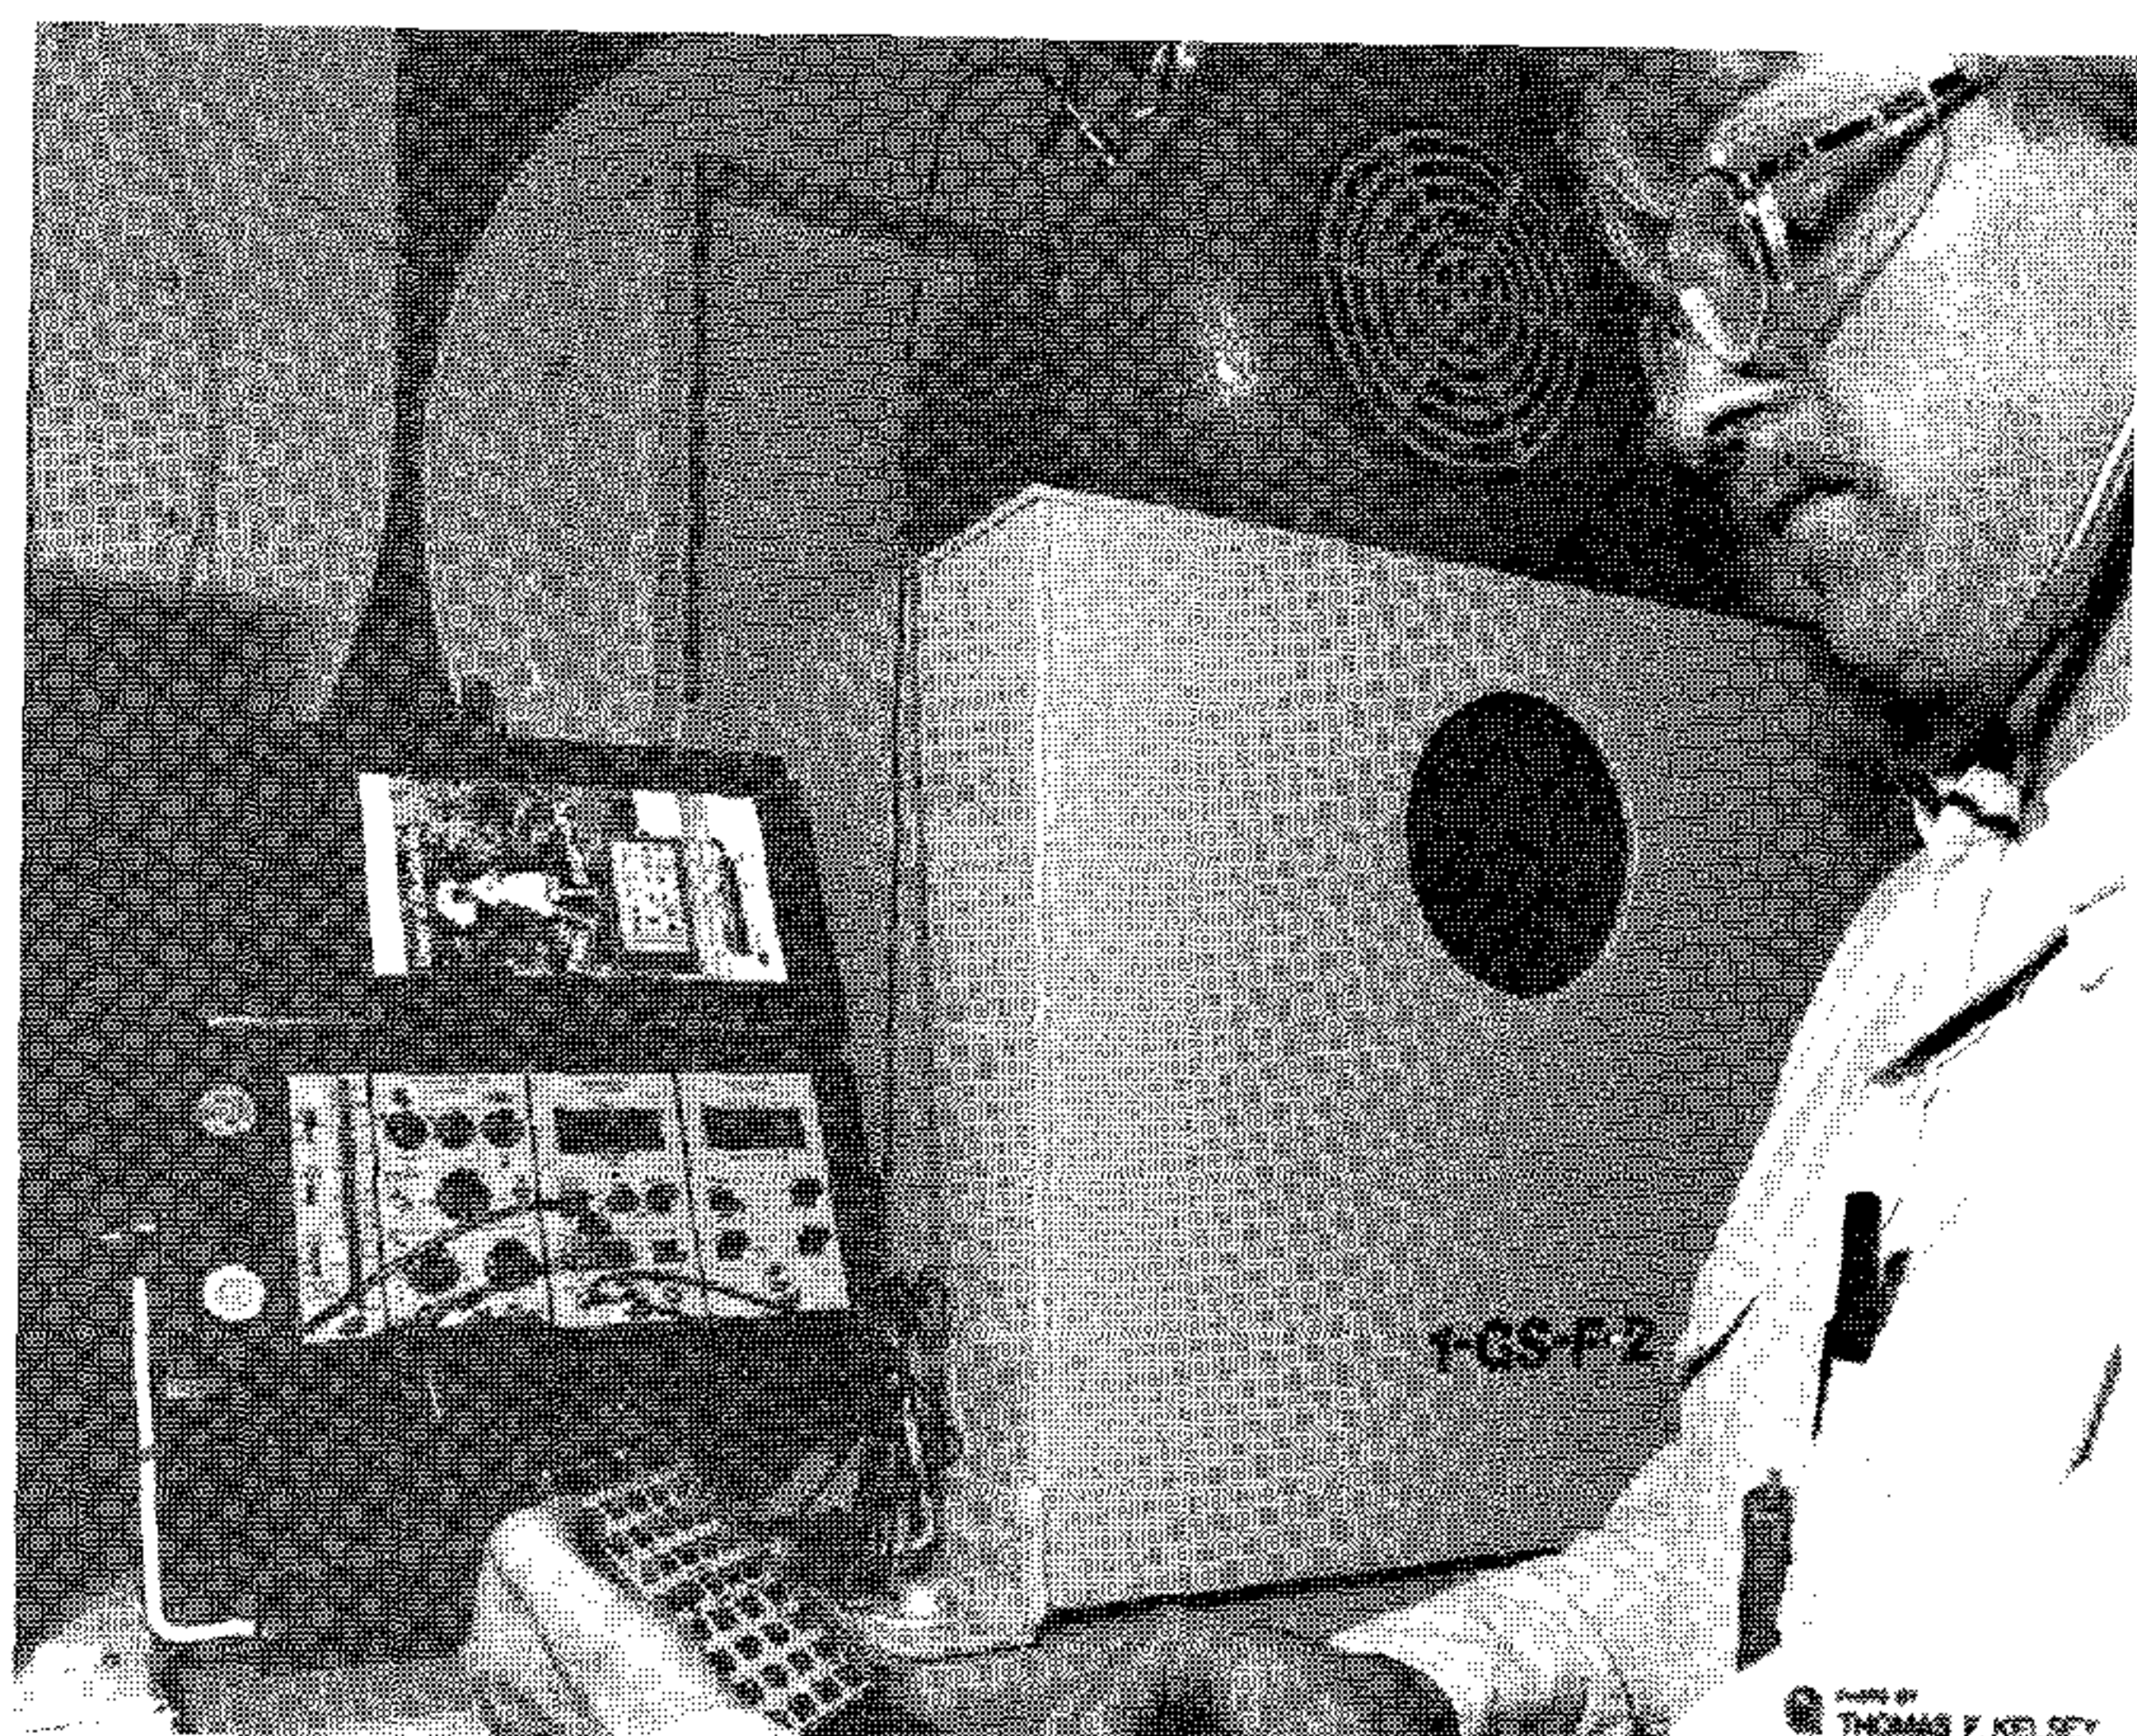
Fig. 6. Using the Type 3537 Portable Tracking Balancing Set to balance a gland steam fan

When the need to rebalance a rotor arises, either the Type 2515 Vibration Analyzer or a Type 3537 Portable Tracking Balancing Set are used. The Type 3537 (see Fig. 6) is a dedicated balancing set which has a narrowband tracking filter to balance machines running at unstable speeds. Both the Types 2515 and 3537 measure vibration level due to unbalance and phase angle relative to a marker. This information is keyed into a pocket calculator using Balancing Calculation Software WW 9021 which calculates the

mass and its position required to balance the rotor.

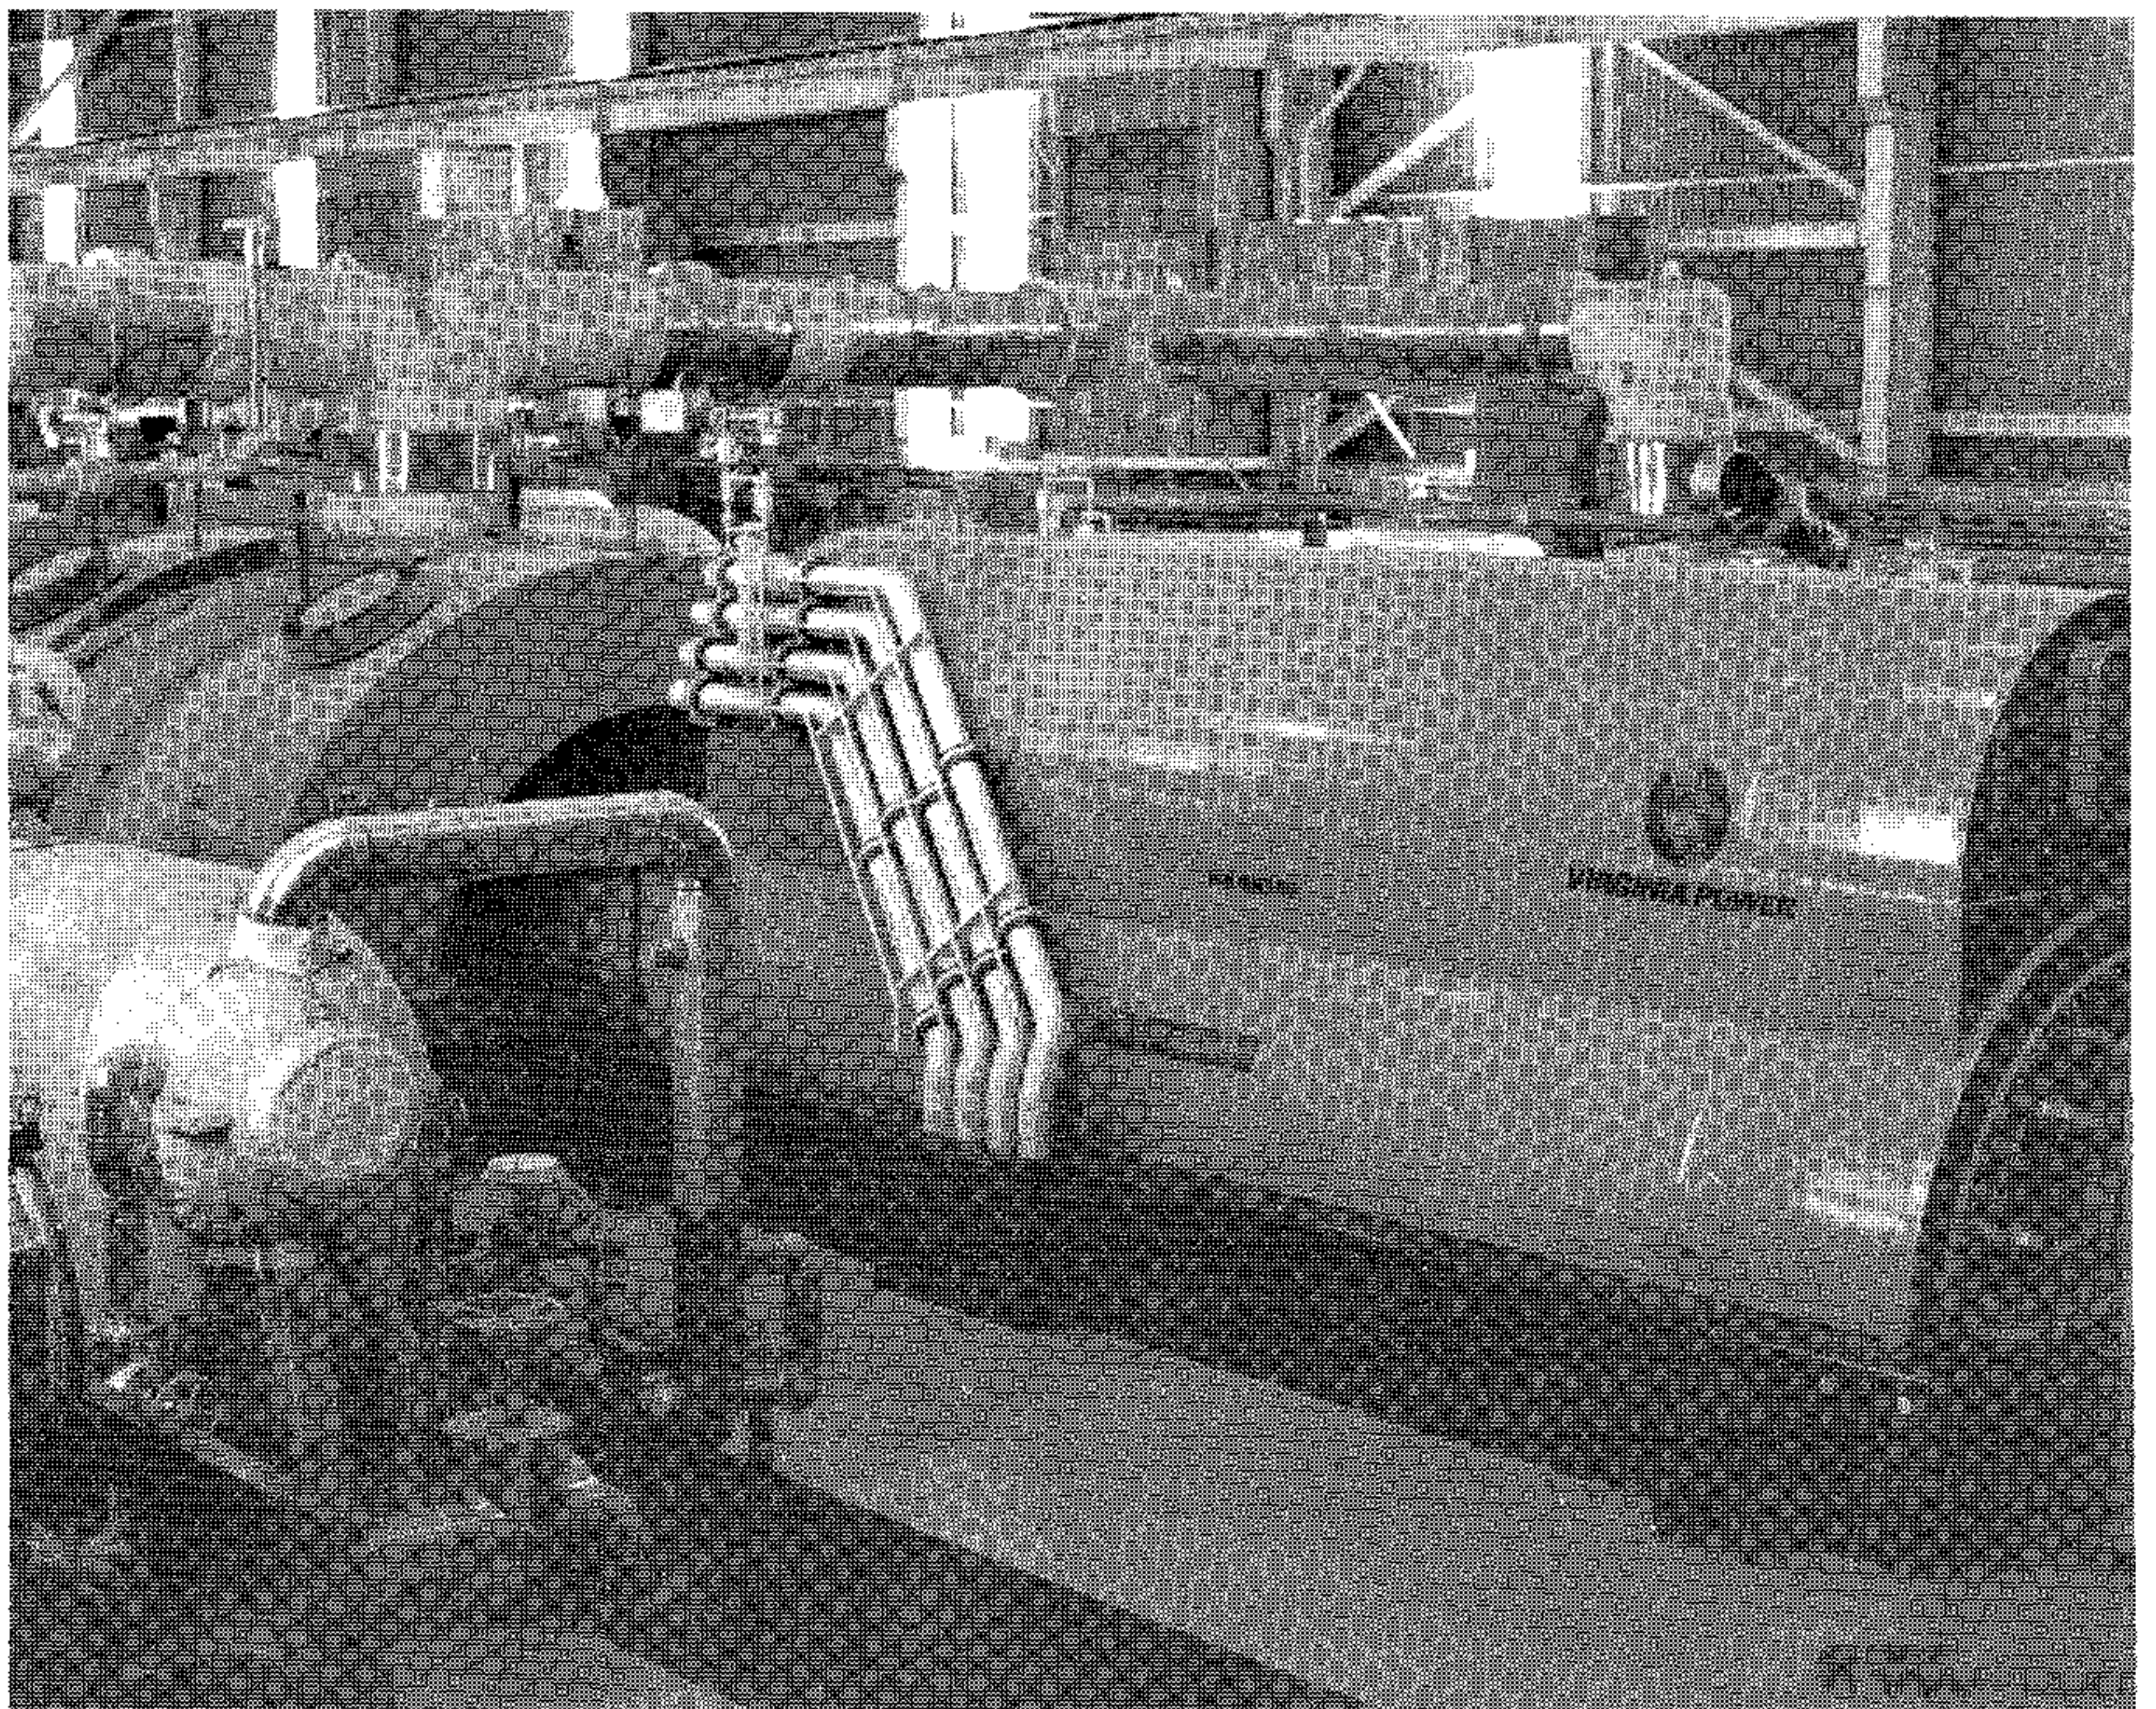
Fig. 19. The main turbine

diesel, the two turbochargers and major shafts and bearings are monitored during test-runs. The installation of a
