Machine-Condition Monitoring using Vibration Analysis

The use of Spectrum Comparison for Bearing Fault Detection
– A Case Study from Alma Paper Mill, Quebec, Canada

by D.N.Brown & T.Jensen
Brüel & Kjær

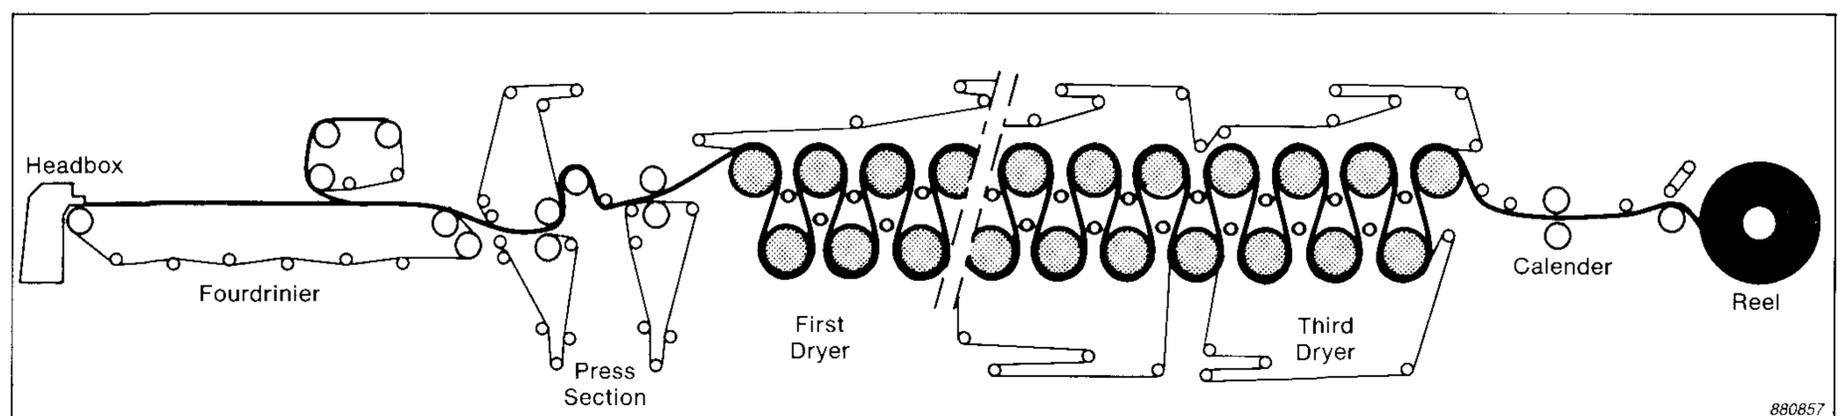
Fig. 1. Layout of a paper machine showing how the paper, which is formed as one long sheet, passes through the critical stages of production

Fig.1 above shows the complex roll arrangement of a paper machine. The paper machine itself is one of the most critical sections in the round-the-clock paper-production process. A breakdown in any section of the paper machine would result in an immediate production stop, with all the detrimental losses in production.

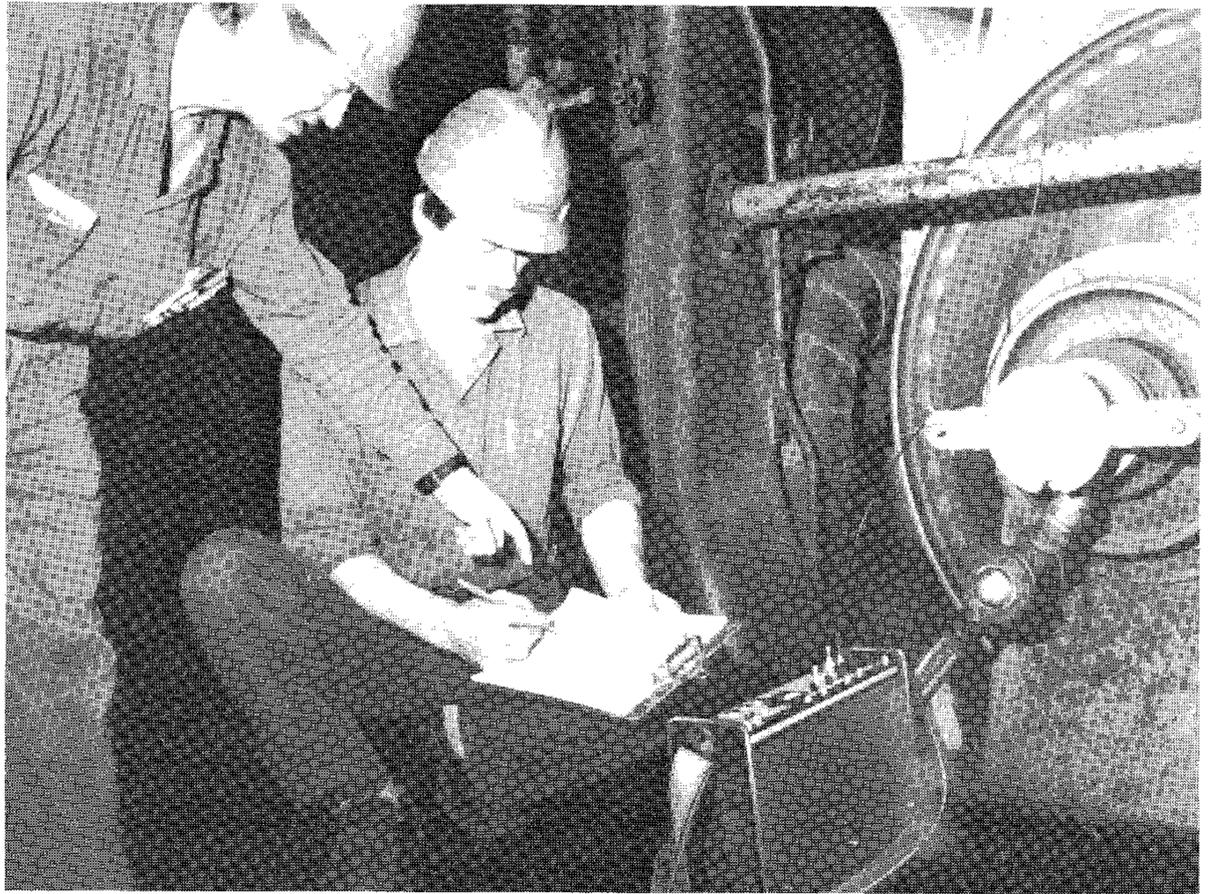
Fig. 2. Recording vibration signals from a dryer-can. Millwrights Regis Gaudreault and Sylvain Pedneault are responsible for collecting and analysing vibration data

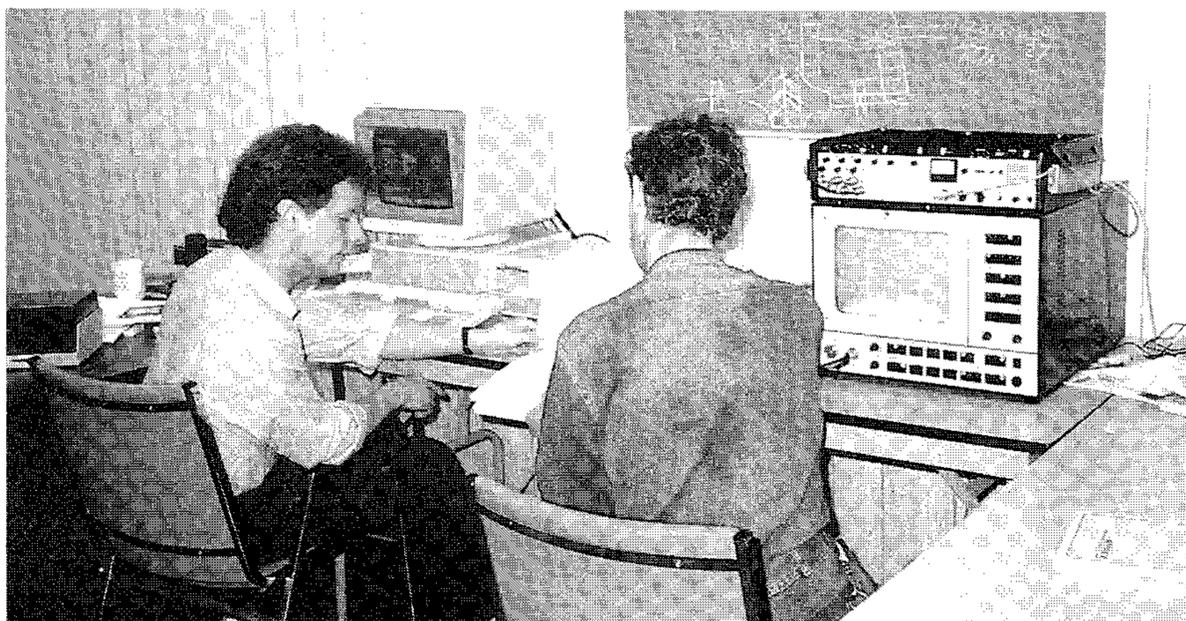
Fig. 3. Analyzing the recorded vibration signals on the office-based analysis system. Millwright Regis Gaudreault discusses the results with Project Engineer Richard Lefebvre

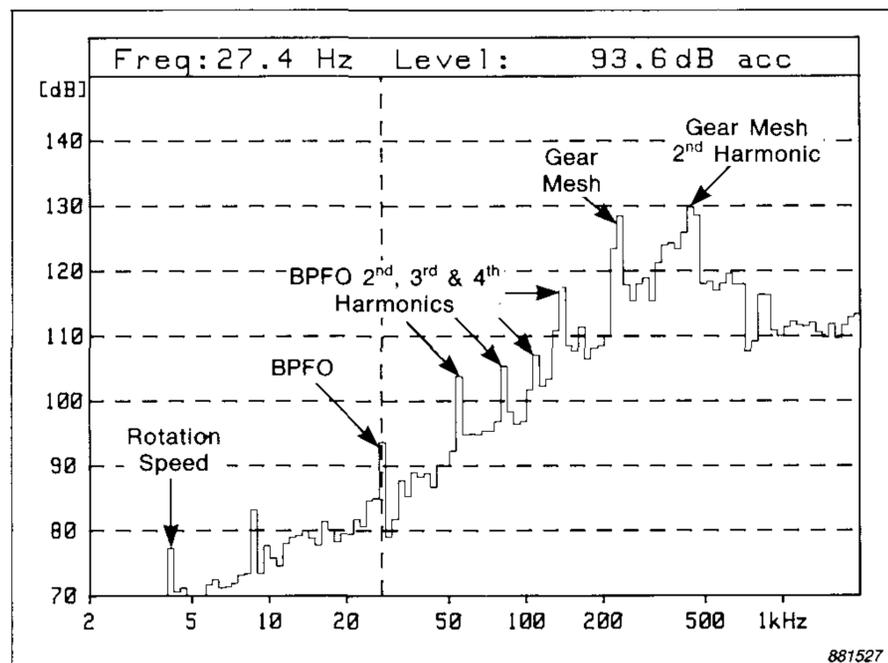
Fig.4 shows a Constant Percentage Bandwidth (CPB) spectrum measured from the bearing just before repair and illustrates how easy it can be to interpret the frequency spectrum. The frequency peaks corresponding to the roll rotation-frequency, the bearing fault and the roll's gear-drive are quite easily seen. The gearmesh frequency, located in the 200 to 500 Hz range, dominates the spectrum, being at a

much higher vibration level than the bearing's BPFO. This would result in broadband detection techniques not picking up this particular fault until at a very late stage.

Fig. 4. The rotation speed, bearing fault frequencies and gearmesh frequencies are all presented clearly in the CPB spectrum

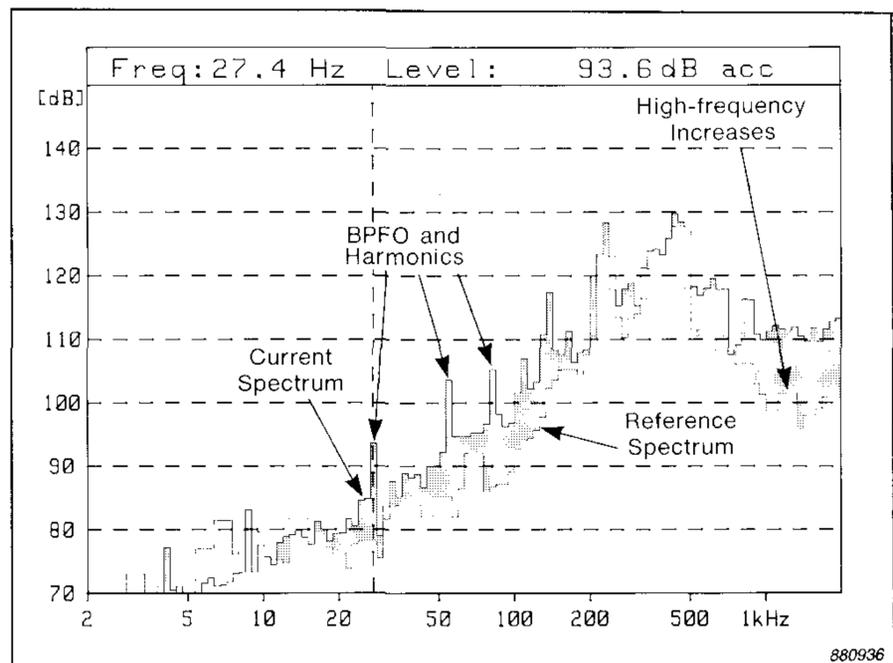
The fault was detected by using spectrum comparison. This showed the discrete-frequency increases at the bearing's BPFO at 27,4 Hz and its harmonics, see Fig.5. Increases are also seen at the high frequencies, which is another indication of a bearing fault. The high frequency increases occur when impacts, which are produced every time the fault comes into contact with the bearing's rolling-element, excite the bearing's natural frequencies. Usually, this high frequency increase is a more sensitive indicator of a bearing fault than detecting discrete frequencies at the bearing's impact rates.

Fig. 5. Comparing the spectrum from Fig.4 with its reference clearly shows increases (indicated by shading) at the bearing's BPFO, its harmonics and in the high frequency range

Having detected this fault, a decision was made to change the bearing at a scheduled shutdown. Had the fault not been detected and the bearing failed, the paper machine would have had to be shutdown without warning for 10 to 12 hrs. If the dryer-can itself had been damaged, then the enforced shutdown could easily have been 24 hrs.

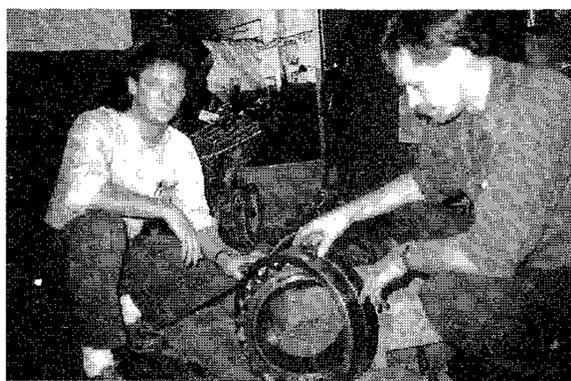
Fig. 6. The damaged bearing from Case 1. Damage to this type of bearing, which was taken from the rear-side of a dryer-can, can result in anything up to 12 hours of lost production due to its inaccessibility. In this particular case, had the bearing completely failed causing damage to the dryer-can itself, then production losses could have been as much as 24 hrs

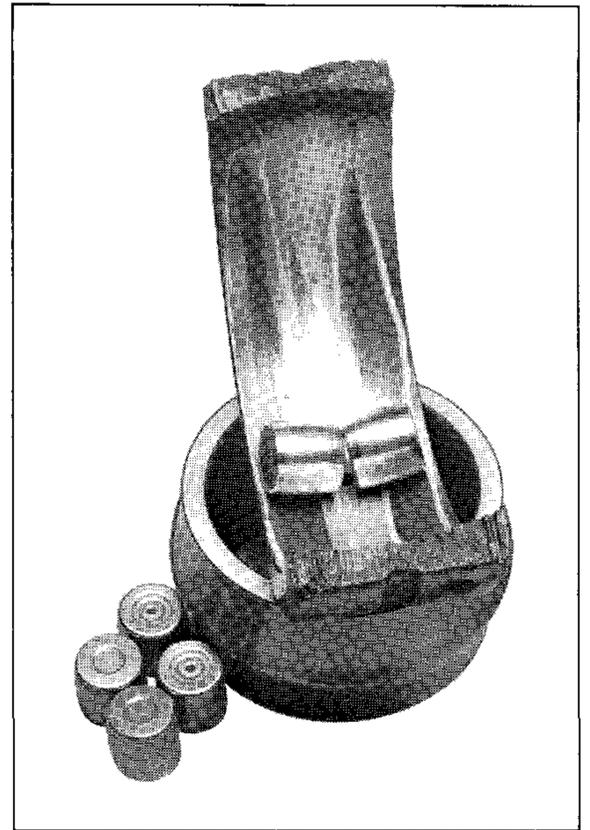
Fig. 8. The damaged bearing from Case 2

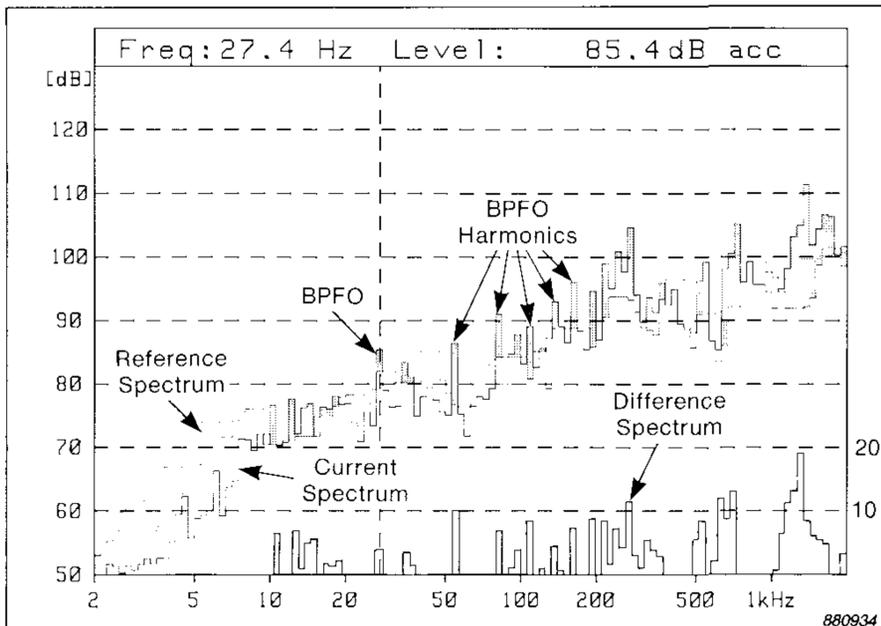
Fig. 9 shows how an outer-race fault was detected by spectrum comparison, indicating an increase in the bearing's BPFO at 27,5 Hz and its harmonics, and some increase at the higher frequencies. Also shown in this figure is the difference between the reference spectrum and the new spectrum which, for the purpose of clarity, only shows the increases.

Fig. 9. Spectrum comparison between the current and reference spectra indicating the presence of a bearing fault. For clarity the difference between these two spectra is shown

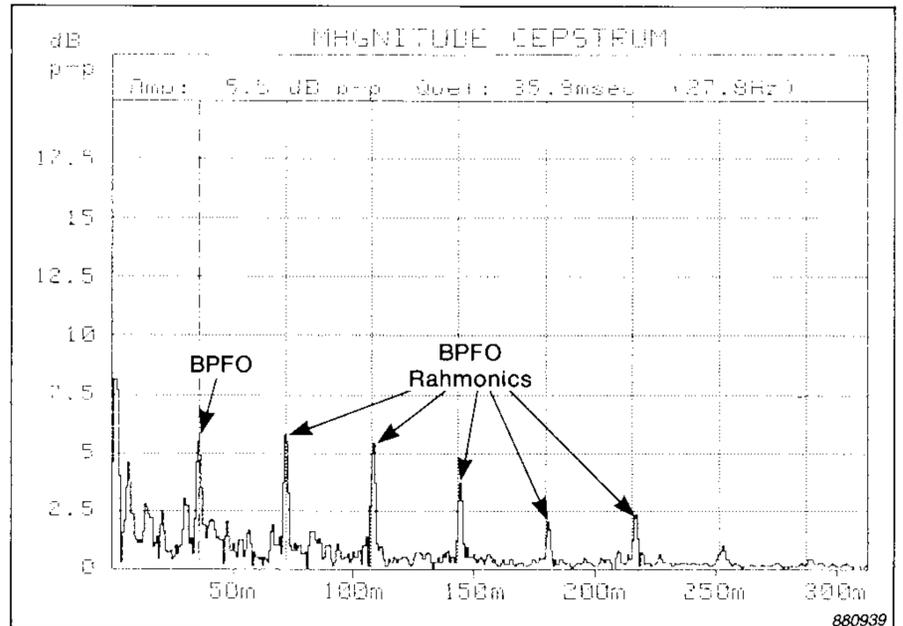
In some cases it can be necessary to confirm the presence of a fault when, for example, background noise masks the bearing impact-frequencies. Fig. 10 shows how the Cepstrum can be used, and clearly shows the presence of the bearing's BPFO.

Fig. 10. Cepstrum clearly showing the bearing's BPFO and thus confirming the presence of a bearing fault

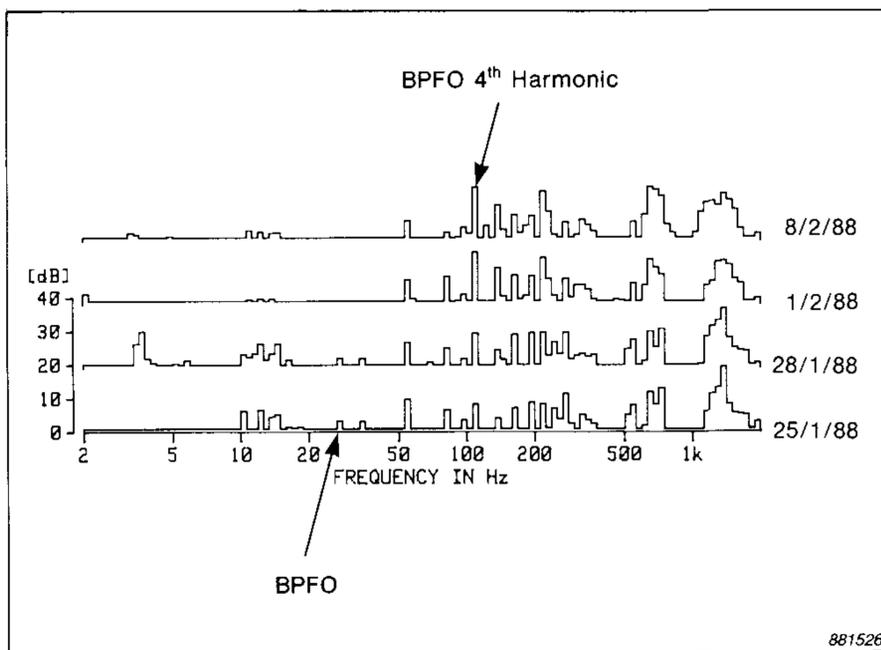
Fig. 11 shows a 3-D plot of the increases (as shown in Fig. 9), and it can be seen that the fault could best be followed by looking at increases in the 4th. harmonic of the BPFO. The fundamental 2nd., and 3rd. harmonics are too buried in noise to be useful.

Fig. 11. 3-D Plot of increases in the vibration spectrum above the reference spectrum, showing over which frequency range to best perform the trend analysis

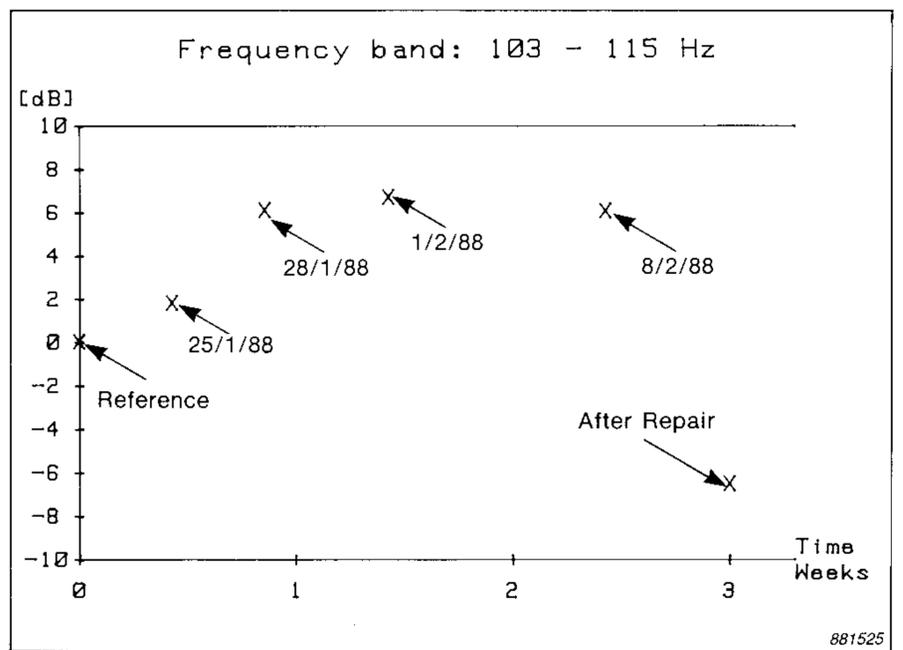
Fig. 12 shows a Trend Plot made at the BPFO's 4th. harmonic. It can be seen that, after the initial increase, the vibration remained at a steady level. It was thus possible to maintain production and change the bearing at a scheduled production stop.

Fig. 12. Trend analysis at the BPFO's 4th harmonic. The bearing's condition stabilised after the initial increase and thus, by keeping track on the trend, production could be continued until a scheduled stop

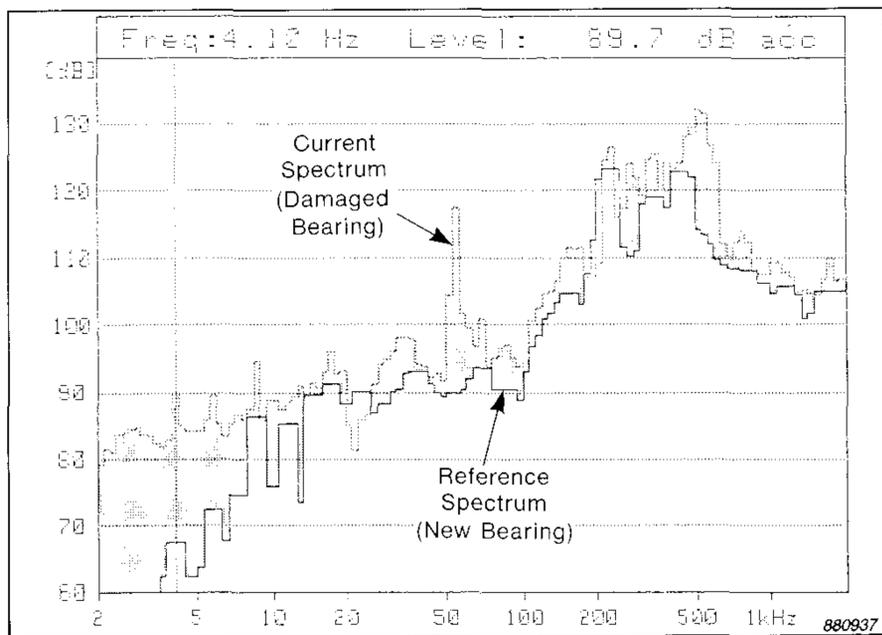
This example is taken from the start of the monitoring programme, and shows measurements made just before a bearing seized. The example shows just how far the vibration levels can be allowed to develop before action is necessary. Fig.13 shows a spectrum comparison, comparing spectra made just before a bearing seized and after being replaced with a new bearing. At the lower frequencies, it can be seen that increases of more than 20 dB were recorded before the bearing failed, and one peak in the mid-frequencies reached approximately 27 dB. Bearing in mind that conditions would be different for each ma-

chine type, it seems that increases of about 20 dB indicate an advanced state of wear, and should definitely signal immediate attention.

This breakdown happened during the introduction of the monitoring programme, and the bearing seized shortly after measurements were made, giving the operator no time to act on the measurements. From the spectra it can clearly be seen that the bearing was in an advanced state of wear.

Fig. 13. Comparing spectra recorded just before a bearing seized and after being replaced with a new bearing (the shaded area indicates the decreases)

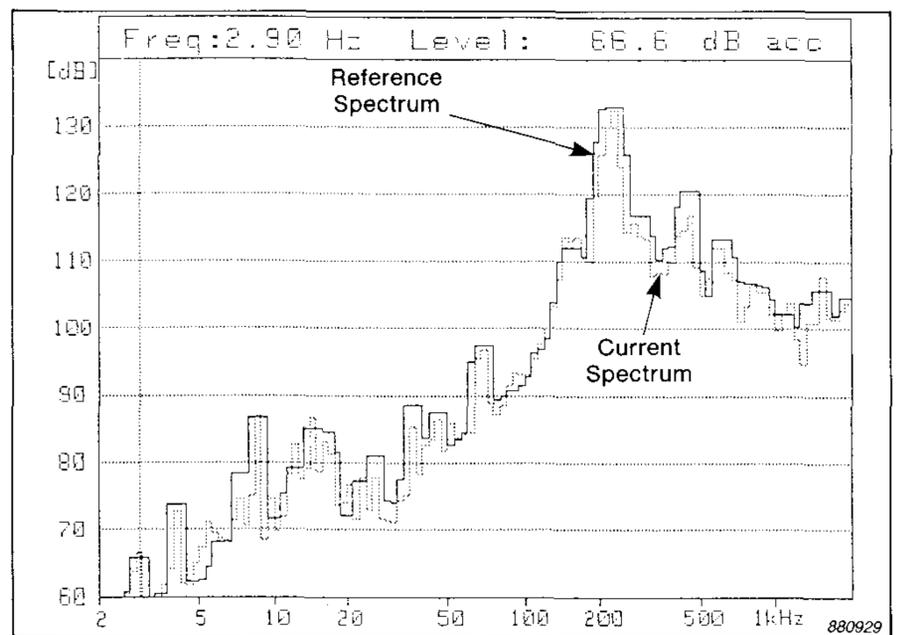
A spectrum comparison was made, but showed no increases and thus no sign of a fault, see Fig.14. However, to be on the safe side and to test the usefulness of the monitoring equipment, the bearing was changed during a scheduled shutdown. On inspection of the bearing it was found to be in perfect condition, as had been indicated by the measurements.

Fig. 14. Spectrum comparison showing no increases, indicating that the bearing is in good condition

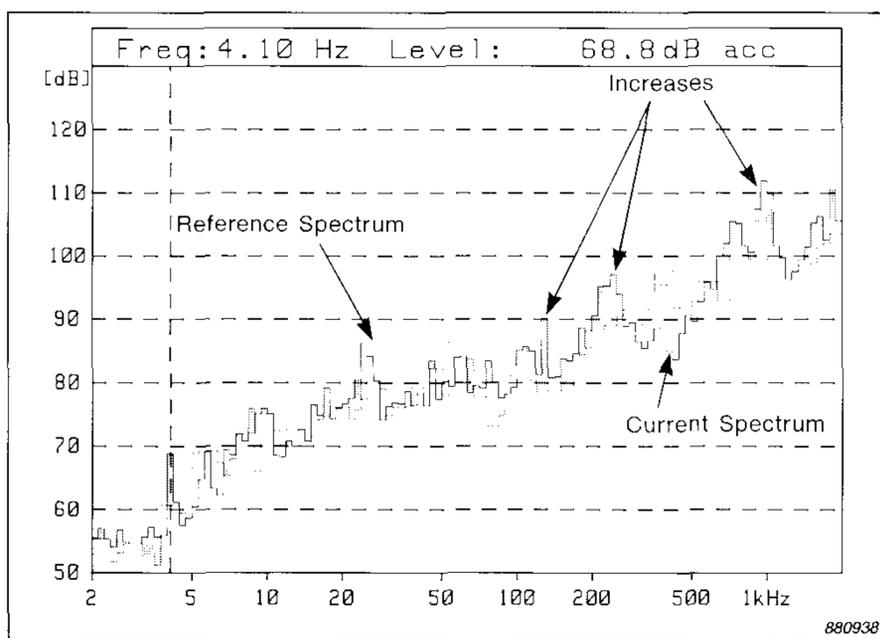
A bearing fault was first suspected after high-frequency level increases were detected by spectrum comparison, see Fig.15. However, the increases were not particularly large and

so it appeared that the fault was only in its initial stages.

Fig. 15. Spectrum comparison showing slight increases in the high frequencies (indicated by the shaded area) indicating the possibility of a fault

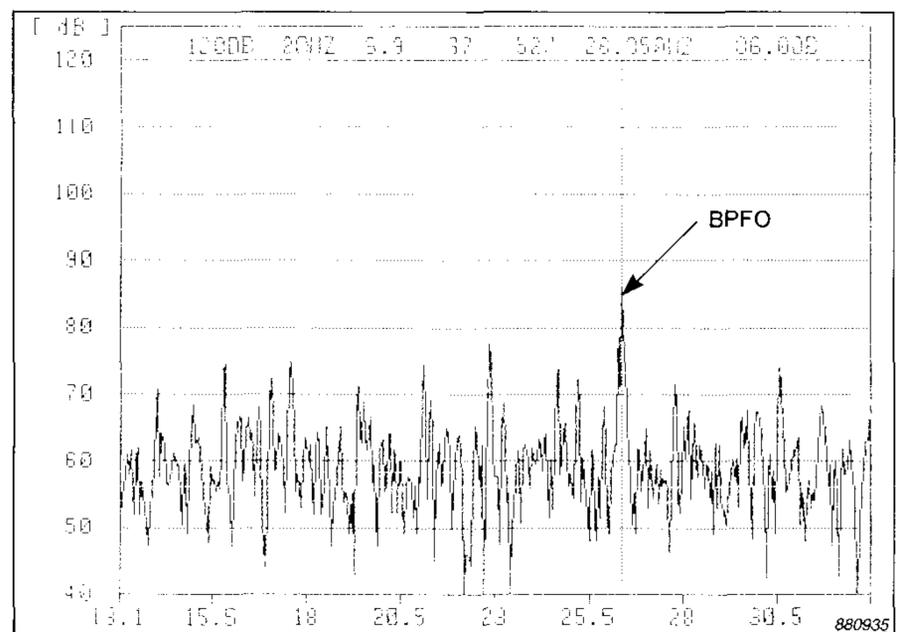
To be completely sure of the presence of a fault, further analysis was then carried out to try and pin-point the exact cause of the increasing vibration level. Fig.16 shows a narrow-band zoomed-spectrum showing the bearing's BPFO at 26,4 Hz. The high resolution that the zoom spectrum provides allowed this frequency to be pin-pointed with extreme accuracy. However, the fault was obviously at a very early stage as the level of this peak was not very high, and hence not all that easy to detect.

Fig. 16. Narrowband zoom spectrum showing the outer-race fault frequency (BPFO) at 26,4 Hz, indicating a fault in its early stages

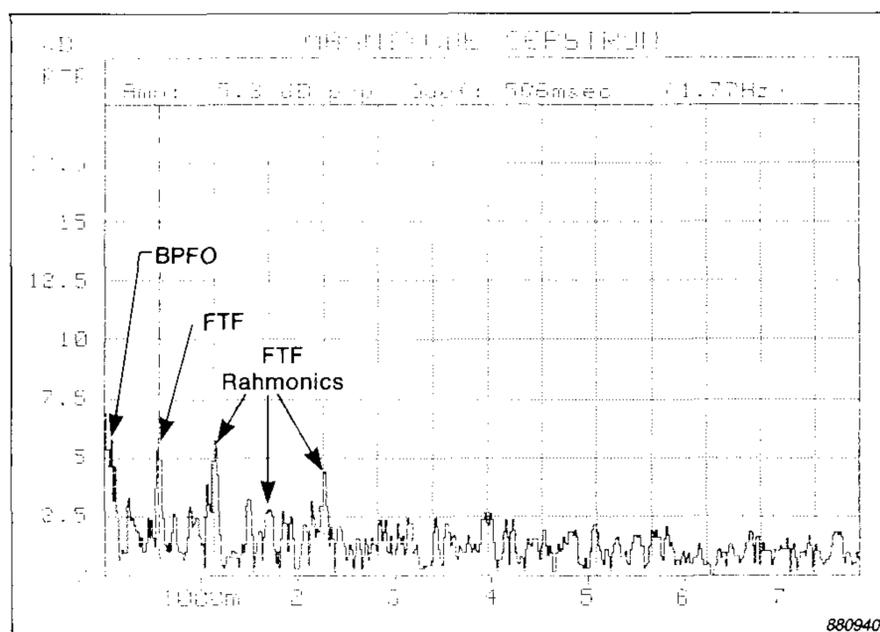
Cepstrum analysis, however, confirmed the presence of a fault. It clearly indicated faults in both the bearing's outer race and its cage, by identifying the bearing's BPFO and its cage rotational-frequency (FTF). The cepstrum shown in Fig.17 was made by performing a cepstrum analysis of the zoom spectrum shown in Fig.16, and clearly shows the presence of the FTF at 1,7 Hz. The BPFO is also indicated but not easily seen as it is close to the bottom of the scale. It would be necessary to perform another cepstrum over a slightly wider frequency range to see the BPFO more clearly.

Fig. 17. The cepstrum confirms the presence of a fault. It shows the FTF and BPFO (which could also be shown as clearly as the FTF by performing the analysis over a different frequency range)

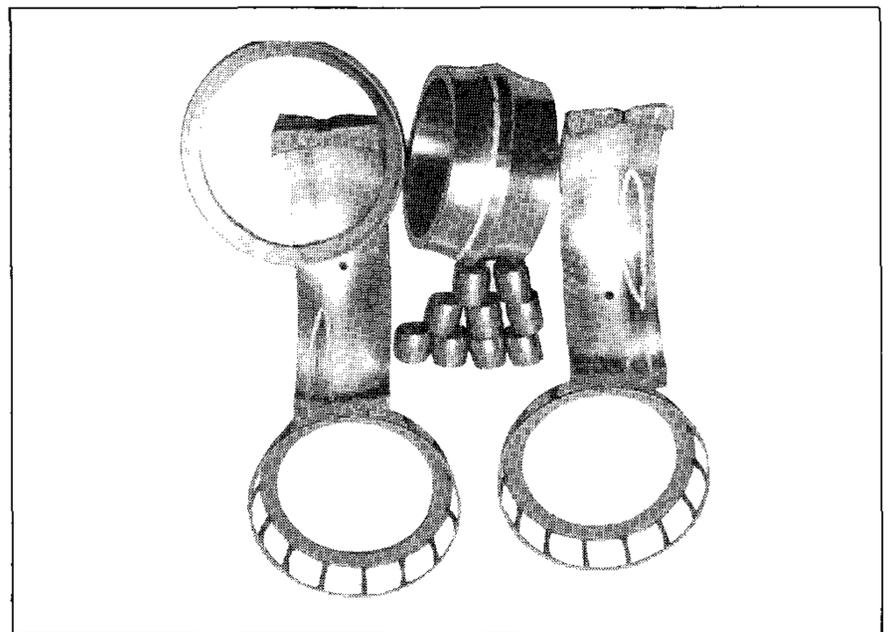
Fig. 18. The damaged bearing from Case 5

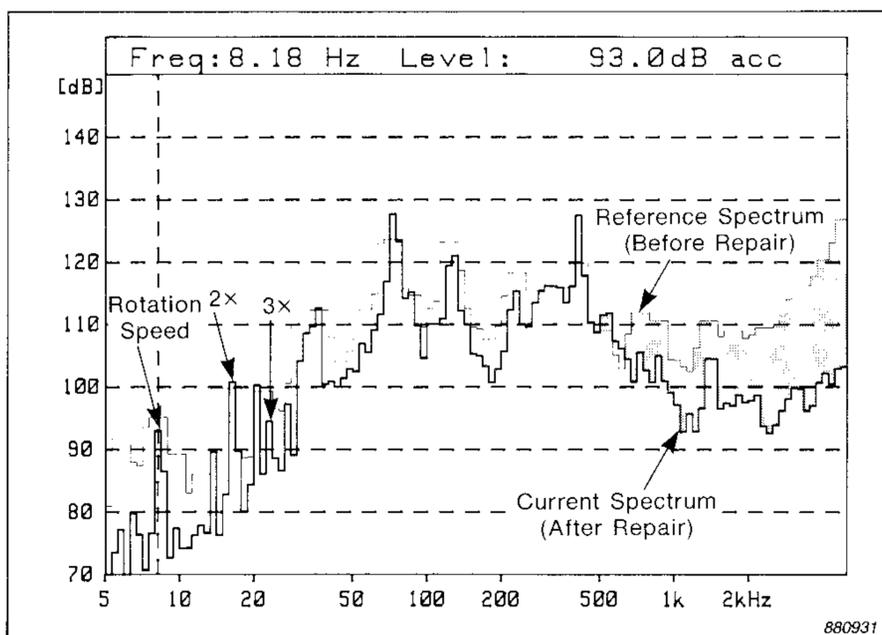
A spectrum comparison indicated the presence of a fault, but it was not sure at which end of the roll the fault was, as the same type of bearing was fitted front and back. Fig.19 shows a spectrum comparison made just before and after changing the roll's front-side (tending) bearing. A reduction in the vibration levels at the higher frequencies was seen and, on in-

spection, a small amount of damage was found on the bearing's outer race. However, large vibration components at multiples of the rotational frequency were still quite evident, indicting a looseness problem.

Fig. 19. Spectrum comparison made just before and after repairing the front bearing, the shaded area indicates the reduction in vibration level at the high frequencies. A problem still remained, indicating that it may be at the other end of the roll

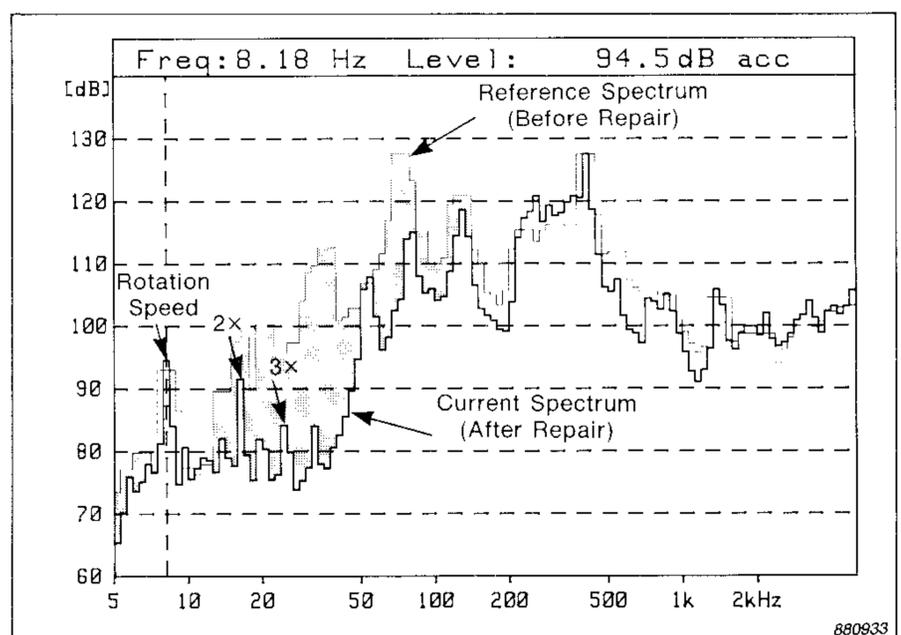
The rear bearing was subsequently removed and the inner race found to be completely broken. Fig.20 shows a spectrum comparison made just before and after repairing this rear bearing, and it can be seen that the harmonics and mid-range frequencies had dropped in level significantly. It was estimated that the bearing would only have lasted another 2 to 7 days before

Fig. 20. Spectrum comparison made just before and after repairing the rear bearing which was found to have a broken inner-race. The shaded area indicates the reduction in vibration level

total failure. The monitoring programme, however, had allowed both bearings to be changed at the scheduled shutdown.

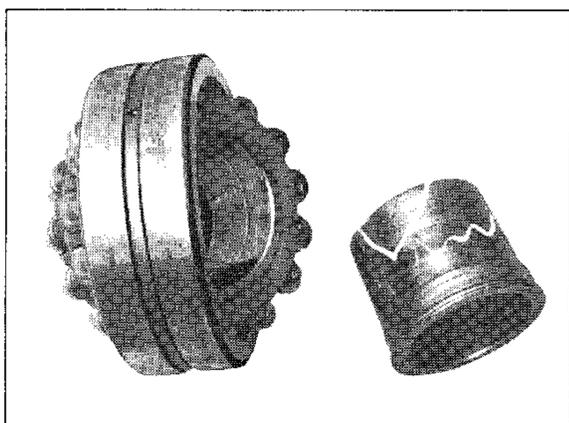
Fig. 21. The damaged rear bearing from Case 6. Detecting this fault had not been easy as measurements were only possible on the front-side bearing. To overcome this problem it would be necessary to permanently mount accelerometers on the rear-side bearing housing and route the cables out to an easy point of access

Measurements were only made on the front bearing due to the inaccessibility of the back bearing, which is a quite common problem on paper machines. However, this case shows the necessity of measuring on both ends of the roll. To overcome the problem of access to the back bearing, therefore, transducers could be permanently mounted on the bearing housings and cables routed to an easy point of access.

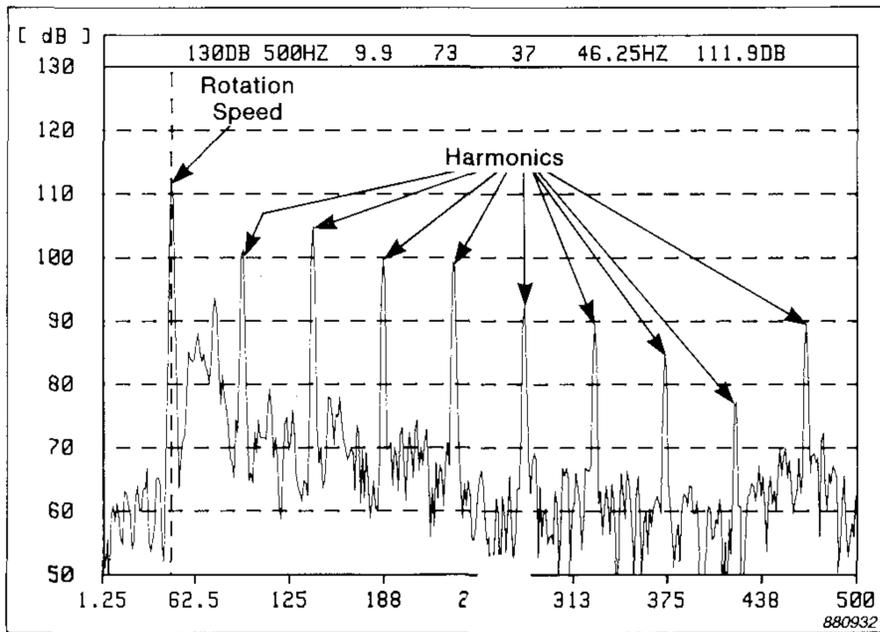
Figs. 23 shows a problem with looseness in a journal bearing of the feed

pump, shown in Fig. 24. The narrowband spectrum clearly shows the fundamental frequency and a large number of harmonics – the classic signs of looseness.

Fig. 23. Narrowband spectrum from the water feed pump, exhibiting the classic signs of a looseness problem

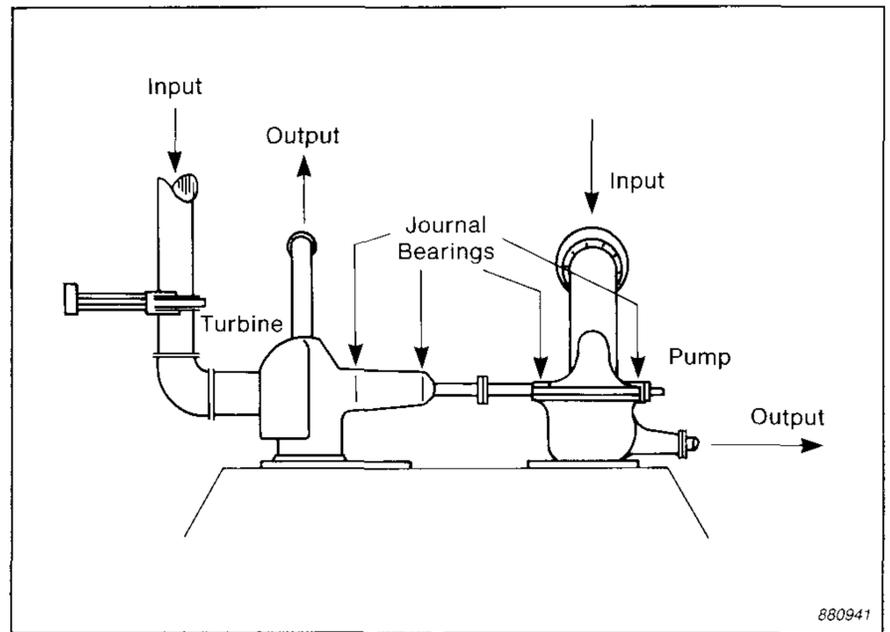
Fig. 24. The steam-turbine driven water feed-pump from Case 7

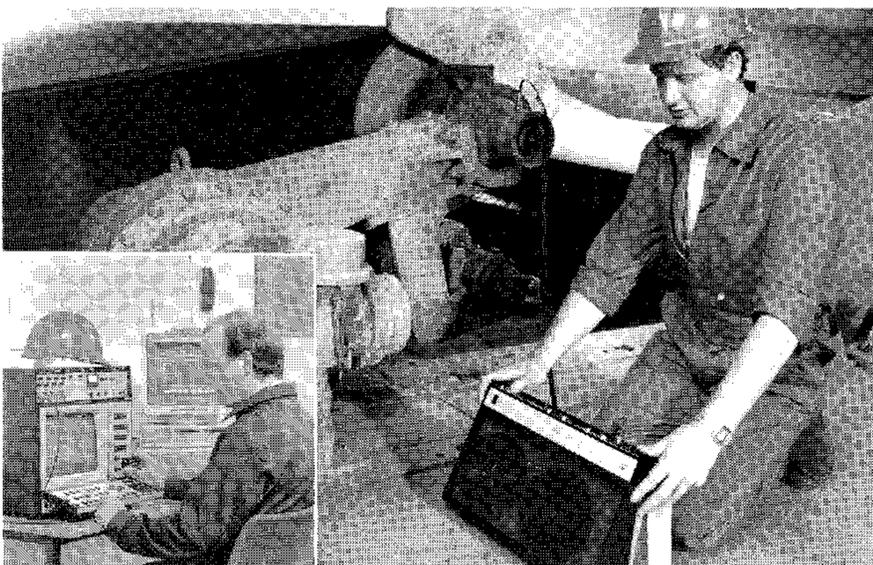
The portable Type 2515 Vibration Analyzer and Personal Computer with software Type 7616 provide a powerful combination for systematic machine-monitoring. A high level of data-base management allows easy access to relevant information, and measurement routes can be made up to help with the large number of measurements necessary on paper machines. The Analyzer is used firstly as an instrument for fault detection using spectrum comparison and then, having found a fault, it is used as an instrument for troubleshooting the fault using features such as zoom, harmonic cursors, cepstrum etc. All data can be down-loaded to the Computer where post-processing is carried out, including spectrum comparison, 3-D plotting and trend analysis.
