Application Notes

Diagnosis of Vibration Problems in Holland

Case Studies from the Groenpol Vibration Consultancy

Matt o'Sullivan
Mechanical Engineer
Brüel and Kjær, Denmark

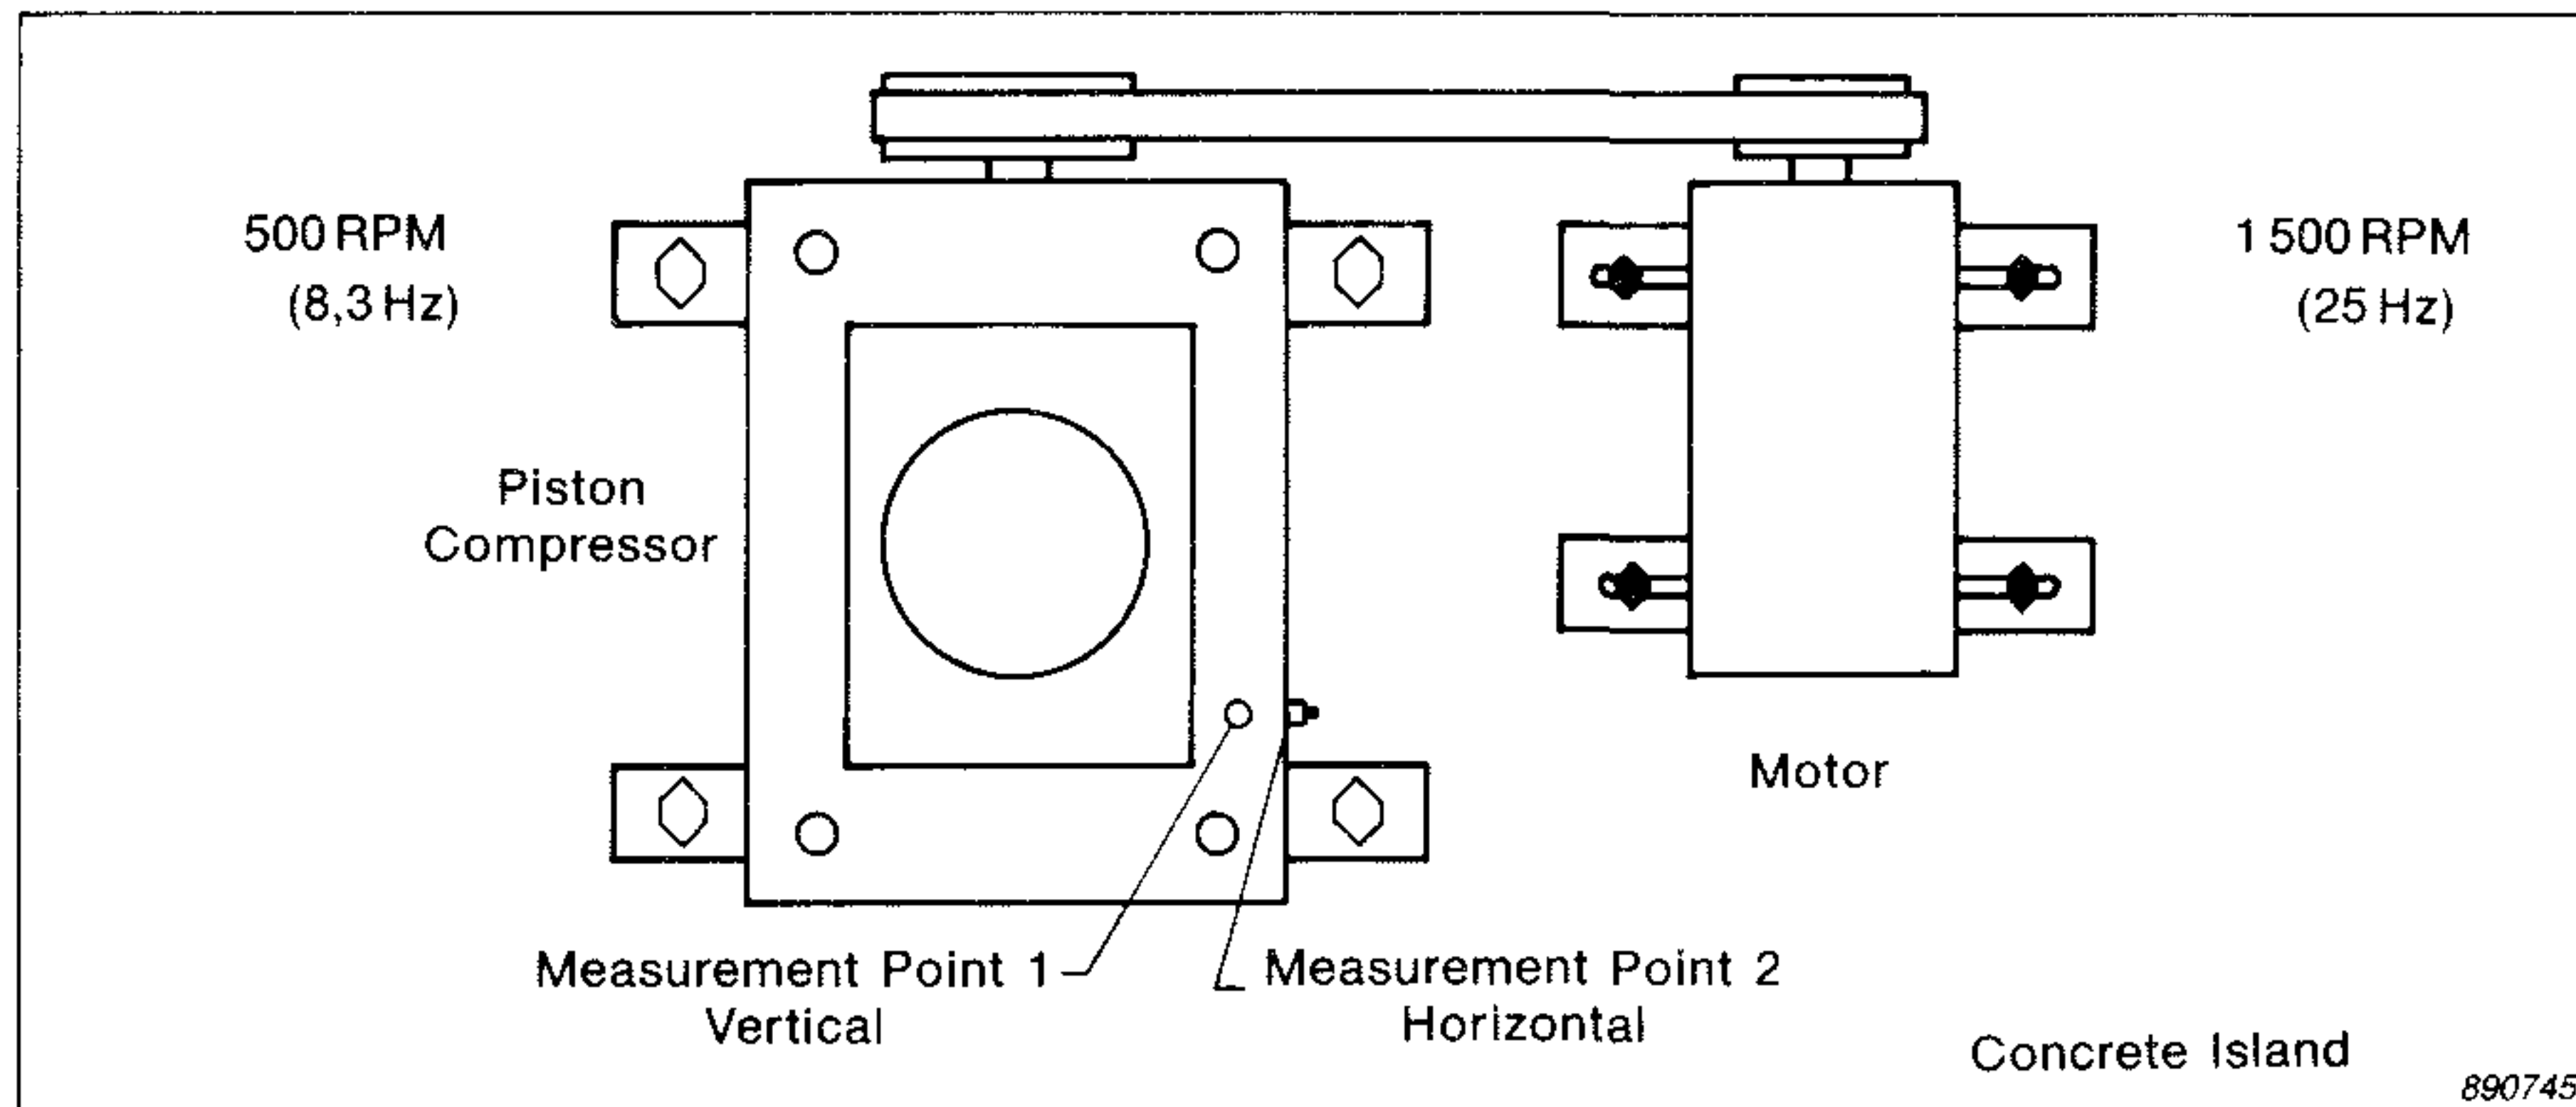
They measured the overall vibration levels, on all three compressors, at the points shown in Fig.1. For one machine the vertical ($12,8\text{mms}^{-1}$) was much higher than the horizontal ($4,4\text{mms}^{-1}$). This result suggested a foundation problem.

Fig. 1. A top view of the motor and compressor on the concrete island. The locations of the vertical and horizontal measurement points are indicated

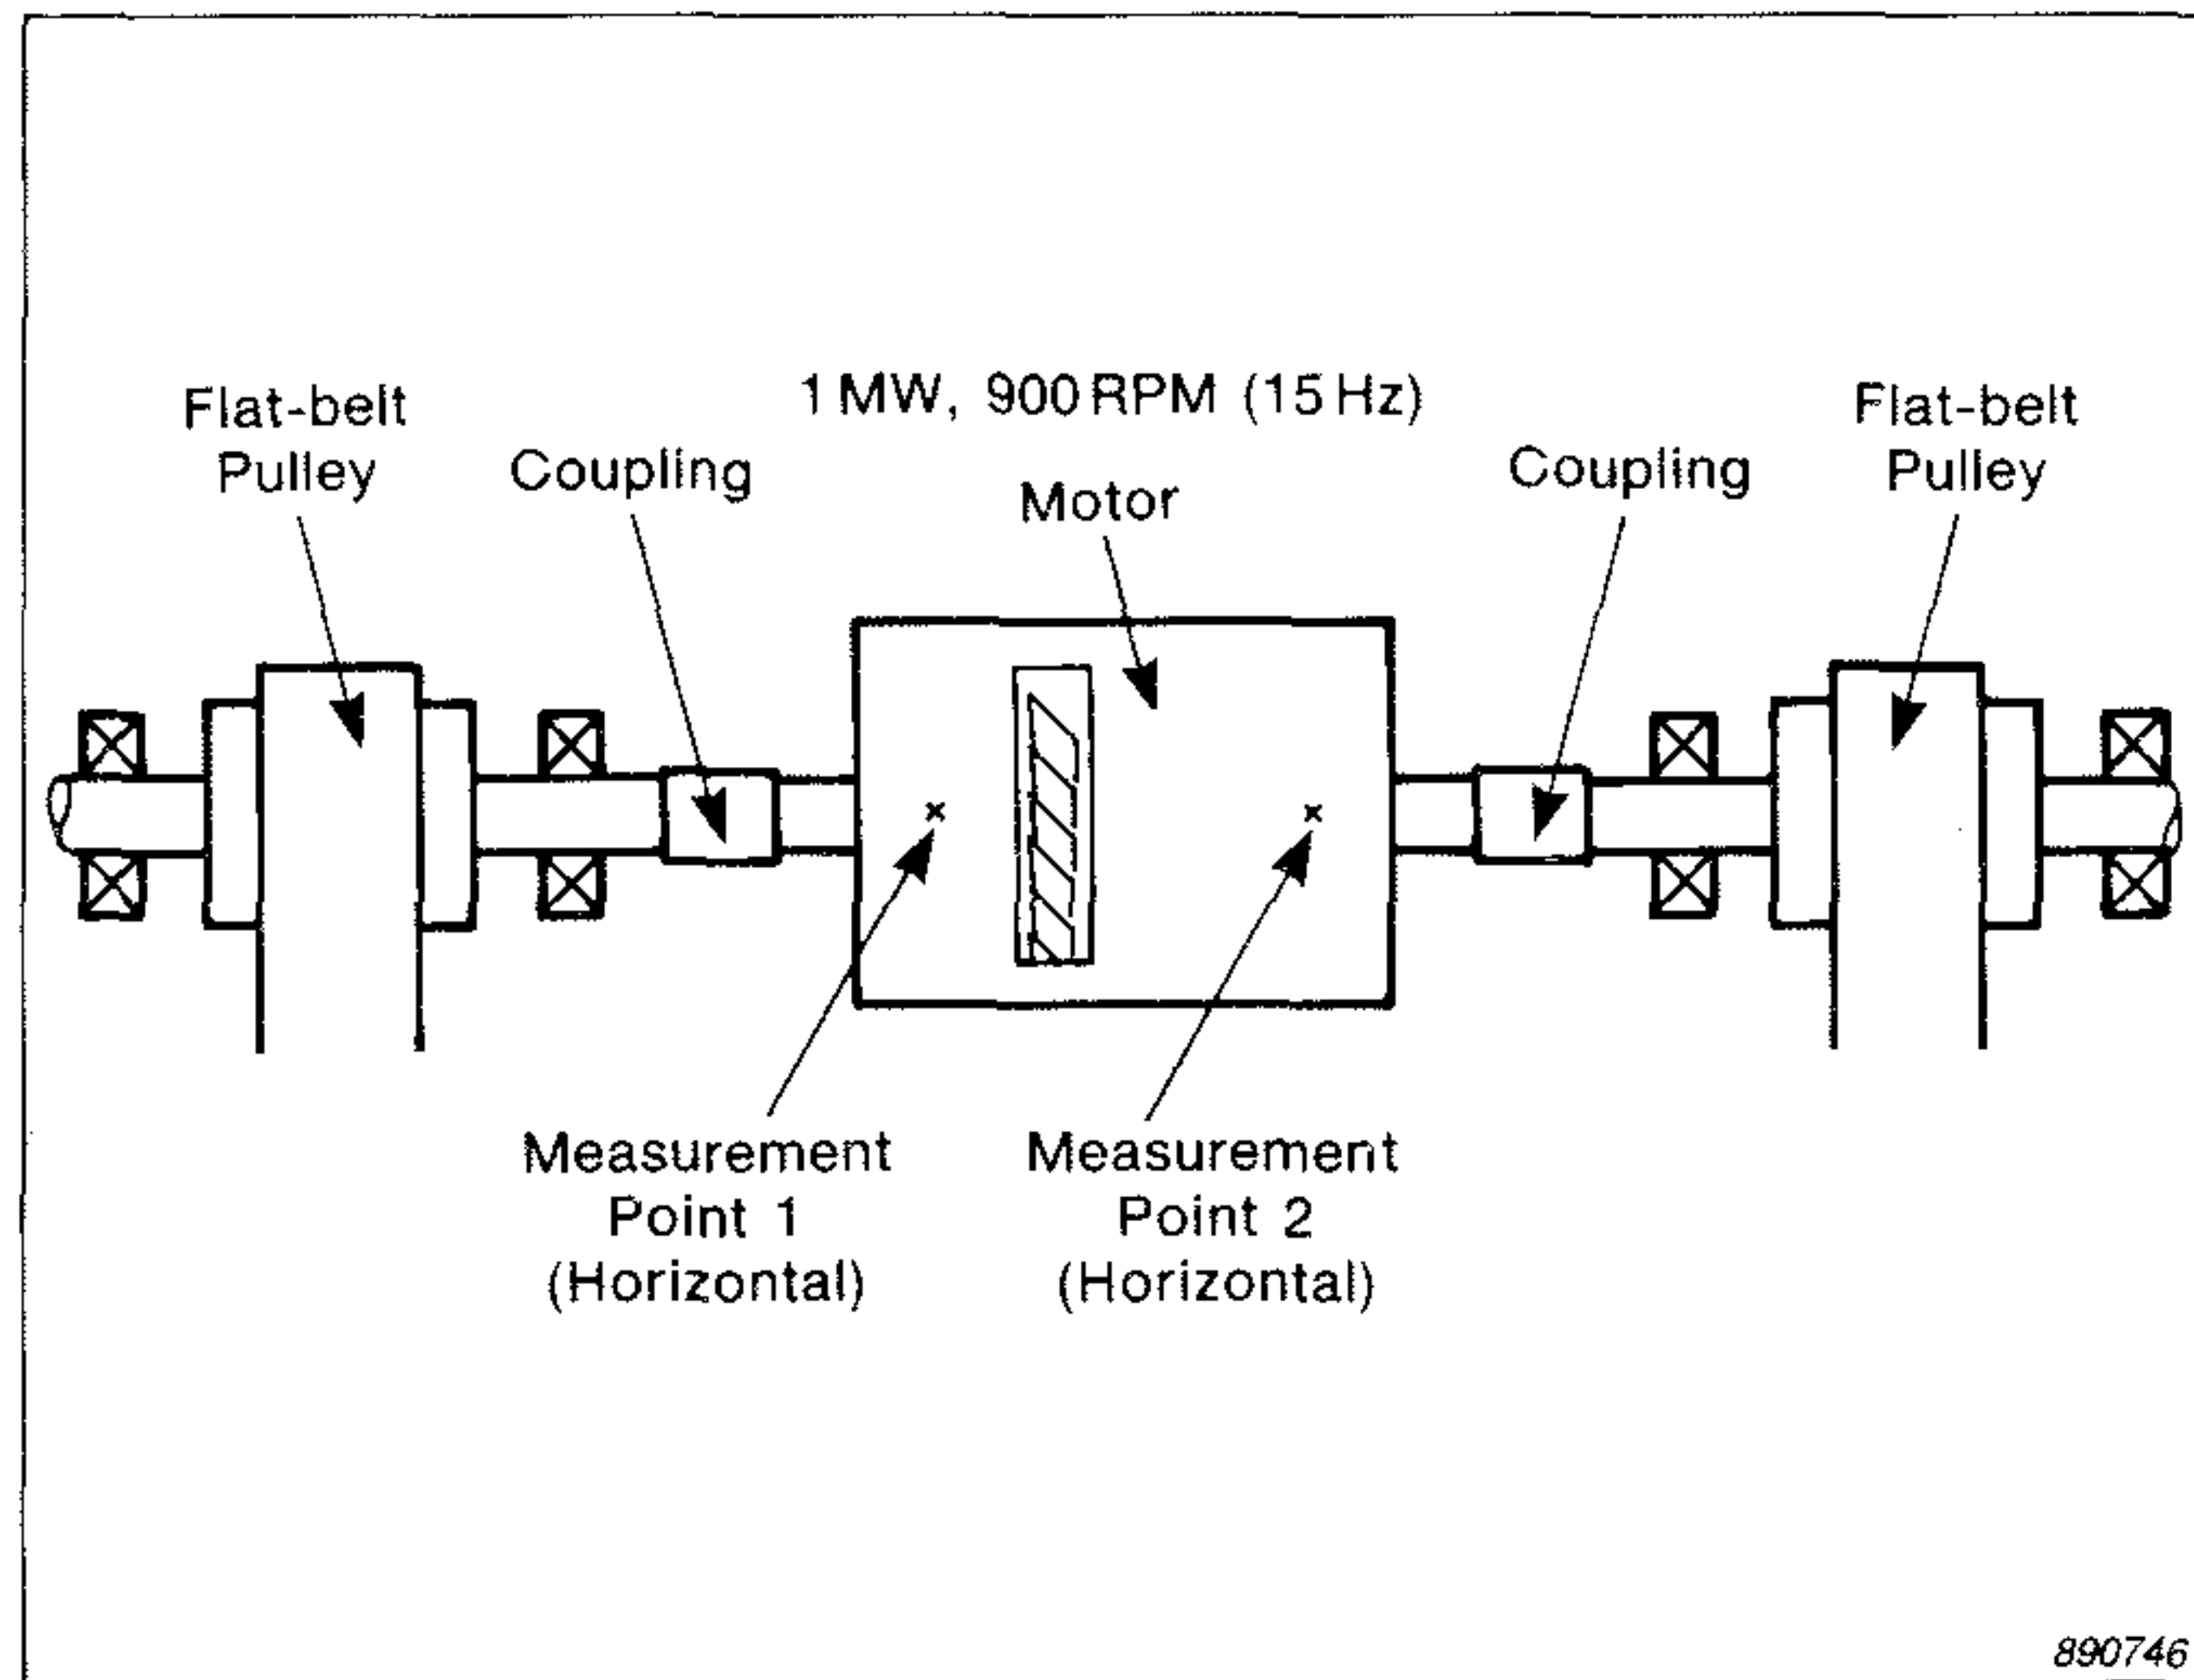
The motor concerned is a 1MW, 900 RPM (15Hz) unit, located high up in an awkward position. It drives flat-belt pulleys at both ends, see Fig.7. When the maintenance staff noticed that the vibration level was relatively high compared to vibration severity criteria VDI 2056, they called Groenpol and asked them to do the repairs in-situ.

To diagnose the fault, Groenpol measured with the vibration analyzer at the two horizontal measurement points shown in Fig.7. At measurement point 1 they noticed a high vi-

Fig. 7. The 1 MW motor drives two flat-belt pulleys as shown. Since it is very large and located high up in an awkward place, the maintenance staff wanted the repairs done in-situ

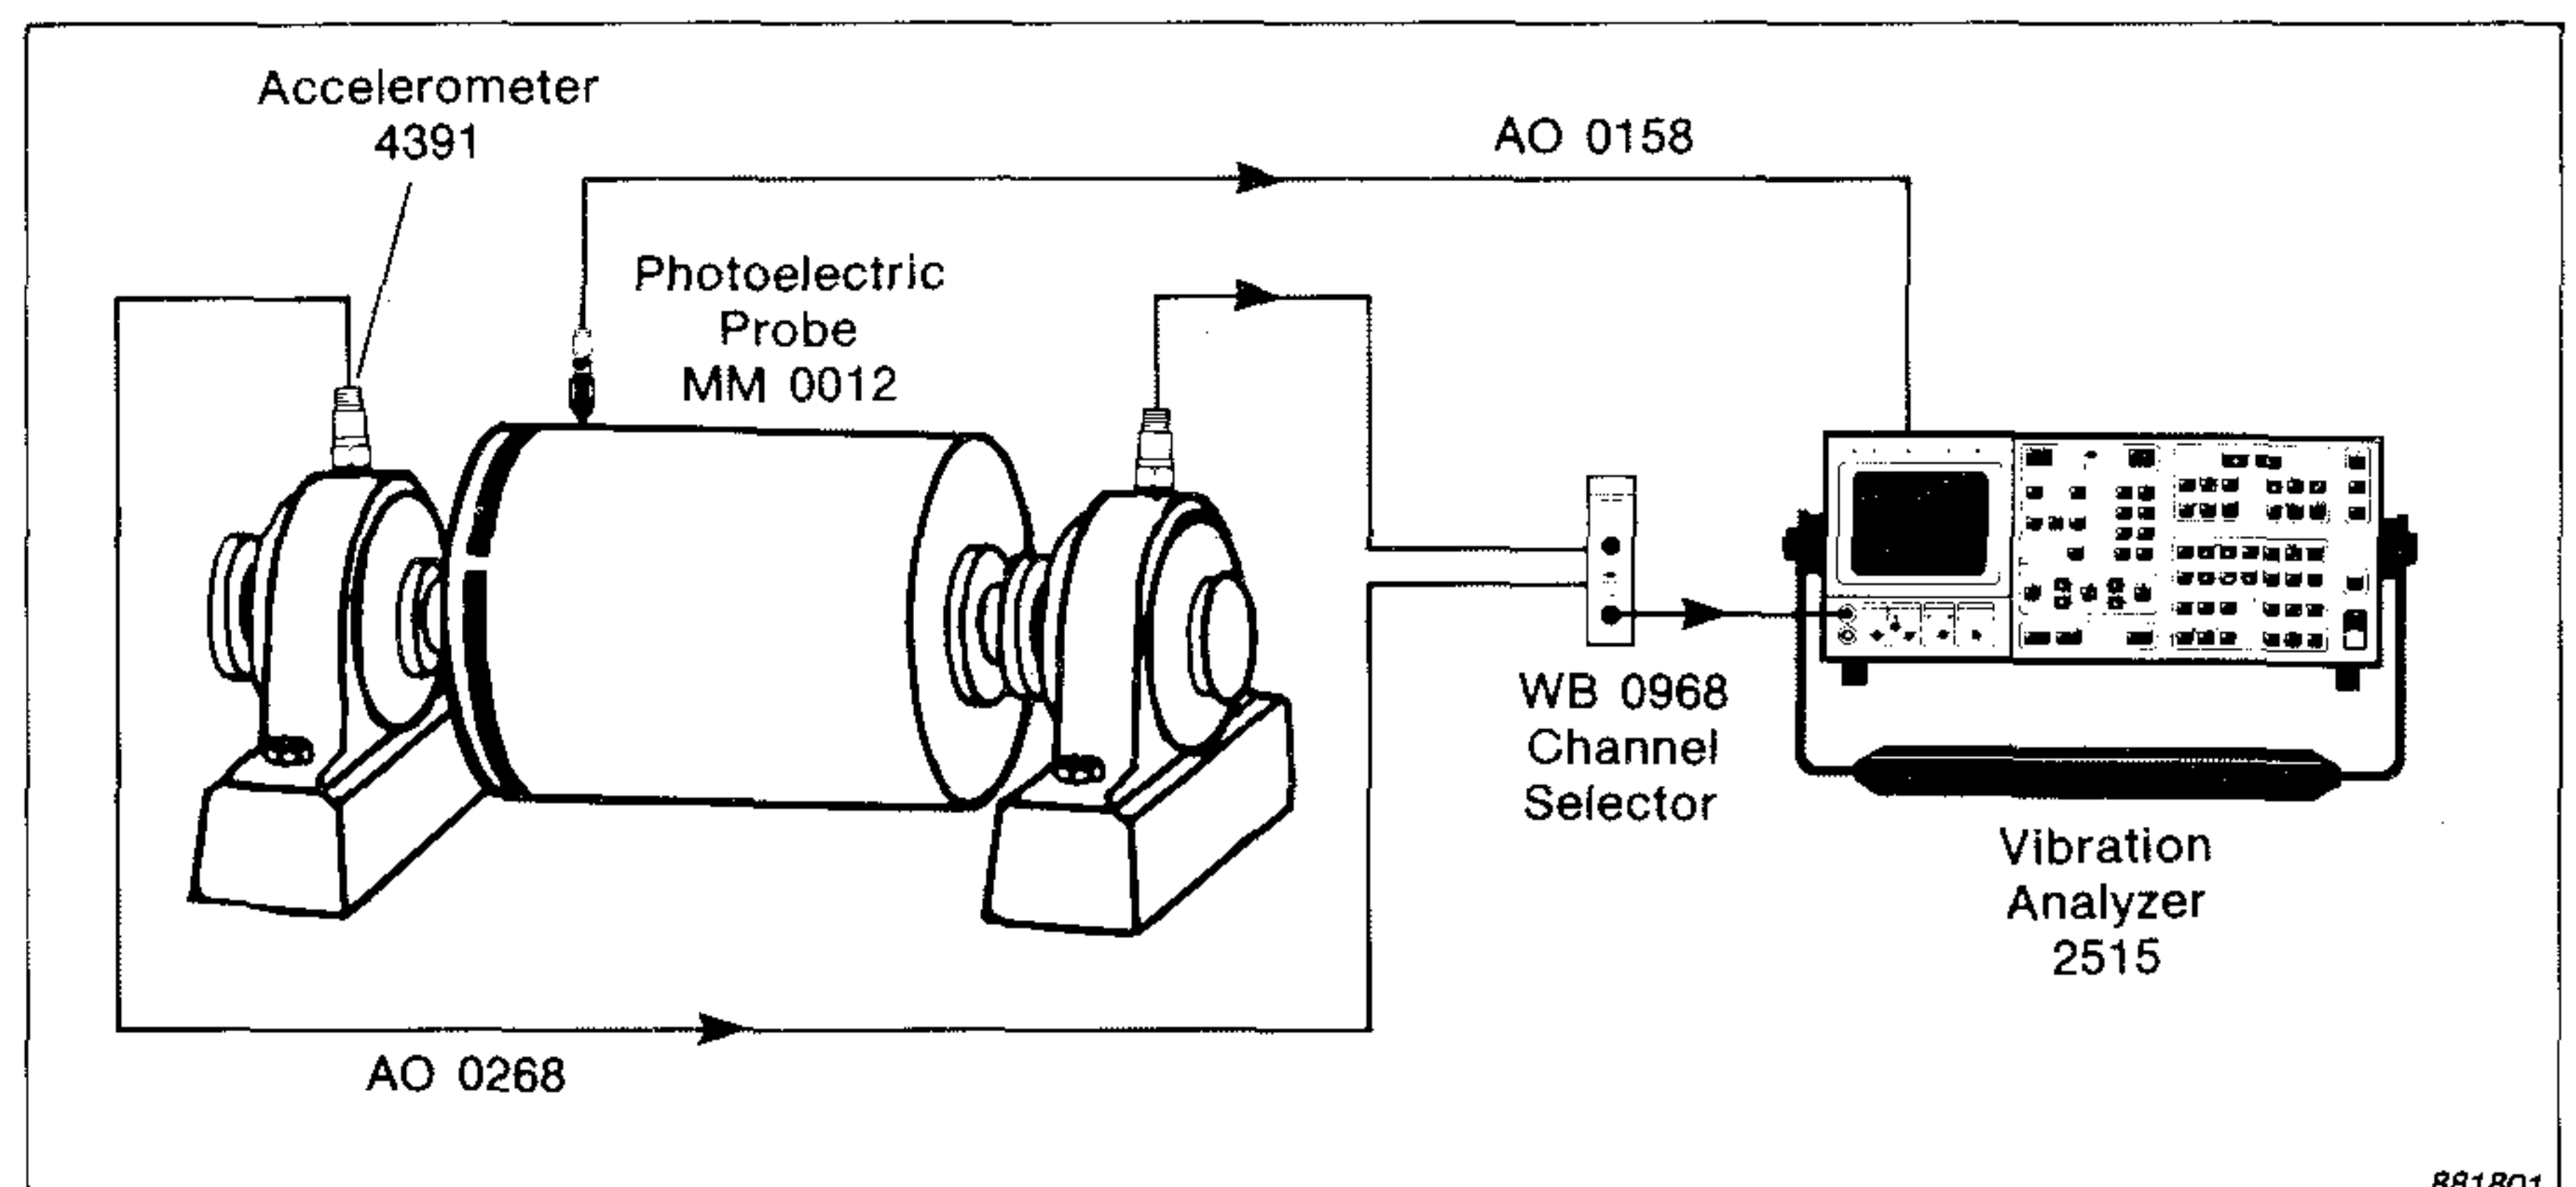
When the vibration level became excessive, the company asked Groenpol to balance the fan. A typical instrumentation set-up for 2-plane, in-situ dynamic balancing is shown in Fig. 10.

Fig. 10. A typical instrumentation set-up for in-situ balancing with a portable vibration analyzer

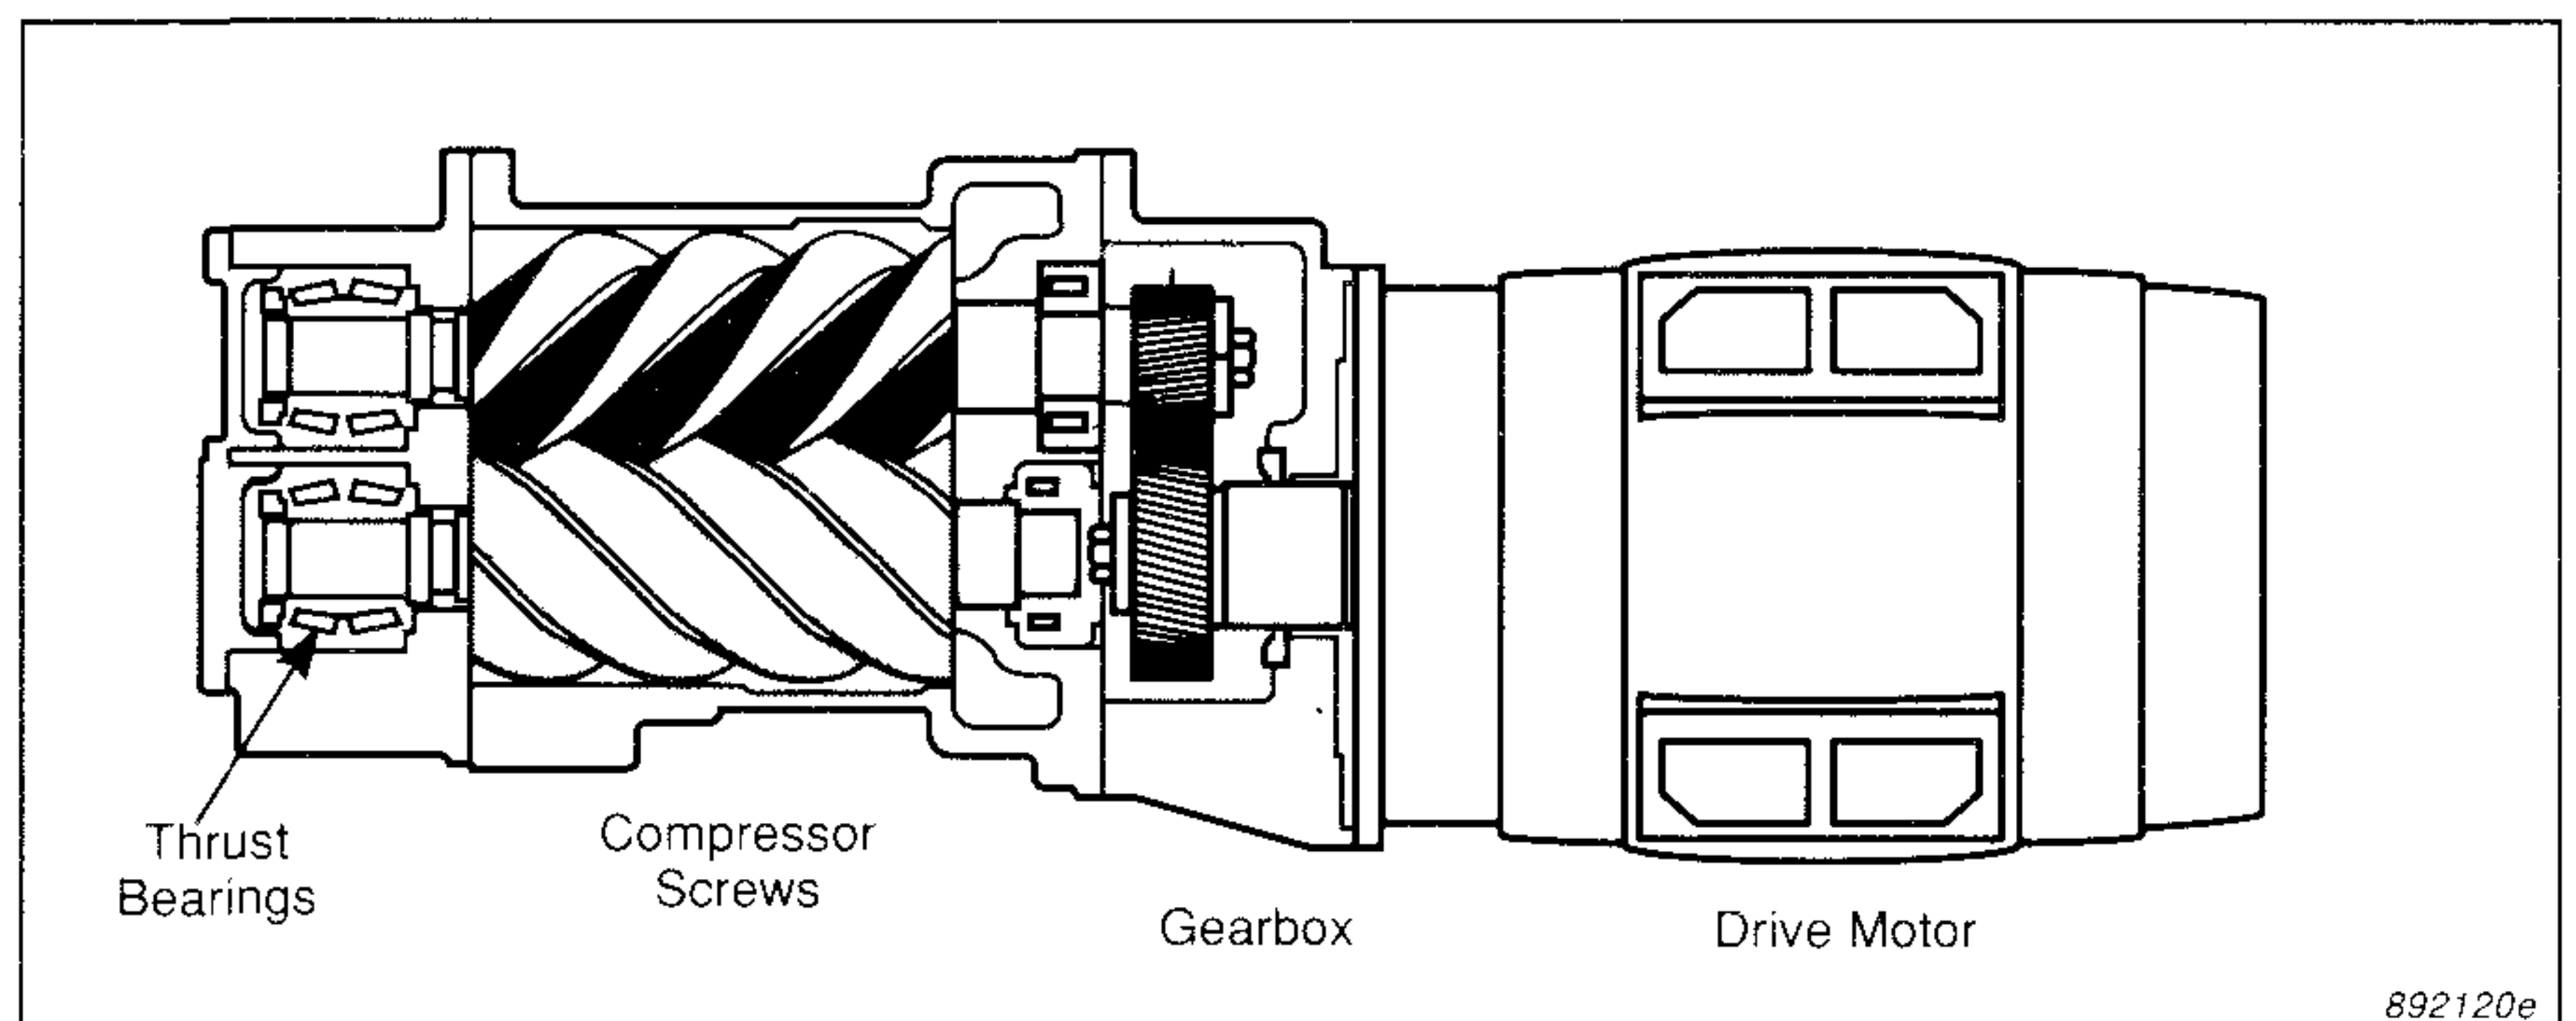
Screw compressors are used for high-pressure compression. Two adjacent, rotating spiral screws trap the gas at one end and force it out the other, see Fig. 13. In small compressors, as in this case, an electric motor drives one screw, which in turn drives the other screw. The speed ratio of the screws depends on the numbers of lobes. These are normally 4 and 6, which means a speed ratio of 6:4.

Fig. 13. A typical, small screw compressor, in which the top screw drives the bottom screw. The spiral profiles on the screws are called lobes; normally one screw has 4 lobes and the other has 6 lobes. The lobemeshing frequency is the product of the number of lobes and the screw rotation-frequency
