# Active Vibration-based SHM System: Demonstration on an Operating Vestas V27 Wind Turbine

Dmitri TCHERNIAK <sup>1</sup>, Lasse L. MØLGAARD <sup>2</sup>

<sup>1</sup> Buel & Kjær Sound & Vibration,

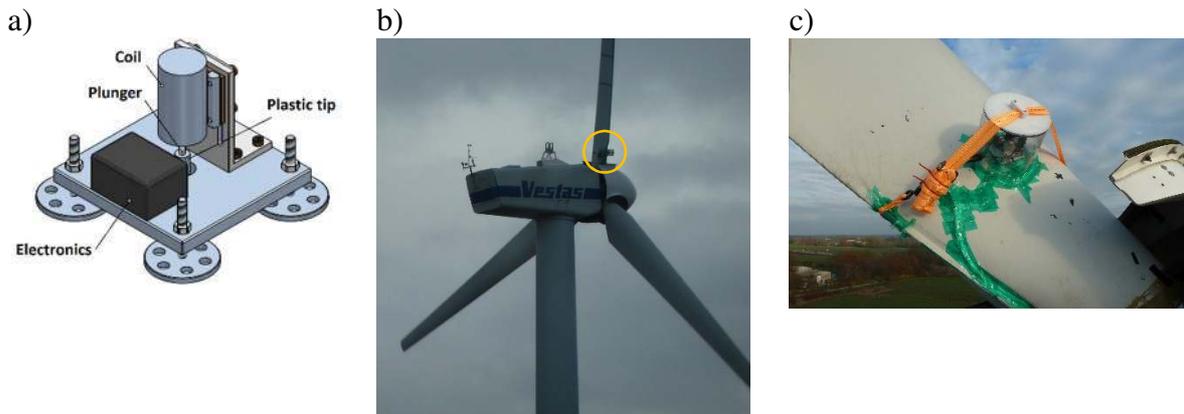
For blade excitation, the same actuator was used as for the SSP34m blade experiment (Figure 1a). The actuator is a simple electromechanical device: a coil is mounted on a steel base; driven by an electrical pulse, the coil “shoots” the plunger towards the structure; after the hit, the plunger returns to the initial position by means of a spring.

Due to the size of the blade, it was not possible to install the actuator inside the blade (as was done on the SSP34m blade). Instead, the actuator was installed outside the blade, on its upwind side about 1 metre from the root, covered by a waterproof lid and secured with a strap (Figure 1b,c).

Figure 1. Actuator: a) design; b) actuator location, inside the circle; c) installation on the blade.

A similar analysis was also performed for two other wind turbine regimes: operating at 43 rpm and idling. While the results of the 43 rpm regime are similar to those presented above, the idling case required taking rotor azimuth angle into account: apparently the samples measured at different blade positions are not directly comparable. A possible reason for this is that while idling, the blade pitch is about  $90^\circ$  and the plunger hit direction lies in the rotor plane. Therefore, the strength of the hit is affected by gravity and depends on the azimuth angle (Figure 1c). When operating, the blades' pitch is around zero, the actuator direction is always perpendicular to the vector of gravity (Figure 1b), and the hit strength is not be affected by the rotor position.

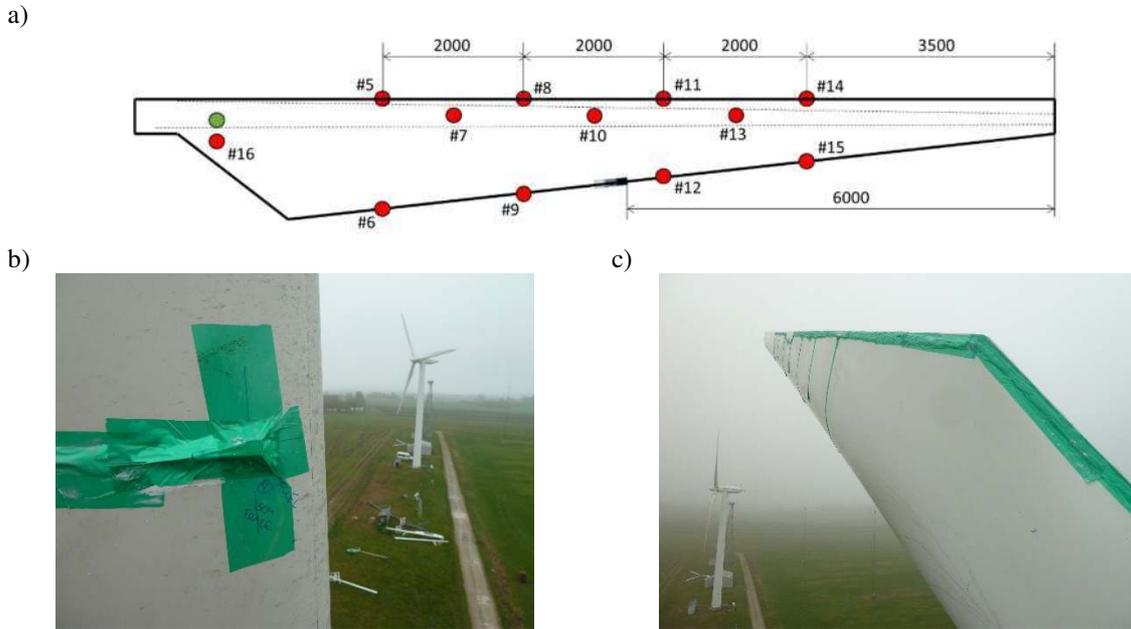
The vibrations were measured by accelerometers. The blade was instrumented with twelve monoaxial piezoelectric accelerometers (Brüel & Kjær Type 4507B); their location is shown in Figure 2a. The nominal sensitivity of accelerometers #5 - #15 was  $10 \text{ mV/ms}^{-2}$  (Type 4507-B-004) and accelerometer #16, located near the actuator, had nominal sensitivity  $1 \text{ mV/ms}^{-2}$  (Type 4507-B-001). For mounting the accelerometers, we used plastic mounting clips, which were glued directly to the blade (no special alignment was performed, the accelerometers' measurement direction was normal to the blade surface). To protect the accelerometers, they were covered by silicon, then “helicopter tape” was applied on top to give the silicon a smooth shape (Figure 2b). The accelerometers and cables were placed on downwind side of the blade.

The accelerometer cables run from the accelerometers towards the trailing edge and then along the trailing edge towards the blade root (Figure 2c). The cables were glued to the blade with silicon and covered with helicopter tape. Experience from the previous long measurement campaign on the same wind turbine [10] was used. From the same experience, we knew that

Figure 2. Blade instrumentation: a) red circles – location of the accelerometers; green circle – actuator location; b) accelerometer mounted on the blade; c) cable arrangement.

The initial artificial damage was introduced Dec. 9, 2014 (Figure 5a) by technicians from service company Total Wind Group. The trailing edge was opened and extended to simulate a crack. The length of the opening was 15 cm. The opening was covered by helicopter tape to prevent atmospheric water from coming into contact with unprotected inner blade material. Dec.15, 2014 the opening length was extended to 30 cm (Figure 5b) and Jan. 06, 2015 to 45 cm (Figure 5c). Jan. 19, 2015 the defect was repaired. The defect location in the blade is shown in Figure 2a and zoomed in in Figure 5d.

The covariance matrix is an  $N \times N$  symmetric matrix, where  $N$  is the number of sensors selected for the analysis (either the full set or a subset of the sensors in Figure 2a). The number of distinct elements in the matrix is  $K = N(N + 1)/2$ . If all 12 sensors are selected, the size of the vector is 78, which may reduce the reliability of the statistical model. To avoid this, a dimensionality reduction based on principal component analysis is employed to find a representation with a smaller dimensionality  $K$ . The feature vector  $\mathbf{y}_i \in R^K$ , computed for  $i$ -th actuator hit, becomes a "sample", describing the state of the blade at time  $t_i$ .

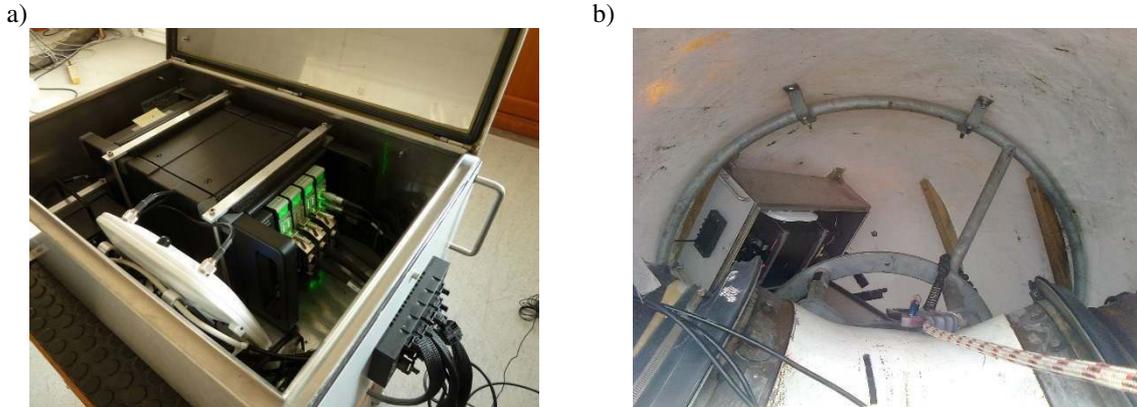
The data acquisition system and the electronics were placed in a waterproof box (dimensions  $60 \times 45 \times 20$  cm<sup>3</sup> and weight 25 kg), which was mounted to the inner surface of the spinner (Figure 3). The equipment was powered by 24 V from the nacelle via a slip ring.

Figure 3. Data acquisition system: a) The waterproof box with LAN-Xi system (more modules are shown); b) the waterproof box is mounted inside the spinner but the cables are not yet connected.

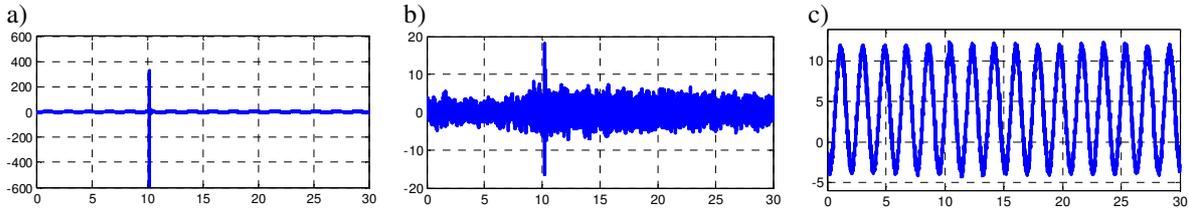
The data acquisition system was controlled by Brüel & Kjær PULSE LabShop software. The software was programmed to start data acquisition, wait 10 seconds, initiate an actuator hit and measure for another 20 seconds. Then acquisition was stopped and the system waited

for four and a half minutes and initiated again. Thus, 12 actuator hits and corresponding datasets were produced every hour. Typical signals are shown in Figure 4.

Figure 4. Typical signals: a) accelerometer #16 (20cm from the actuator); b) accelerometer #15 (8.5m from the actuator); c) DC accelerometer.

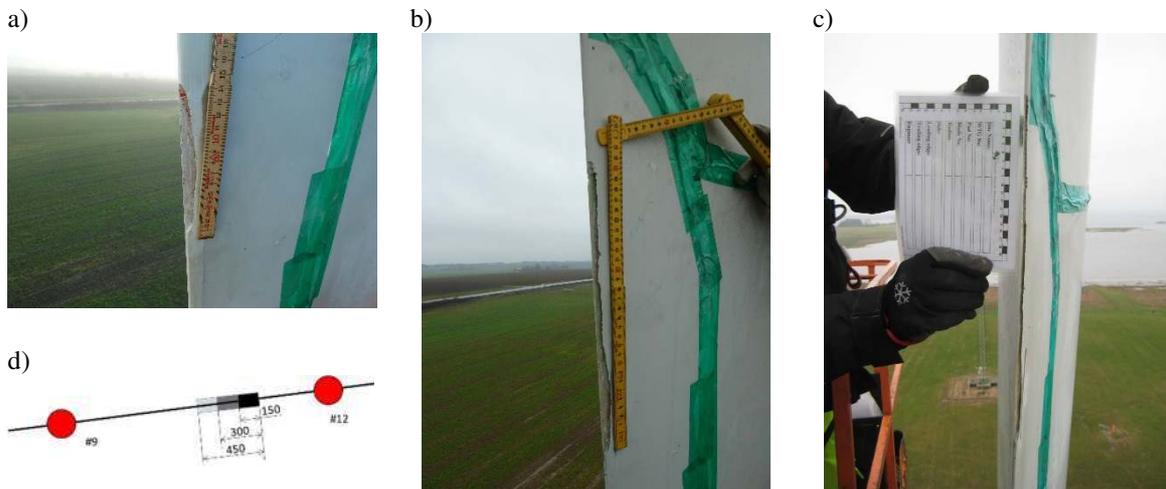
Figure 5. Implementation of the artificial blade damage. a) Initial 15 cm trailing edge opening; b) extended to 30 cm; c) extended to 45 cm. d) damage location in the blade relative to accelerometers, and its development: 15 cm > 30 cm > 45 cm correspond to black > dark grey > light grey.

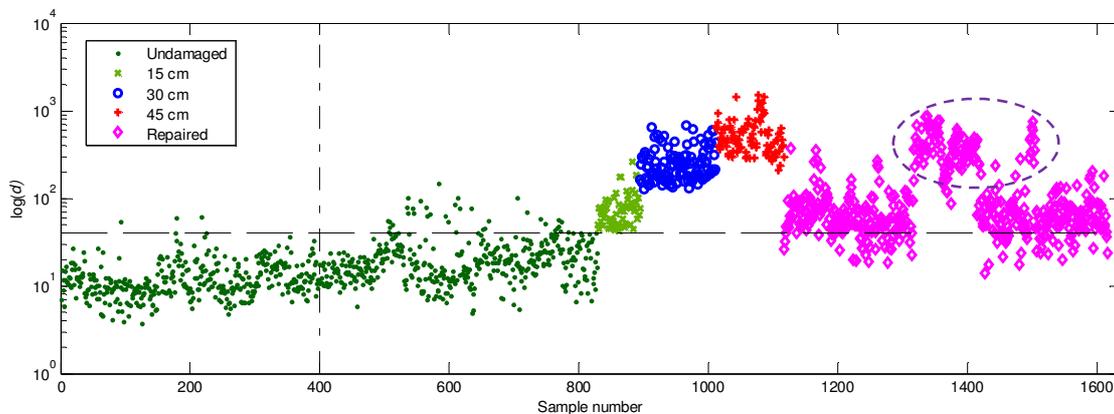
Figure 6 illustrates the analysis. The dark green dots represents the normal state; the dots to the left of the vertical dash-dot line are used for training and the threshold value calculation (horizontal dashed line). Four dots (1% of 400) are lying above the threshold, as they are allowed outliers. Model verification is performed using the remaining 428 samples from the normal state. It can be seen that 38 samples of the normal state are located above the threshold; they represent the Type I classification error (false positive or false alarms). They comprise almost 9% of the amount of samples in the verification set, i.e., significantly more than we allowed when forming the normal state modal. This may indicate that the size of the training set is not sufficient to cover all possible operating states, or that the samples are drifting due to some unknown reasons (for example, some slow changes of the SHM's hardware).

The light green crosses represent the samples belonging to the 15 cm crack state. None of the samples is below the threshold, indicating that there are no Type II errors (missed failure).

The blue circles and red vertical crosses represent 30 cm and 45 cm crack states, respectively. Both sets are well above the threshold, meaning that 100% of the damage cases are detected. Most importantly, there is clear evidence that the damage index increases with the damage amount, thus we can conclude that the technique is not only capable detecting damage but can also reflect its development.

Finally, the magenta diamonds represent the samples from the repair state. It is clear that for this state, the damage index decreased but did not go below the threshold: indeed, after the repair, the structure still differs from the initial intact state. Thus, a new model of the repaired state is necessary to proceed with monitoring. What is curious is the bursts of the damage index values between samples no. 1300–1400 and around 1500 (denoted by a dashed oval). An ongoing research is supposed to link this observation with either weather conditions or the changes in behaviour of the SHM hardware.

Figure 6. Logarithm of the damage index (1) vs. sample number computed for the 32 rpm wind turbine regime. Left to the dash-dot vertical line: training set; horizontal dashed line: threshold.

The input data is extracted from the database by querying the rotor rpm being in the range [30, 34] and the pitch angle  $\leq 0$ . The query finds 828 samples of the undamaged state, 66 of the 15 cm opening state, 117 samples – 30 cm, 105 – for 45 cm and 500+ for the repaired state. The latter was limited to 500 samples. Signals from accelerometers #5, 8, 9, 11, 12, 14, 15 are used for computing feature vector ( $N = 8$ , employing dimensionality reduction, with 99.9% variance explained,  $K=13$ ). The model of the normal state is constructed based on the first 400 samples of the normal state; the threshold value is calculated based on the same set, allowing 1% of the samples to be outliers.
