Envelope analysis – the key to rolling-element bearing diagnosis

by Joëlle Courrech and Mark Gaudet
Brüel & Kjær

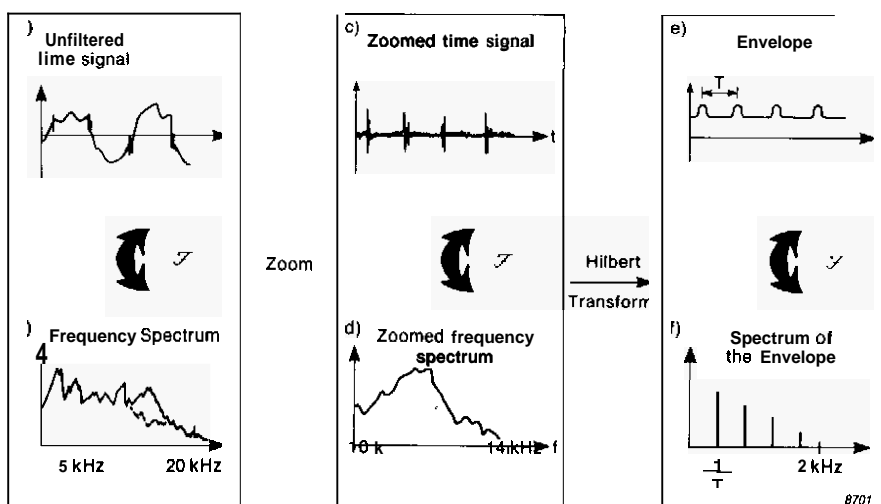
The 2032/34 uses zoom to extract the region of the resonance excited by the hearing-fault, from the frequency spectrum. Then the Hilbert transform is used to produce the envelope of the filtered time signal.

The envelope-analysis principle of the 2032/34-based system is shown on the previous page:

(a) is the time signal of the vibration measurement, from the bearing housing.
 (h) is the corresponding frequency spectrum, which is related to the time signal by the Fourier transform. An increase in level in a particular frequency range (as indicated by the dotted line) is detected when a structural resonance has been excited by a fault.
 (d) is the frequency spectrum extracted by zooming around this particular frequency range. It contains the structural resonances which have been excited by the impacts produced by the fault(s).

(c) is the corresponding time signal, which contains only the resonance frequency which is modulated by the impact frequency.

(e) In the analogue process, the time signal is then rectified and smoothed by a detector to produce the envelope of the time signal. Consequently, the envelope contains only the low modulation-frequency component relating to the impact rate(s). The 2032/34 produces a very accurate representation of the time signal, which is free from the limitations of a smoothing circuit, by using the Hilbert transform to calculate the magnitude of the time signal.

(f) The time envelope is then frequency analyzed to establish the impact

frequencies. This reveals the presence of a bearing fault. The Dual-Channel Analyzer Type 2032/34 computes the frequency spectrum of the envelope of the zoomed time signal, when controlled either by a computer with the Envelope Analysis Program for the 2032/34 or by Graphics Recorder Type 2313 with Application Package BZ7006.

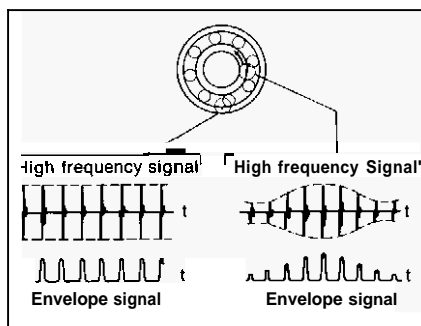
Fig. 2. The modulation effect caused by a fault on the stationary and on the rotating race.

Figure 2 illustrates the difference between the signal produced by a fault on the stationary race and a fault on the rotating race. In the first case, the fault will always be subject to the same load and the resulting impacts will have equal amplitudes. In the second case, the fault will rotate in and out of the loaded region, causing modulation of the impact amplitudes by the rotation speed of the shaft.

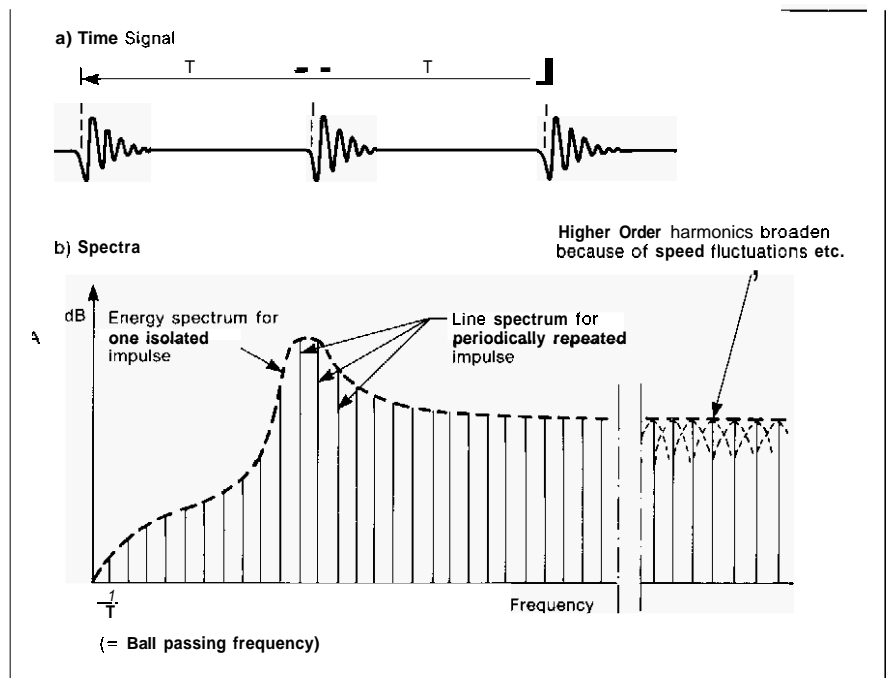
Fig. 1. Frequency spectrum for an idealized impact fault.

Figure 1 illustrates the result of analyzing an impactive fault exciting only one resonance. The dotted line represents the energy spectrum of one pulse, that is the frequency response of a single-degree-of-freedom system. If the pulses are identical and are uniformly spaced by T , the spectrum of the impact series would be a line spectrum comprising all harmonics of the repetition frequency $1/T$, with the largest amplitudes in the vicinity of the resonance frequency. The repeti-

tion frequency could be determined by zooming in this region and establishing the harmonic separation. In practice, there are small differences between the pulses and in their spacing; as a consequence the higher order harmonics broaden and eventually merge. As an example, a speed fluctuation of 0,1% would cause merging around the thousandth harmonic. At low frequencies the influence of speed fluctuations is very small. However, the harmonic pattern of the hearing fault(s)

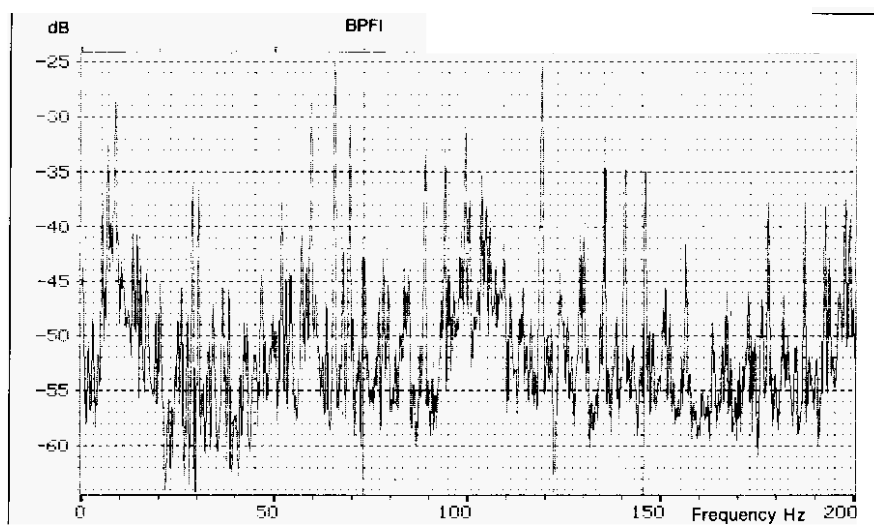
Fig. 3. Baseband vibration spectrum up to 200 Hz for a faulty ball-bearing. It is very difficult to detect any of the bearing characteristic frequencies.

The frequency spectrum of the acceleration signal for the ball bearing is shown in Fig. 3. This is the region in which we would expect to detect the hearing characteristic frequencies for a faulty hearing. It's very difficult to detect any of the bearing frequencies in the baseband measurement because other vibration sources have produced more dominant frequency components.

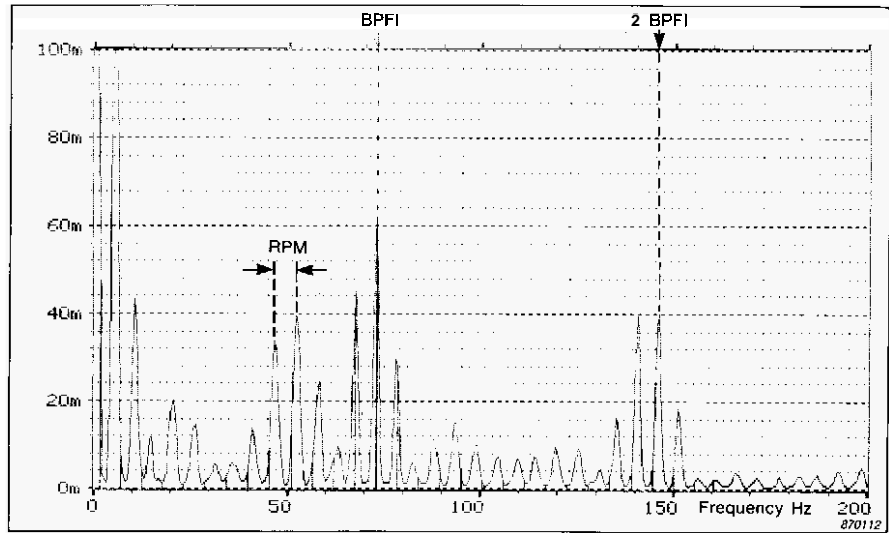
Fig. 4. Envelope of the frequency analysis (zoomed around 9kHz) of the faulty ball-bearing. The BPFI and sidebands modulated by the RPM are clearly evident.

Consequently, 2032/34-based envelope analysis was used to produce the envelope of the zoomed time signal. The corresponding frequency spectrum was calculated using the Graphics Recorder Type 2313 together with the BZ7006 Application Package, and this is shown in Fig. 4. This clearly shows the BPFI at 73Hz and the second harmonic at 146Hz; the sidebands are caused by modulation due to the rotation speed which is 5,3Hz. This modulation occurs as the fault moves through the loaded area of the bearing.

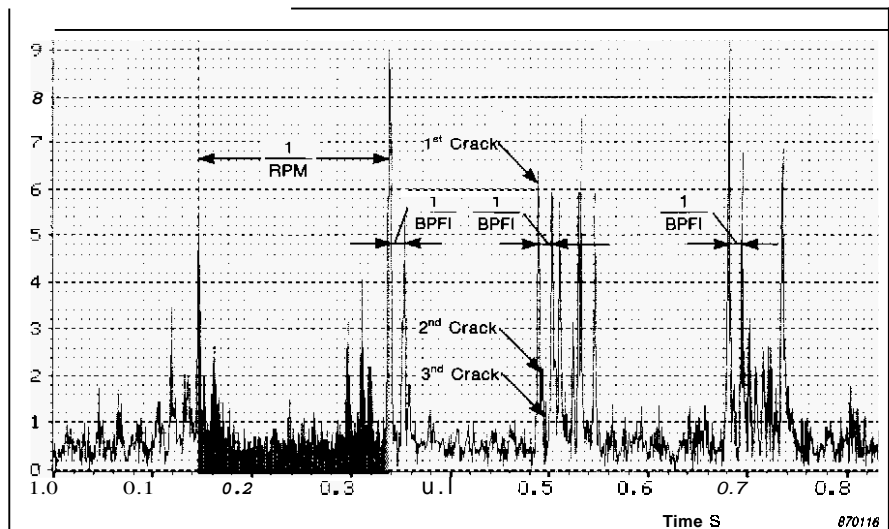
Fig. 5. The envelope's time-signal showing a series of impacts repeating at the rotation frequency. Close inspection reveals three closely-spaced peaks, relating to three transverse cracks on the inner race.

The envelope of the zoomed time-signal is shown in Fig. 5. This reveals a series of peaks repeating with a period equal to $1/BPFI$. Each time a ball passes a crack, an impulse is produced, which results in a peak. On examining Fig. 5 more closely, three more-narrowly spaced peaks are evident. These peaks originate from three transverse cracks on the inner race. The three-peak pattern is repeated as balls pass over the three cracks. These impacts are clearly amplitude modulated with a period equal to $1/roller-rotation\ frequency$.

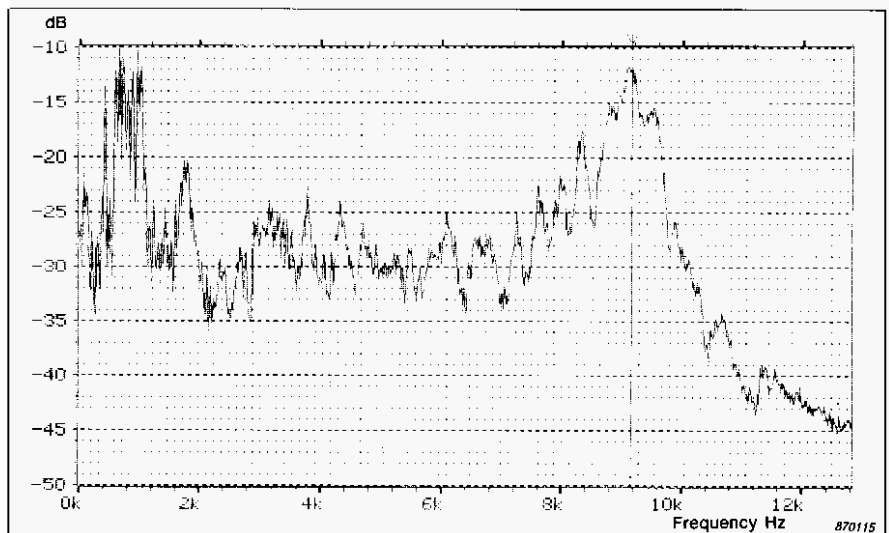
Fig. 6. Response function (0-12,5kHz) produced by a hammer test, showing the structural resonances for the bearing housing. The resonance at 9kHz was used for the zoom analysis.

As no reference spectra were available for the paper-drier, a hammer test was used to produce the frequency response to an impact. This reveals the structural resonances of the hearing, which are shown in Fig. 6. The structural resonances are concentrated in the 8kHz to 10kHz region, which is the region most suitable for zoom analysis as it offers the greatest signal-to-noise ratio.

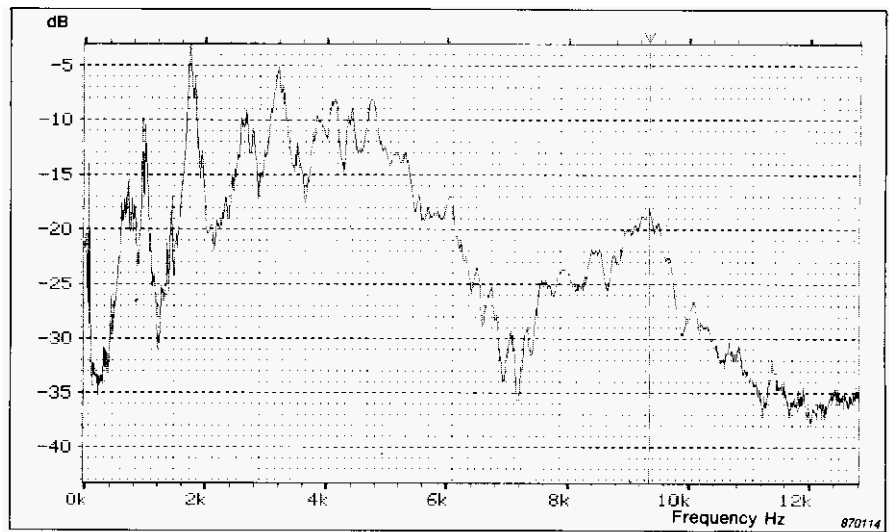
Fig. 7 Vibration spectrum up to 12,5kHz showing the same resonance region as the hammer-test response.

To perform a hammer test on the hearing housing, the machine has to be stopped. Often, this is impossible (for example: in the continuous process industry) and in this case the vibration spectrum must be used to establish the most suitable zoom region. The vibration spectrum up to 12,5kHz is shown in Fig. 7; the same structural resonance region is evident in the 8kHz to 10kHz region.
